Risk – What Does It Mean To Me?

Dew Point Corrosion: A Case Study	5
Field Replication of Gas Turbine Blade Microstructure	8
Announcements	10

Dew Point Corrosion: A Case Study

Field Replication of Gas Turbine Blade Microstructure

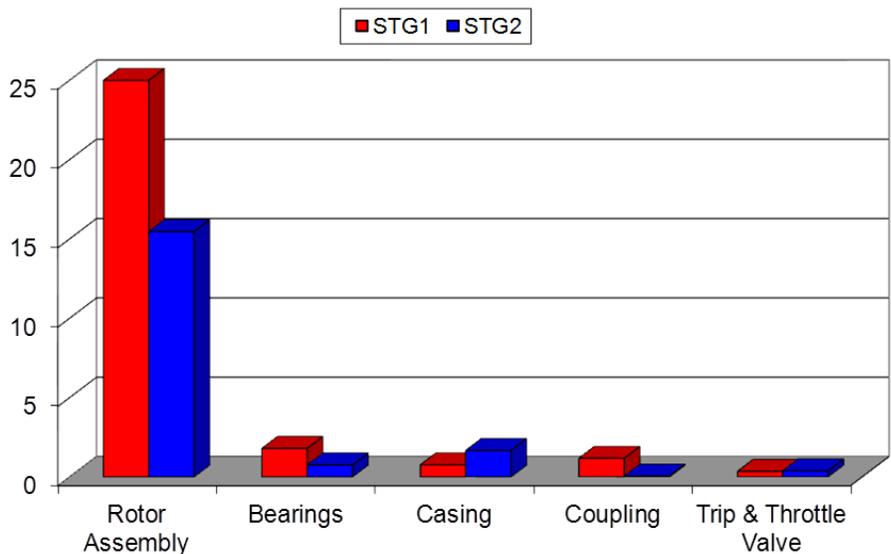
Figure 1. STG1 has higher risk of a rotor assembly failure as compared to STG2.

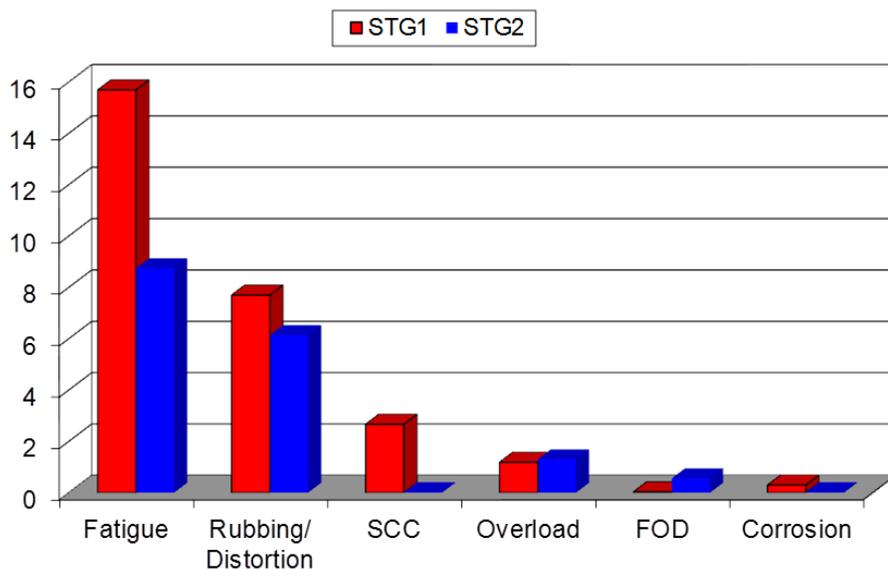
Figure 2. The highest risk failure mode for both STG1 and STG2 is fatigue.

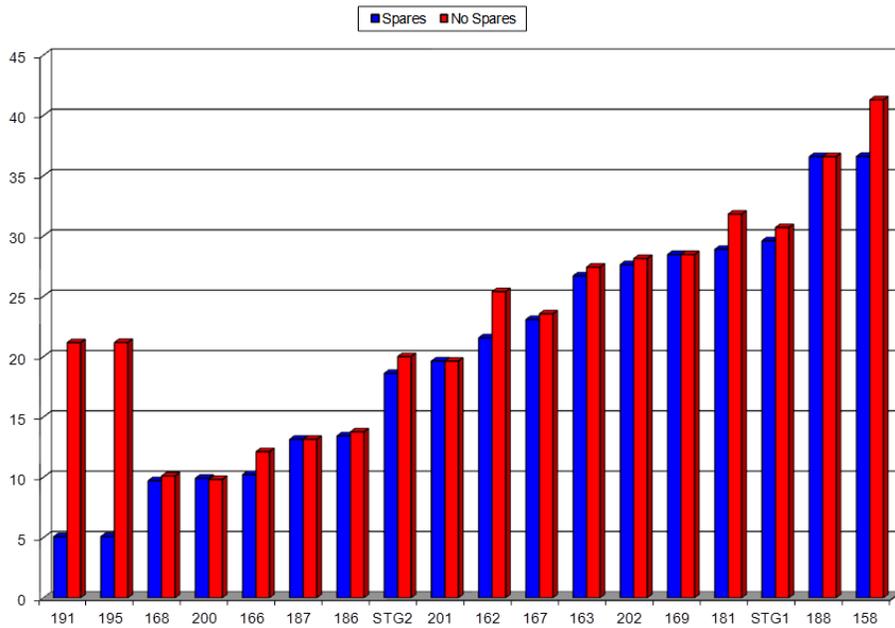
Figure 3. STG1 is a higher risk unit as compared to STG2.

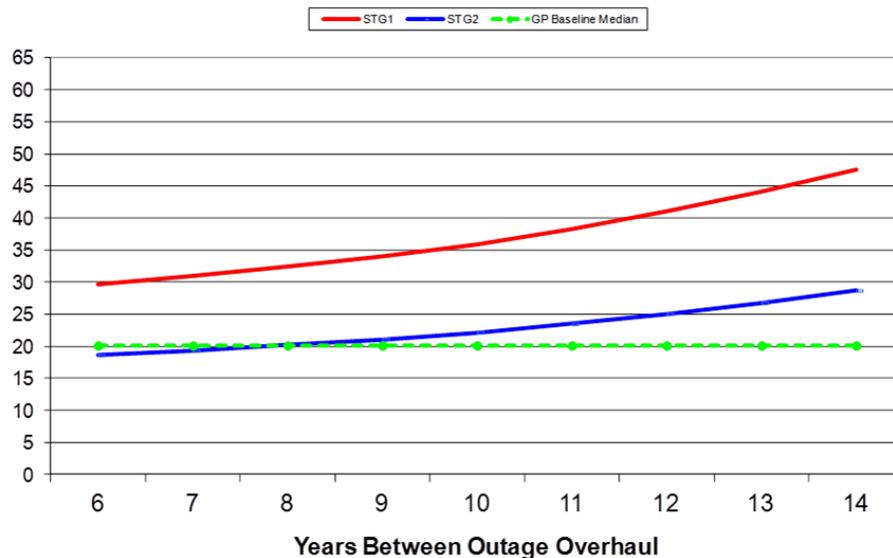
Figure 4. The risk for both STG1 and STG2 increases as the time between overhauls increases.

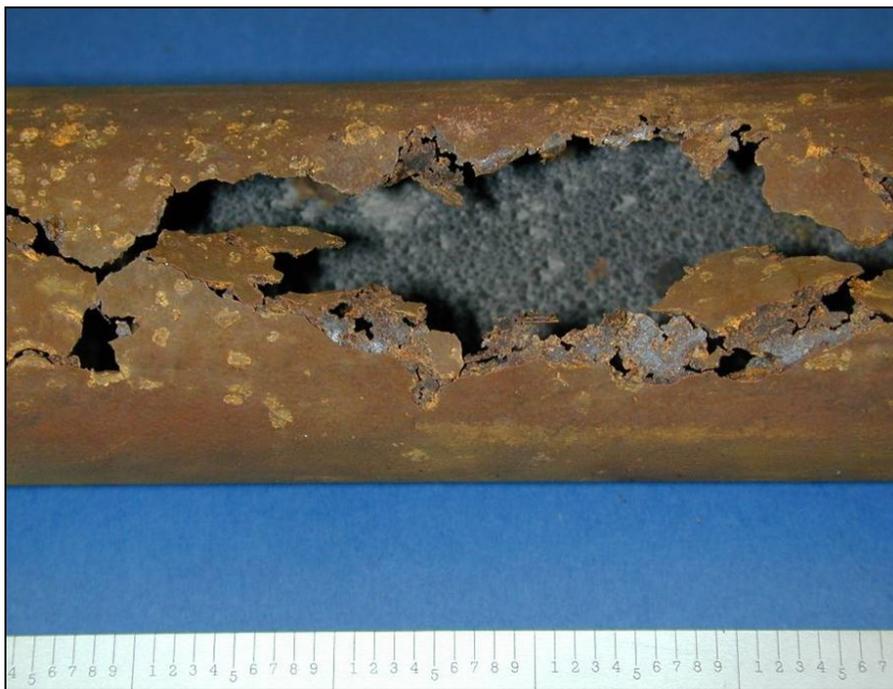
Figure 1. The air heater tube section in the as-received condition.

The tube came from a boiler that burns bark, tire-derived fuel, and gas fuels. It has a flue gas temperature between 480 and 500° F during normal operating conditions. The as-received tube section is shown in Figure 1.

The air heater tube section exhibited corrosion on the external surface of the tube. The ends of the tube were badly damaged. In addition, the wall thickness was extremely low. A perforation was noted over most of the length of tube. Cross sections from the air heater tube were removed at the failed area and at an area remote to the failure. The cross sections were

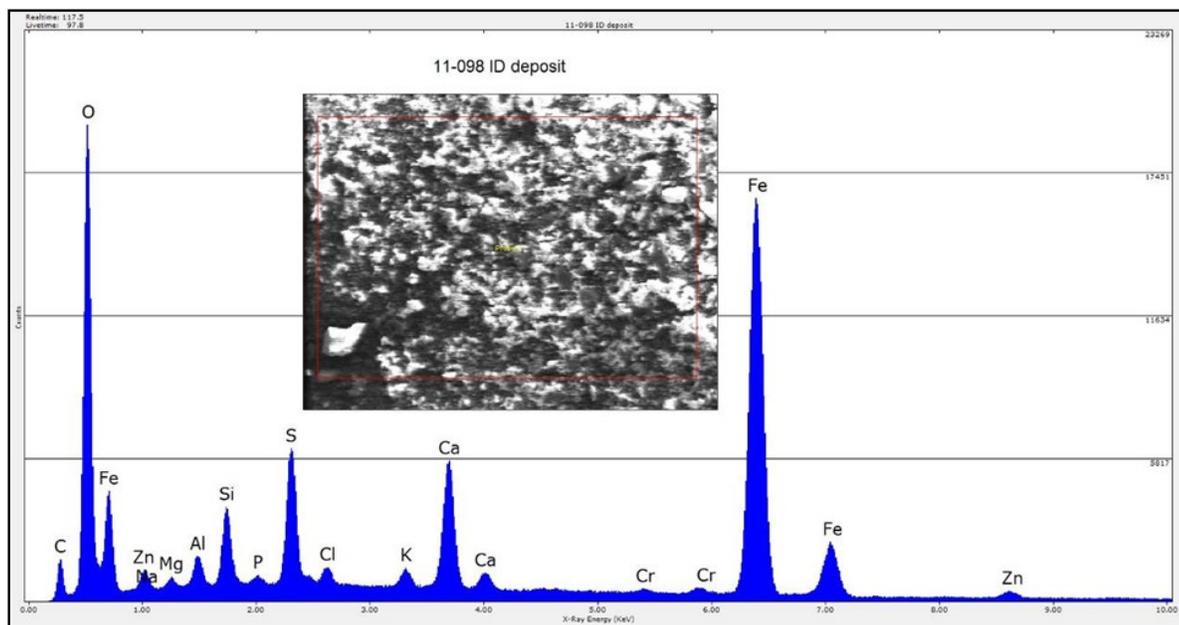
The deposits collected from the internal surface of the tube were analyzed in-situ using the scanning electron microscope (SEM), where elemental analysis was performed using energy dispersive X-ray spectroscopy (EDS) to determine their composition. The EDS spectrum of the chemical composition of the internal deposits is shown in Figure 2, and the results are summarized in Table I.

The deposits consist mostly of iron and oxygen. Lesser amounts of carbon, aluminum, silicon, sodium, calcium, and zinc were present. In addition, trace amounts of sodium, magnesium, phosphorus, chlorine, potassium, and chromium were present. In this case of dew point corrosion, elements such as sulfur and

Figure 2. EDS spectrum of the chemical composition of the deposits collected from the internal surface of the heater tube.

chlorine in a wet environment can react with the cooled vapors to form acidic compounds such as a low concentration of sulfuric acid, which is very corrosive to carbon and low alloy steels, such as CorTen.

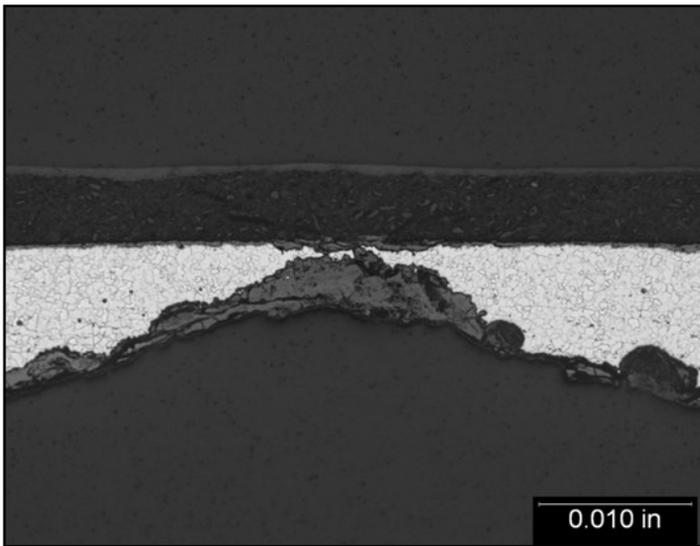
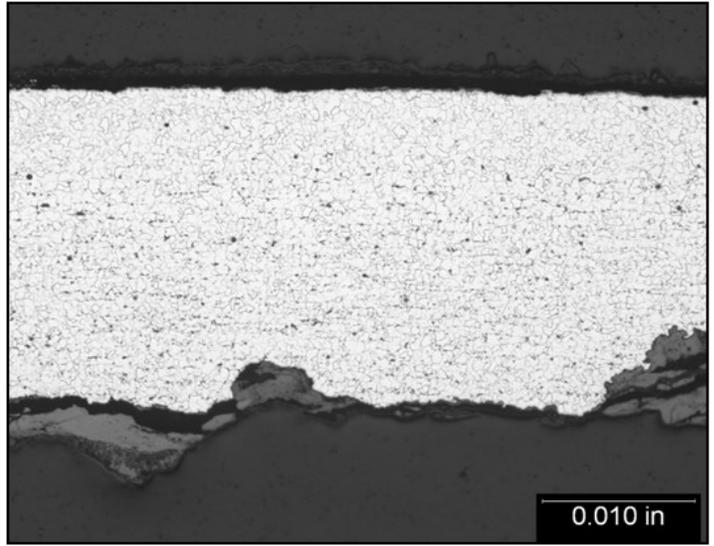
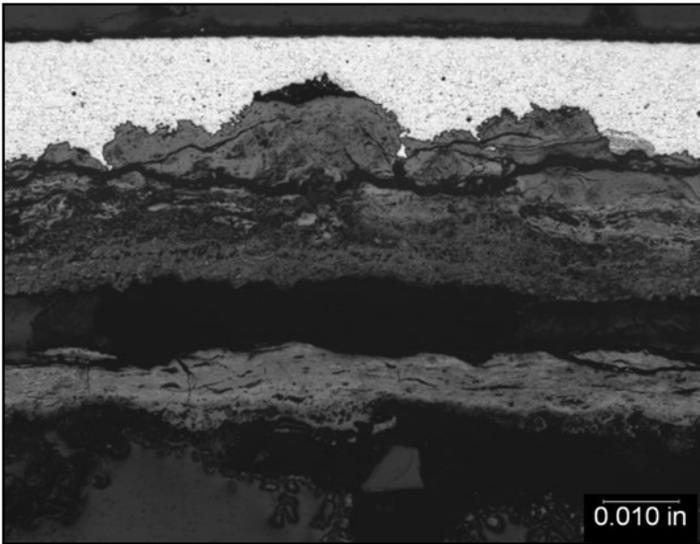
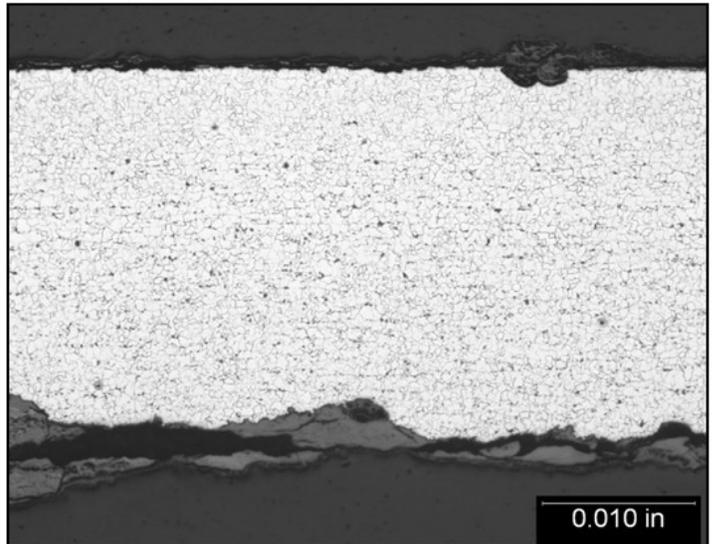
prepared using standard metallographic techniques of mounting, grinding, polishing, and etching. Severe wall thinning of the air heater tube was observed in the perforated area (Figure 3). The cross section opposite from the perforation revealed deposit accumulation as well as severe wall thinning. The typical

microstructure for all the air heater tube sections consisted of pearlite and carbides in a ferrite matrix. There was no heat damage observed in the microstructure of the air heater tube. In addition, no material defects were noted that contributed to the failure.

Figure 3. Micrographs show the typical view of the perforated area (top images) and remote from the failure (bottom image) of the primary heater tube.

The following items are measures that can be used to prevent or minimize dew point corrosion are:

Using a steam preheater to heat incoming air before it enters the preheater.

Addition of neutralizing fuel additives like calcium or magnesium oxide/hydroxide. Such additives prevent an acidic environment.

Controlling air leakage from perforated cold end tubes.

Using fuels with lower sulfur content.

Injection of ammonia to reduce the acidity of the flue gas.

Employing a high pressure water spray of deposits on the fire side after boiler shutdown, followed by a lime wash to neutralize acidic substances.

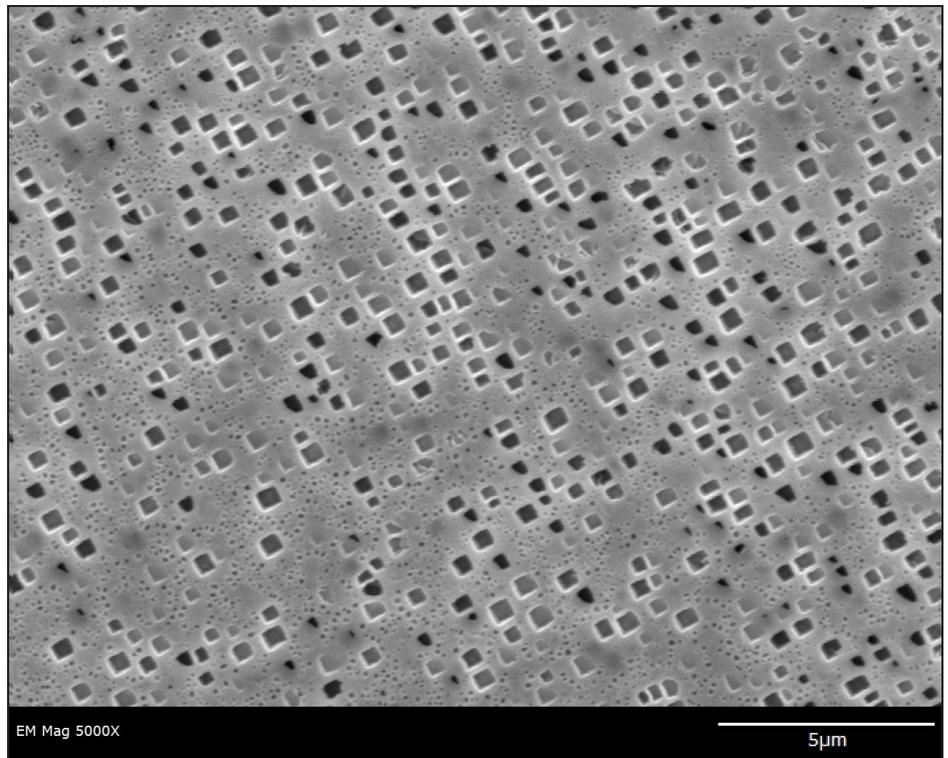
Figure 1. Typical gamma prime after ageing heat treatment

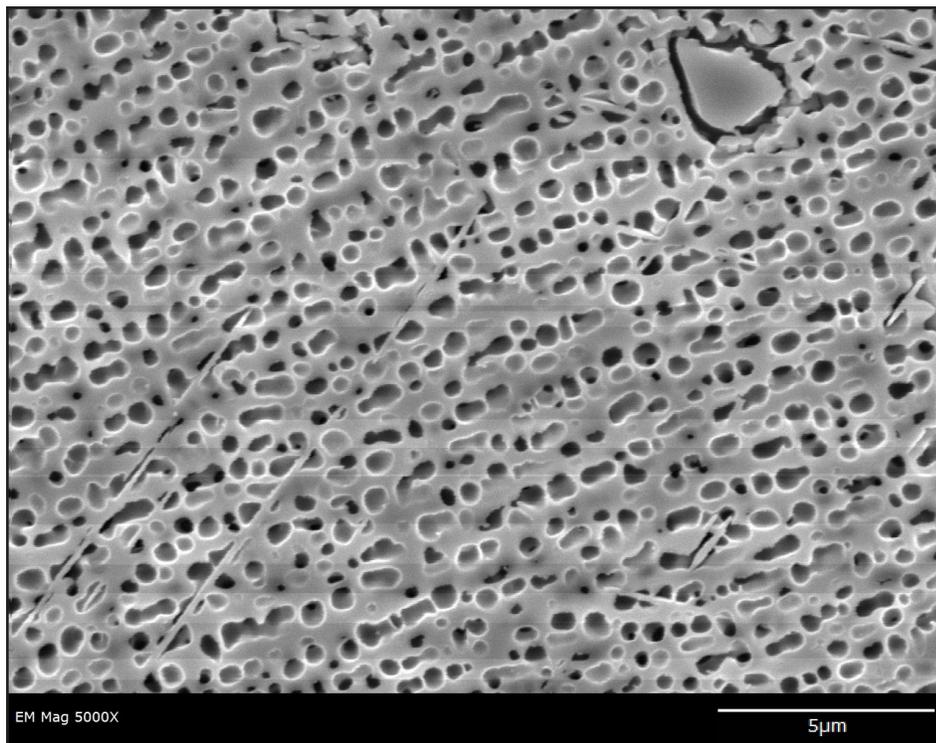
Figure 2. Typical gamma prime after a complete hot gas path cycle

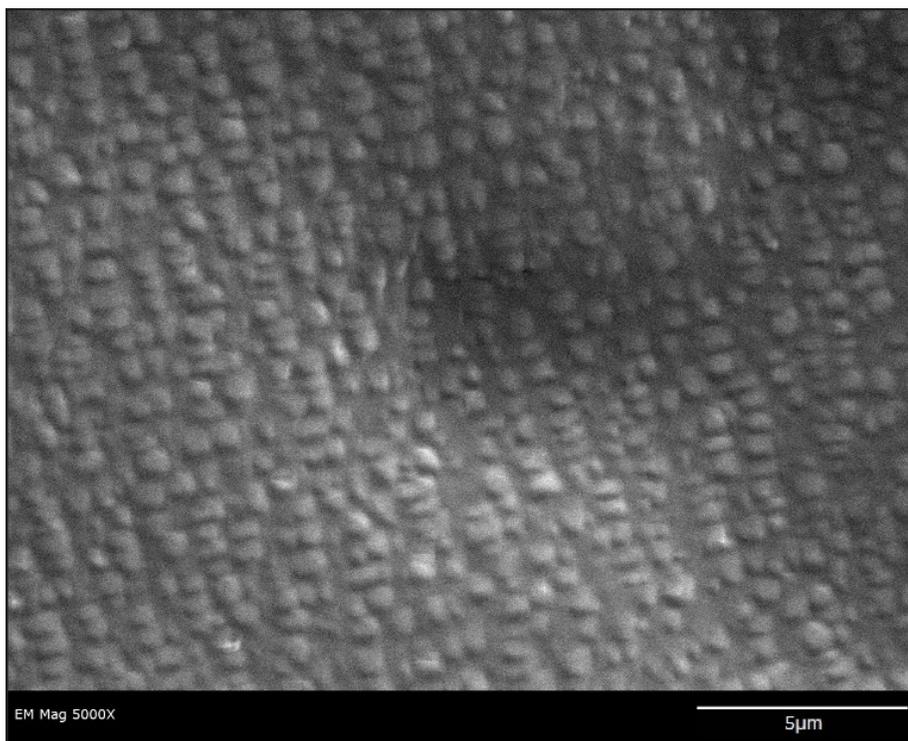
Figure 3. Typical replica of gamma prime after exposure to hot gas path conditions
