Investigation: Water Cooled Generator Stator Bars

By: Karen Fuentes
Sr. Principal Engineer

MIC in Stainless Steel Tubes

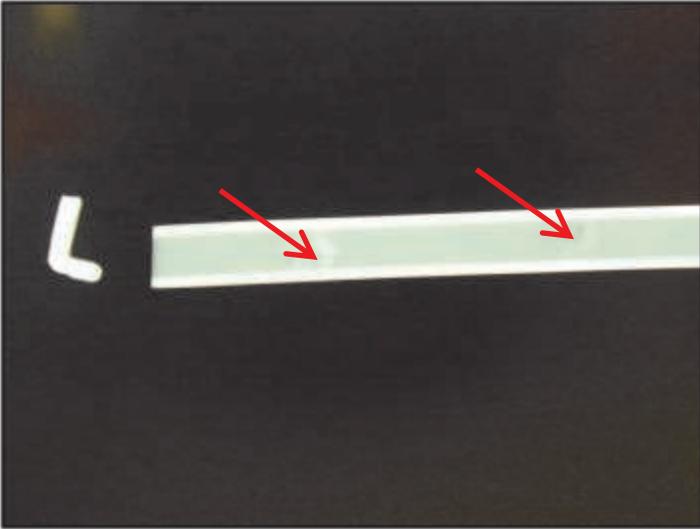
Figure 1.

The stator bar sections containing restrictions and plugs were initially X-ray radiographed in the assembled condition to try to determine the location of the restriction and plugging. However, because of the stacking of the cooling strands, specific areas of blockage could not be discerned in the radiographs. The stator bar sections were sectioned further and the shorter lengths were re-tested using the air velocity method. Once the section was reduced to approximately one foot or less in length, the cooling strand with the plug or restriction was marked and the stator bar section was disassembled and the cooling strand removed from the bulk of the stator bar section. The individual cooling strands were then radiographed to identify the specific location of the plug or restriction (Figure 1 and Figure 2).

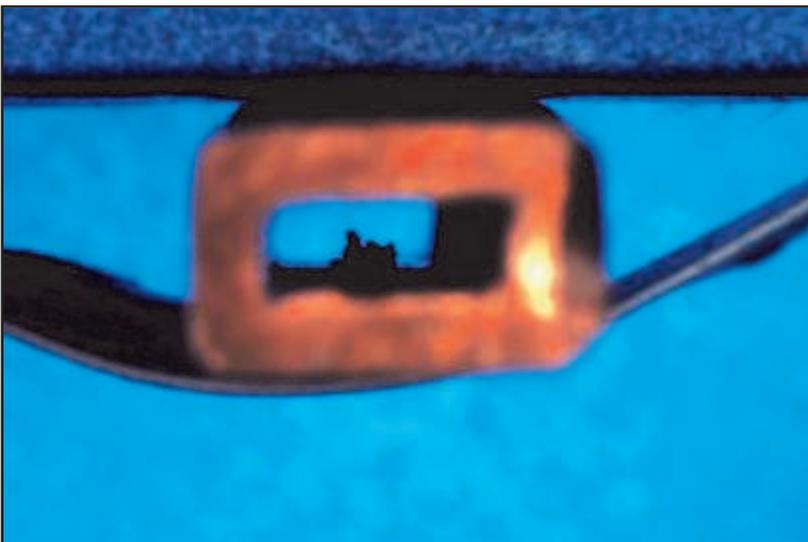
Figure 3.

Upon initial sectioning, the internal condition of the strands with the plugs was visually examined and photographically documented. The deposits were observed extending from the inner walls of the strands (Figure 3) and in some cases completely

plugged the internal passage. The deposits were dark grey to black in appearance.

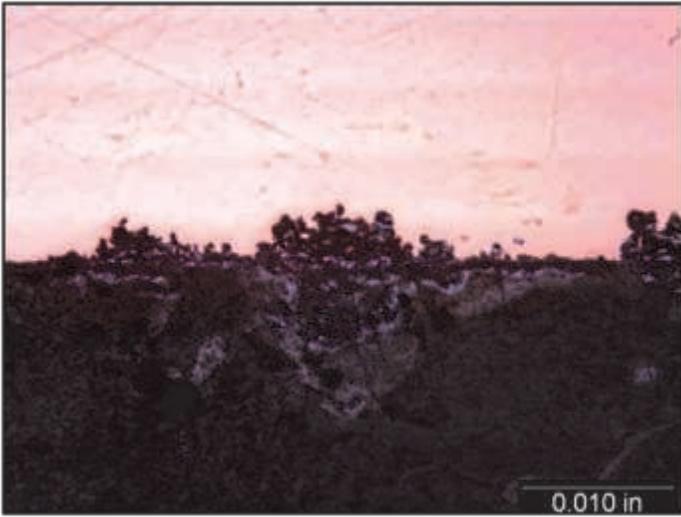
Figure 4.

A sample from a straight section of the stator bar was found to contain a bend when the strand was removed from the bar. It contained a buildup of deposits. Examination of the internal strand wall showed that there was pitting under the

deposit build-up (Figure 4). The pit bottoms were uneven and appeared deepest under the thickest deposits.

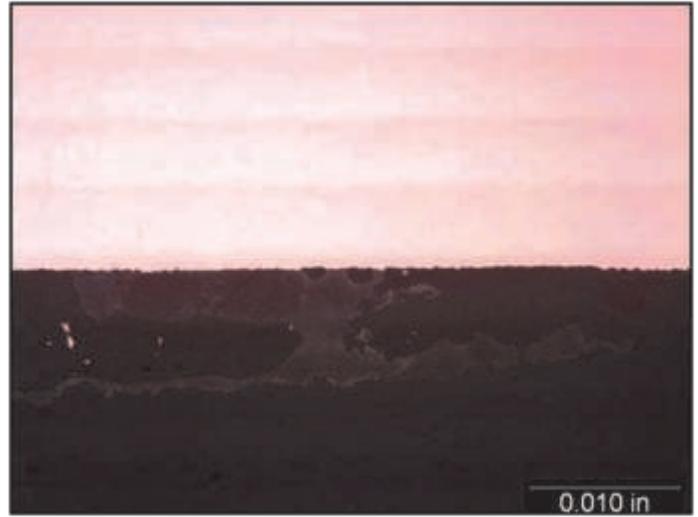
Figure 5.

The section of the strand prepared downstream of the build-up contained a thin even layer of deposits. No pits similar to those observed along the internal strand walls of the sample in the plugged area were observed. The appearance of the internal strand wall was slightly different in areas where there were voids in the deposit at the strand wall, as compared to areas in which the deposit was in contact with the strand wall (Figure 5).

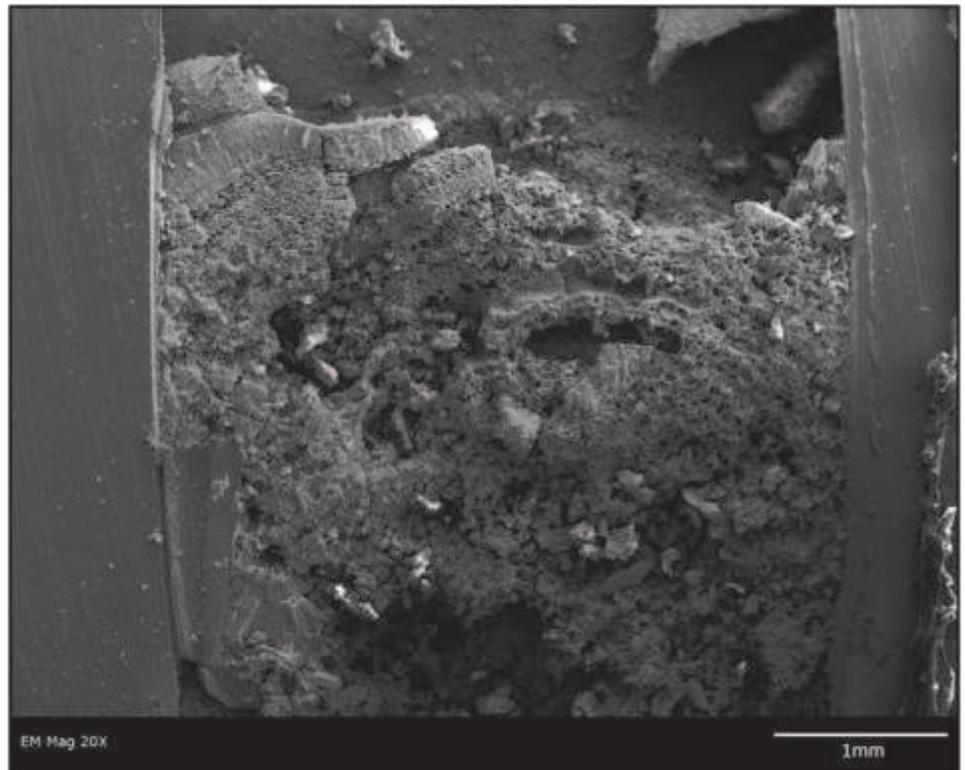
Figure 6.

The morphology of the material building up and plugging the strands was documented at various magnifications in a scanning electron microscope (SEM). Three morphologies of oxide were observed (Figure 6): feathered, thicker layer

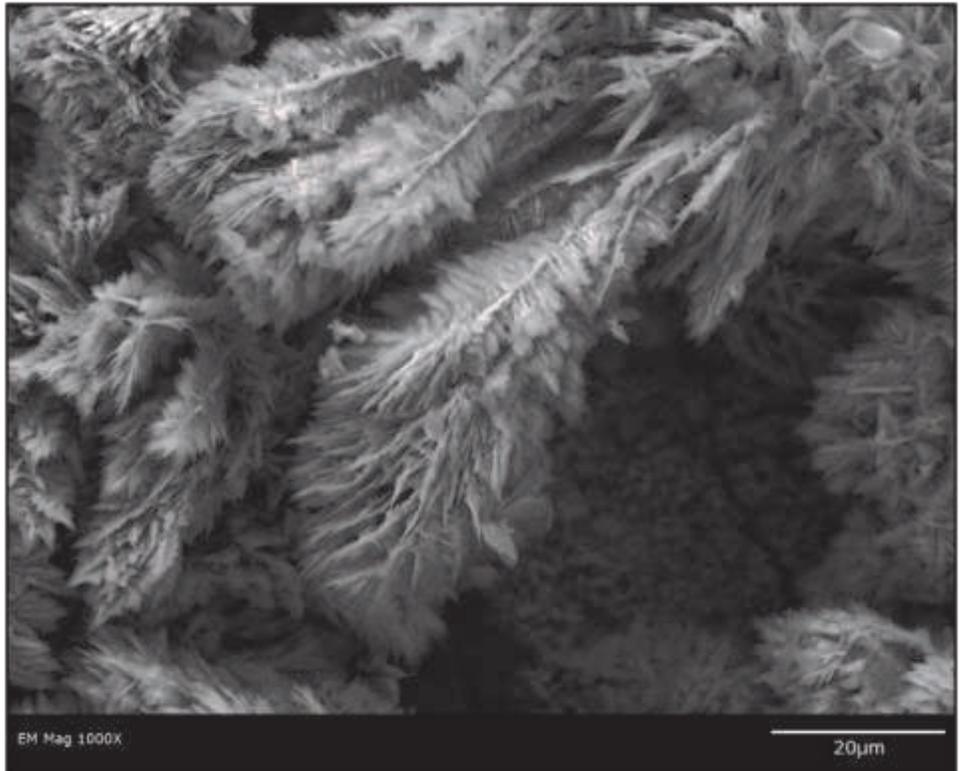
Figure 7.

extending into the cooling water stream (Figure 7), coral-like, thicker layer extending into the cooling water stream (Figure 8), and thin layer along the surface, some with rosette-like appearance (Figure 9). The layering suggests that different morphologies were formed at different times or under different conditions.

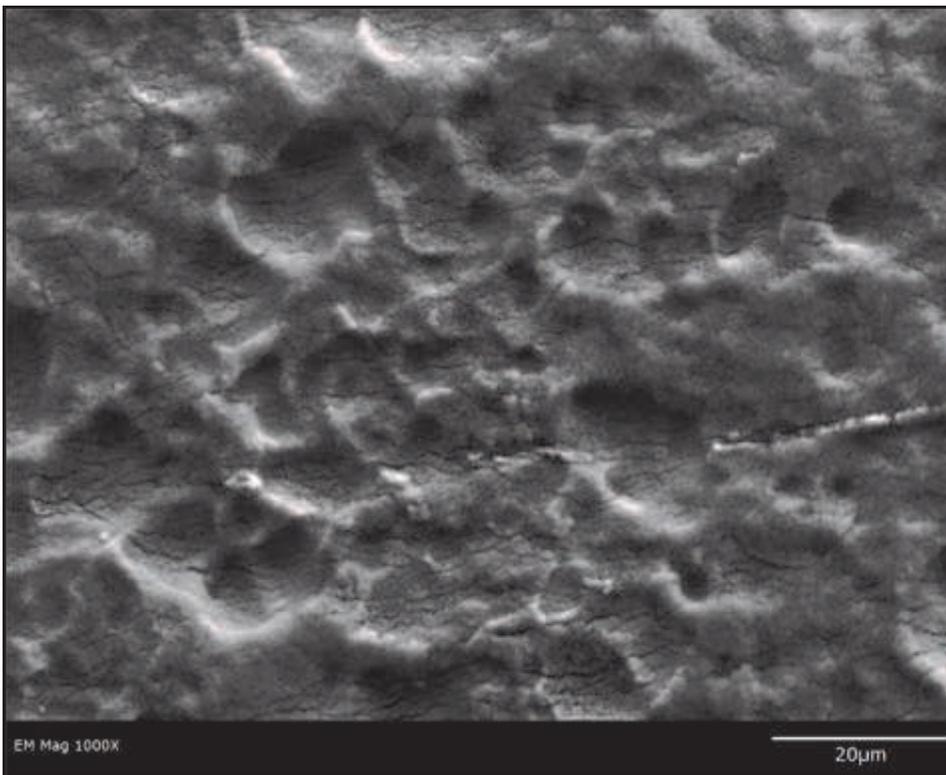
Figure 10.

Examination of the strand walls on the sample removed from the straight section of the bar with no indications of restrictions or plugging had a pocked appearance (Figure 10).

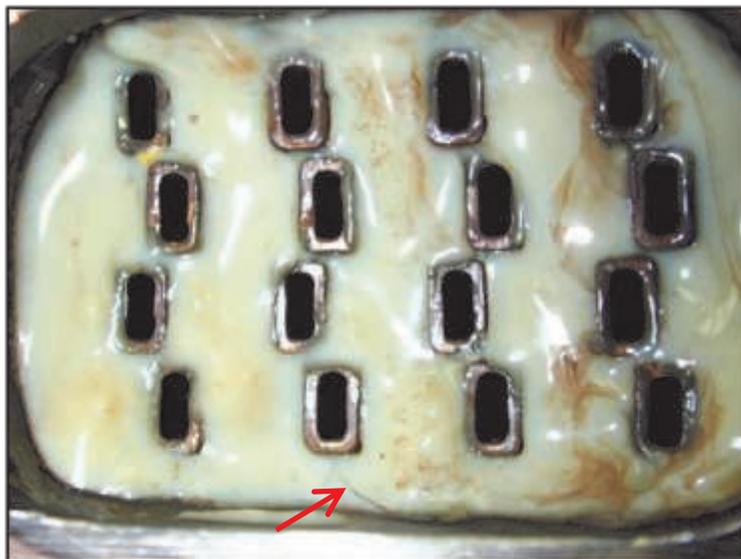
Figure 11.

water boxes on each end of both bars were relatively free of deposits. Some cracks were observed in the epoxy coating, but no spalling of the epoxy was observed (Figure 11).

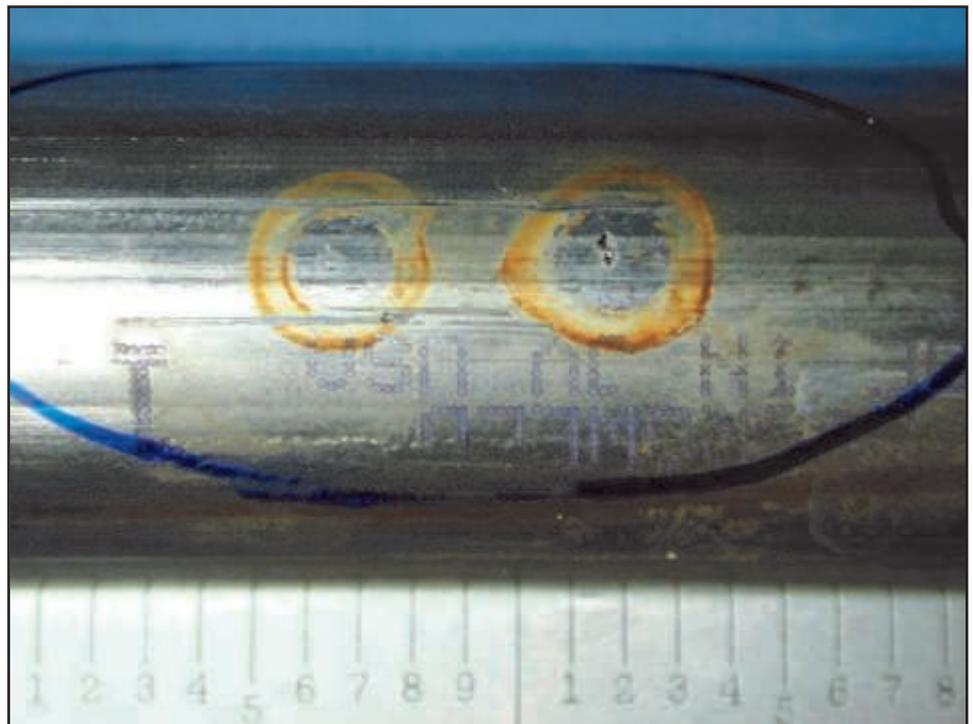
Figure 1.

The perforations appeared to initiate from the external surface (cooling water side) and had rust-colored rings surrounding each leak (Figure 1). The rust colored rings were suggestive of tubercles or bacteria slime colonies surrounding the leaks characteristic of microbiologically influenced corrosion (MIC). In addition, all of the perforations were on the tops of the tubes as they were positioned horizontally in the condenser. After examining the external

organisms) which typically result in rust color streaks emanating from the penetration, as seen on these samples. Dried-out deposit colonies in ring form were noted in the areas of localized pitting. The color of the deposits (reddish-brown) is also characteristic of MIC caused by iron oxidizers.

resistant stainless steels have been specified and can be selected as replacement. The tube material should have a pitting resistance equivalent number (PREN) of at least 34. Alloys with PRENs greater **than 34 include “super” stainless steels such as** higher molybdenum austenitics, high chromium ferritic stainless steels, or duplex grades.

Additional replacements could include nickel-based alloys or titanium. In addition, the welds in any new metallic piping system should be made in a way that minimizes their susceptibility to localized corrosion (i.e. smooth weld contours). The smoothness of the surface is also a factor. For example, an electro-polished surface will be more resistant to this attack than a standard mill finish simply because it is more difficult for bacteria to **gain a “foothold” on the smooth surface.**

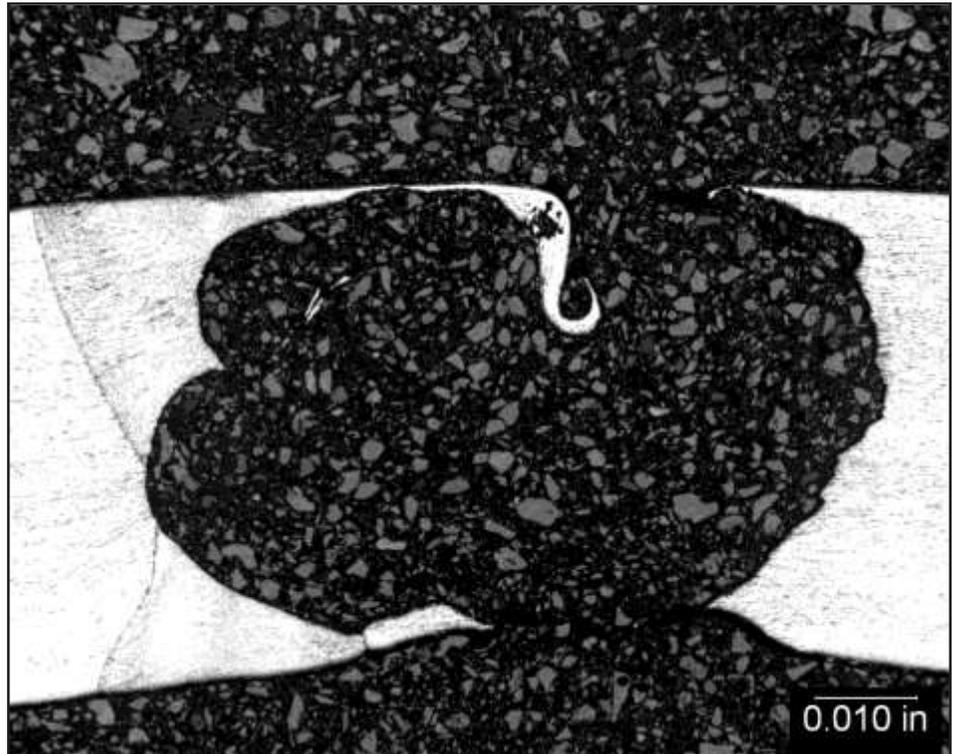
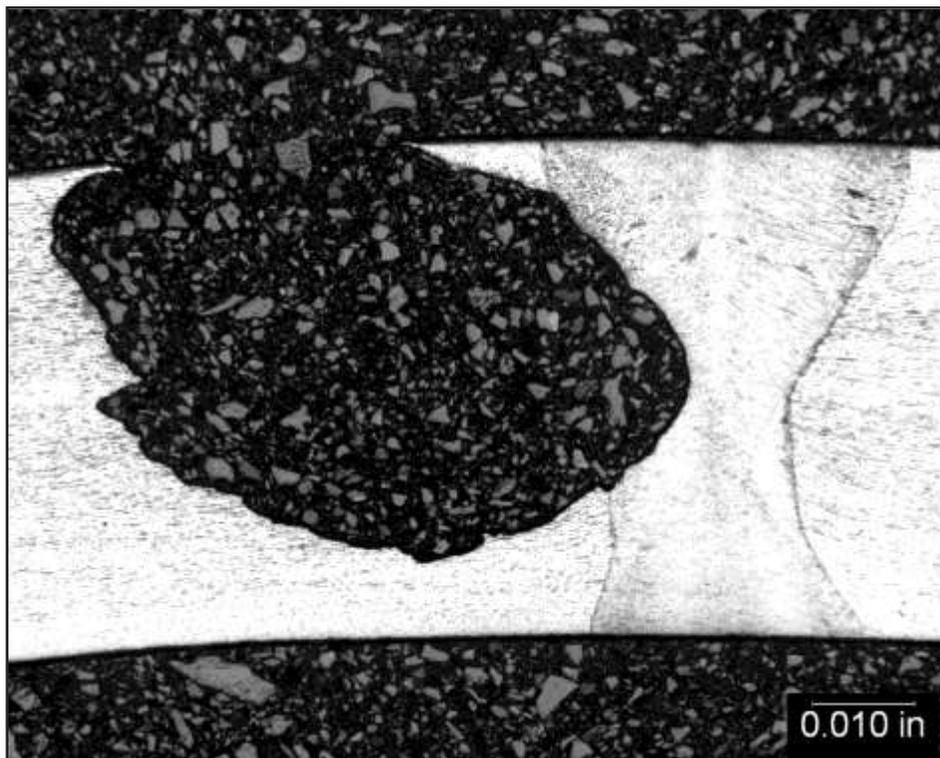
Two perforations were selected for further examination, and both were observed in more detail. The cross-sections showed that the pitting initiated on the external surfaces of the tubes usually at the longitudinal seam weld. Not all of the pitting on the three tube samples was adjacent to the welds since the perforations were not all in a straight line; however, the corrosion was preferential to the welds and the heat affected zone (HAZ) of the welds. The pitting was

undercut and progressed through the entire wall thickness (Figure 2 and 3). The undercut nature is indicative of MIC.

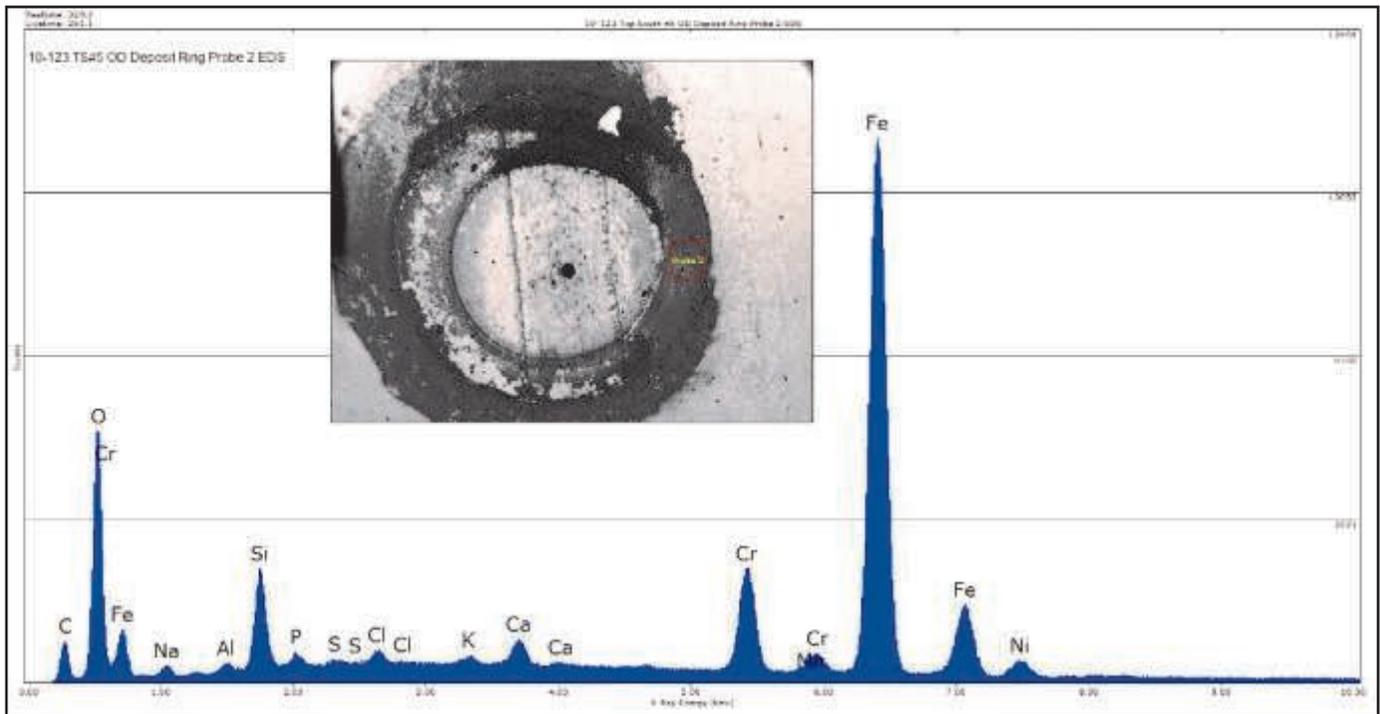
Figure 4.

The rust-colored ring deposit surrounding one of the perforation on the external

surface was analyzed *in situ* using energy dispersive X-ray spectroscopy (EDS¹) in the scanning electron microscope (SEM) to determine its elemental composition (Figure 4). The ring deposit consisted primarily of oxygen, iron, silicon, chromium, and carbon. Smaller to trace amounts of calcium, sodium, aluminum, nickel, potassium, chlorine, phosphorus, sulfur, titanium, magnesium, and manganese were also detected. Chlorine and sulfur can be associated with various types of bacteria that can cause MIC. The carbon was also high, indicating that something organic such as bacteria could be present. None of the other elements were out of the ordinary for stainless steel tubes exposed to treated cooling water.
