the Conduit

Summer 2008

Recovery Boiler Lower Furnace Problems

**By Ronald Lansing, P.E.
and Max Moskal**

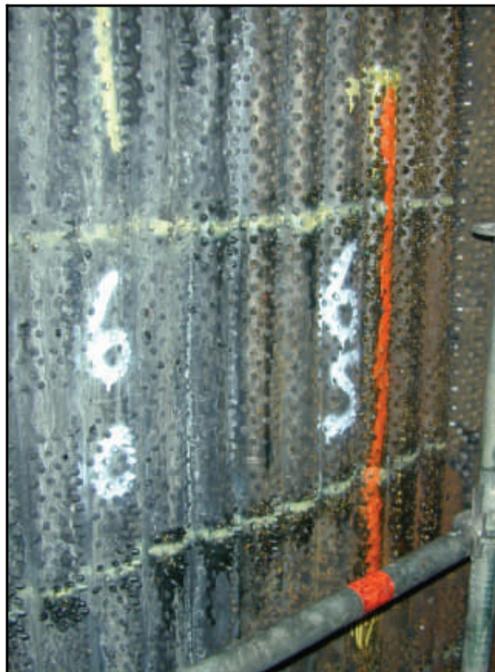
The studs would corrode away by sulfidation at rates dependant on the liquor and/or smelt chemistry and temperatures. The tube wall thickness would also become thinner (Figure 1). Many low-pressure boilers still operate and experience long life with studded

Figure 1. Lower furnace studded tubes can become thin and difficult to test with UT between the studs. Thinned tubes can be seen in the orange area.

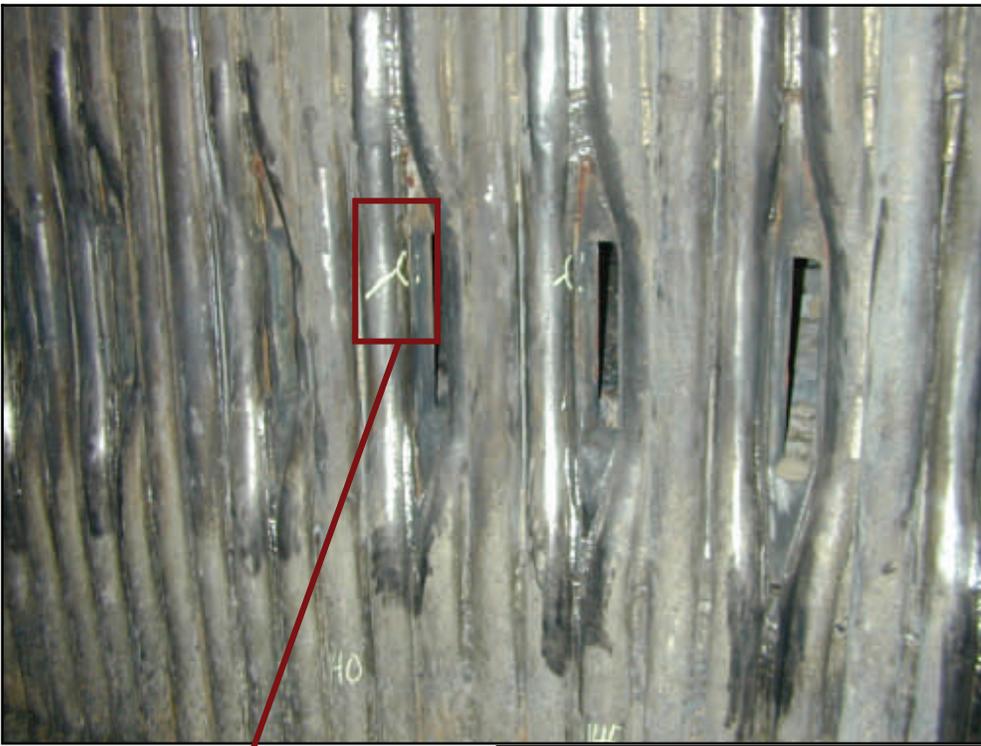
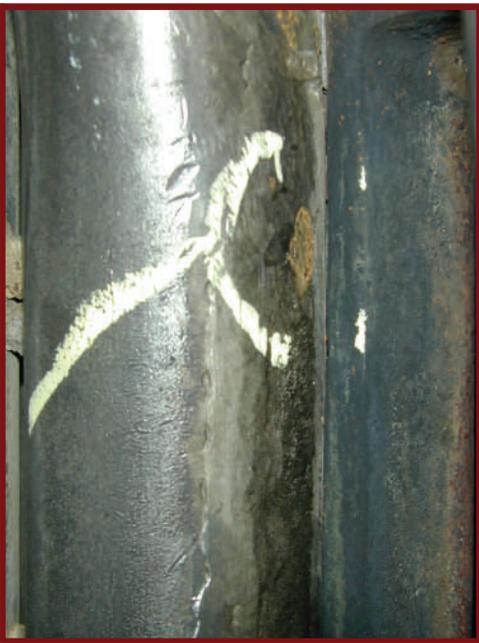
that the thinning mostly occurred in the stainless steel. Small bald spots (Figure 2) thin much slower and could be more easily monitored and re-clad as necessary. Many mills used weld overlay, such as Type 309L stainless steel, to repair bald spots at air ports. Experience has shown that the overlay corroded as fast as the original cladding, if not quicker. Nickel-based alloys were also not satisfactory in repairing bald areas.

Figure 2. Primary air port "balding" (rusty steel exposed) shown in both images.

Repeated weld overlay invited cracking of air port tubes. Some boilers have been rebuilt with "modern" air distribution systems for better efficiency. However, some of these air port designs have resulted in wide temperature fluctuations at the air port tubes with thermal fatigue cracking as the consequence. Removing fin and crotch plate welds has limited air port crack sites. Alloy 625 and Alloy 825 weld overlays have been found to be more resistant to air port thermal cracking than the original stainless steel.

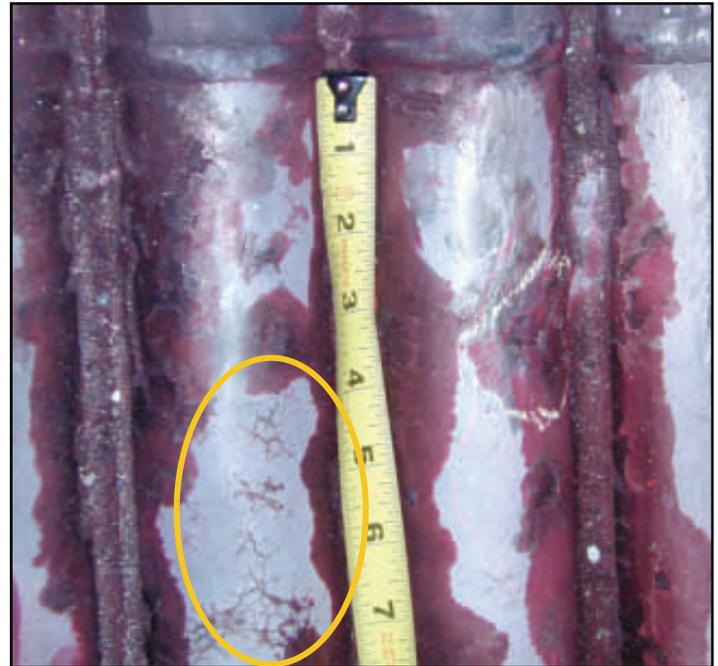
Floor tube stress corrosion cracking (Figure 3) under the smelt bed was found to be due to

contact with hydrated smelt in the critical tube temperature range of 300°F to 400°F. Most of these cracking problems occurred when boilers were reheated above 300°F for dryout while the tubes were in contact with the smelt. The cracking that had been tested using penetrant dye testing seemed to be present mostly within the stainless clad metal and self-arrested areas at the carbon steel interface. If cracking in floor tubes occurs, it is often best to wait until cracking becomes more widespread to replace the tubes, and then use the Alloy 625 or Alloy 825 (nickel base) weld overlay on the floor. The floor tube cracking has been regularly monitored in some boilers in-lieu of wide spread cladding replacement.

Figure 3. SCC cracking on a stainless steel clad floor tube can lead to spalling (circled).

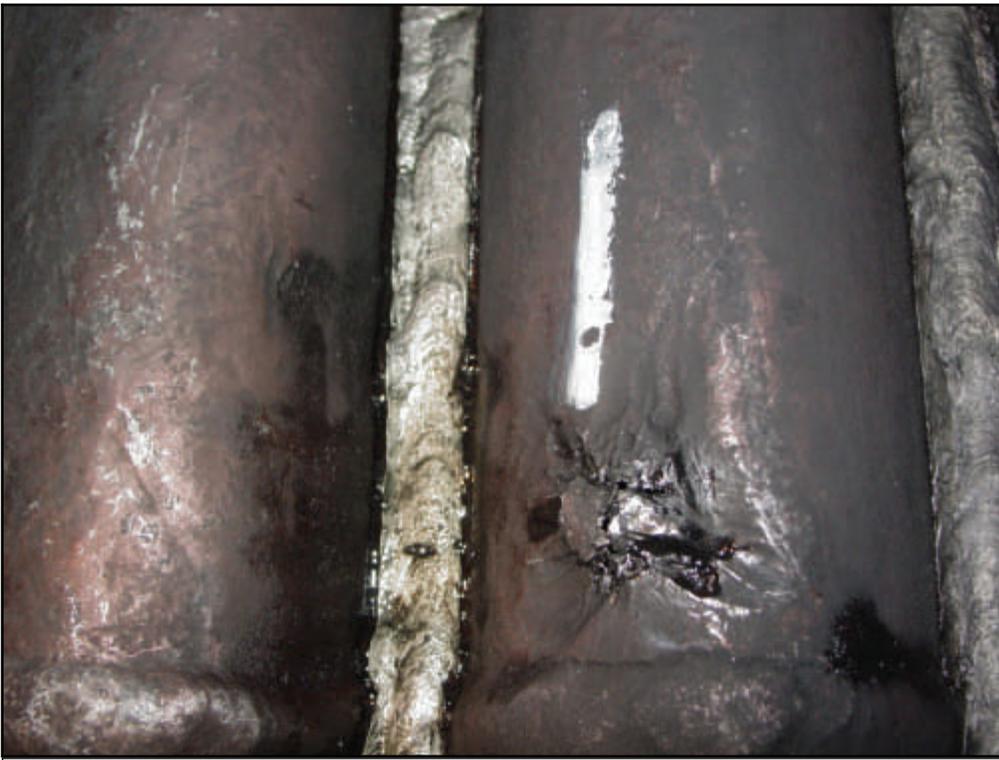
boilers have decanting bottoms, which are not as sloped as the original floor designs. The almost horizontal floor tubes can be prone to low-flow problems, sometimes leading to localized tube

Figure 4. Floor tube leak at weld. The low flow of the horizontal tube combined with weld drop-through initiated DNB boiling tube overheating/thinning.

overheating (Figure 4). In addition, sagging can cause “puddles” in the floor, which may further inhibit flow (Figure 5).

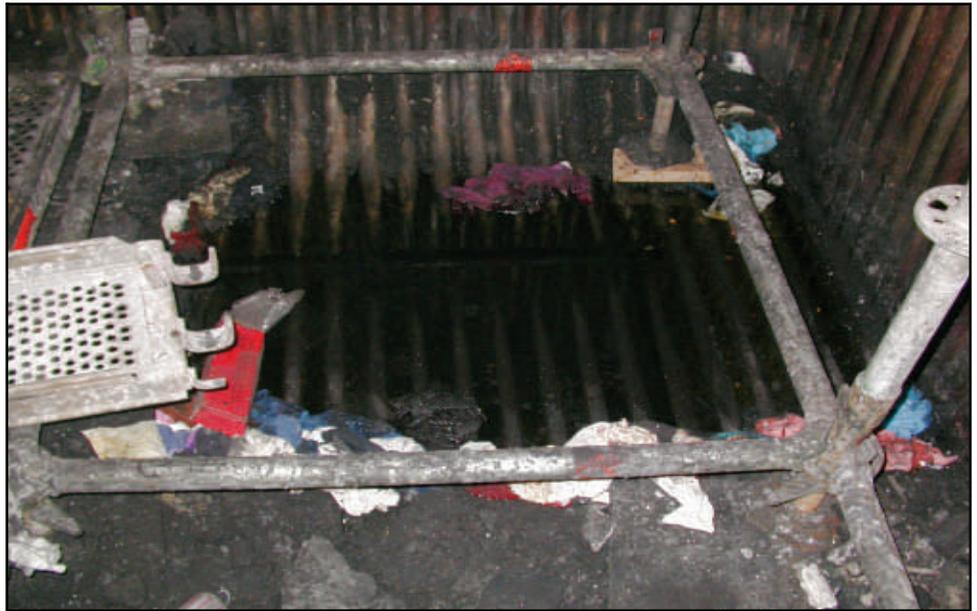
Figure 5. Decanting floor “puddle” area with smelt bed removed.
