the Conduit

High Energy Piping Evaluation, Part 3 of 3

Forensic Investigation of a Gas Turbine Event

Inspection and Repair of Batch Digesters Part I of 3

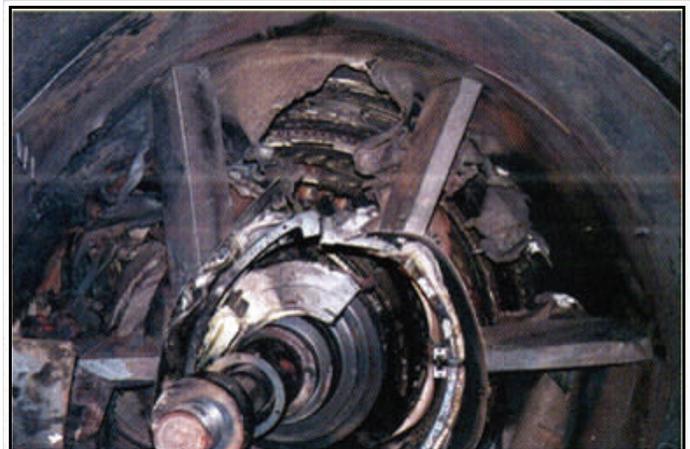
Figure 1. Power turbine failure exhibits considerable collateral damage.

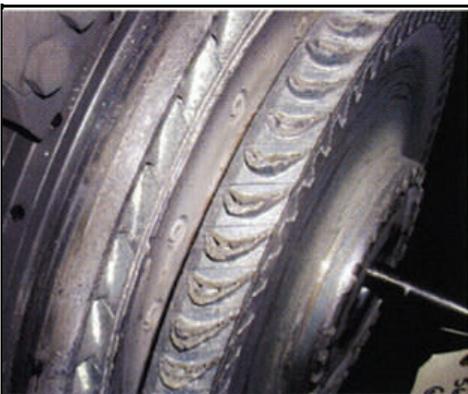
Figure 2. Life exhaustion caused the blade failure that wiped out this turbine.

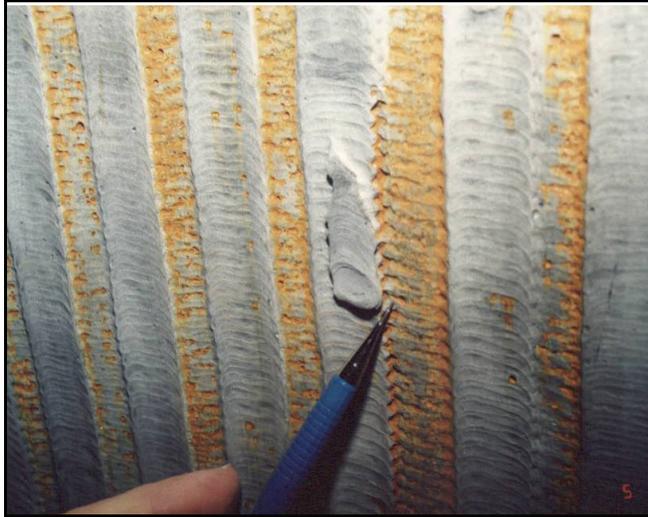
Horizontally applied overlay is conventional for batch digesters. This GMAW vertical-down overlay has insufficient corrosion resistance due to excessive carbon steel dilution and low thickness.

Weld overlays using the GMAW process may be applied in either the horizontal or the vertical directions. However, experience has shown that the horizontal method of application to be more resistant to the aggressive batch digester environment.
