# *the* Conduit

Vol. 14, No. 2

# Rogue Metallurgy on Safety Devices Endangers Plant Personnel: Failed Clevis in Fall Support Device

By: John Molloy, Principal Engineer

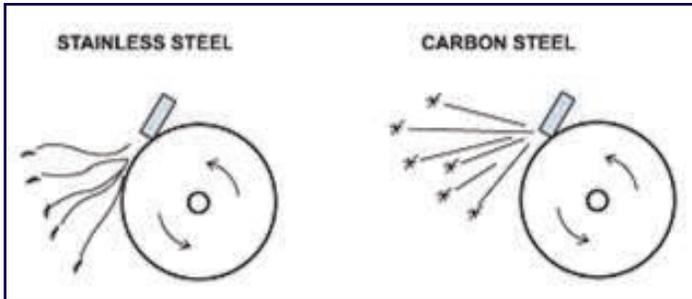
the remaining overlay thickness in the vessel. Testing is performed by careful plunge grinding with a grinding wheel through the stainless overlay. The image of sparks during plunge grinding the stainless steel varies markedly when the underlying carbon steel is reached, Figure 1.

Figure 1. Spark differences by abrasive wheel cutting, stainless steel and carbon steel.

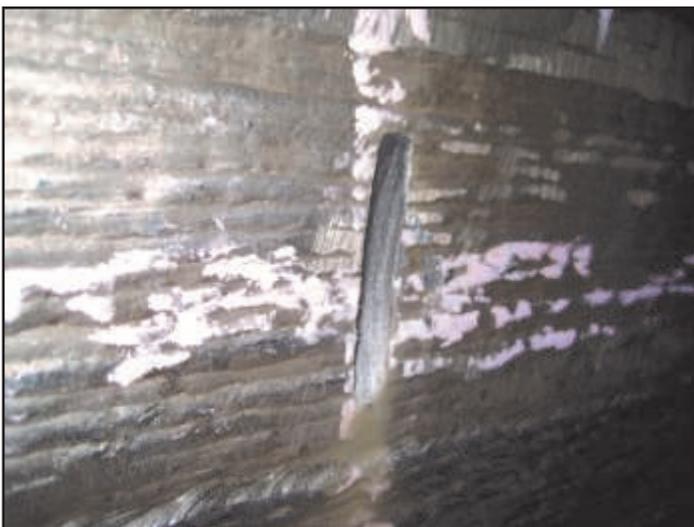
The depth of grinding is then measured to the nearest 0.01 inch with a scale. Application of copper sulfate solution may be applied to visually confirm the thickness of the overlay. Repair of the small grind area is necessary by welding with a matching overlay consumable. The total time for grinding and re-welding thickness test slots is less than one or two work shifts, depending on the number of tests. However, compared to tens of thousands of dollars for new overlay that is not needed, the cost for this testing is very small. An image of a test slot in a digester wall overlay weld is shown in Figure 2.

Figure 2. Plunge cut with abrasive wheel into stainless steel weld overlay to measure remaining thickness.

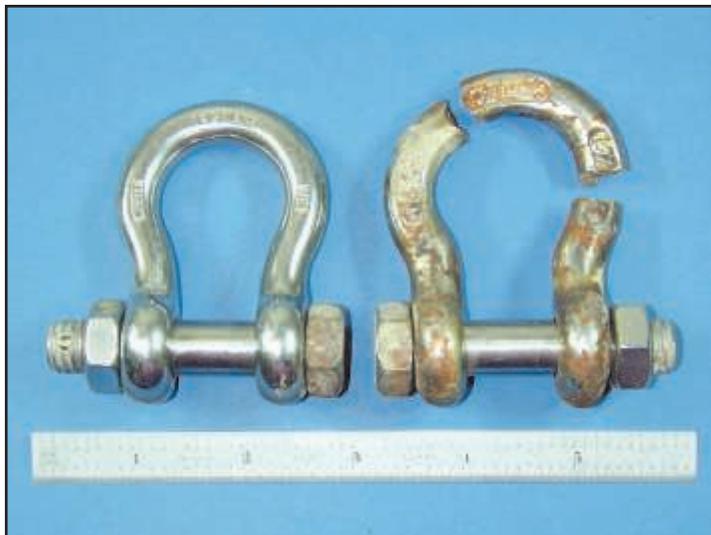
M&M Engineering Associates, Inc. led an investigation into two stainless steel fall support devices used in a paper mill (Figure 1). One of the two clevises was fractured in two places and exhibited localized corrosion. The other clevis was intact and did not exhibit any signs of corrosion. Both clevis samples are reported to have come from the same fall protection devices and had been in service in the same environment for the same amount of time. The fall support devices remained in moderate tension while in storage, thus by fracturing in a static state, the plant personnel were able to notice the problem and avoid unfortunate usage. An additional, new clevis sample in original packaging was also received for reference (Figure 2). M&M Engineering was asked to determine the cause and failure mode of the failed clevis, and compare it to the un-failed clevis and new clevis sample.

Figure 1. Photograph shows the two clevis samples as-received. The Failed Clevis (right) was received along with an exemplar, Un-failed Clevis (left).

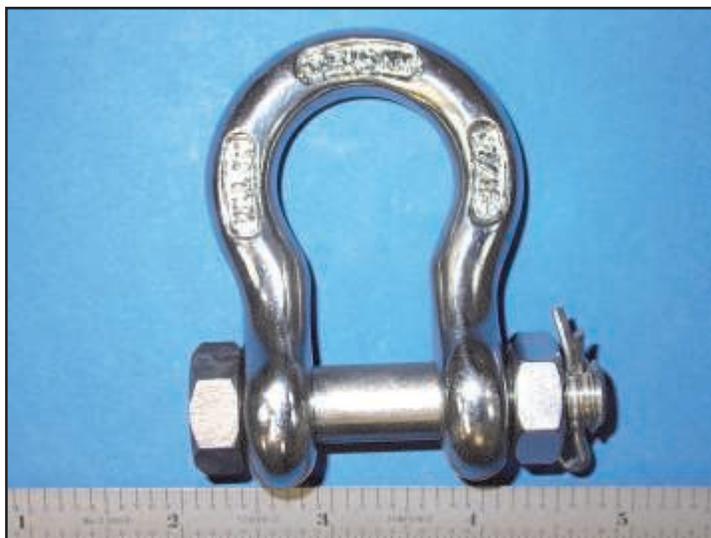
Figure 2. Photograph shows the new clevis as-received.

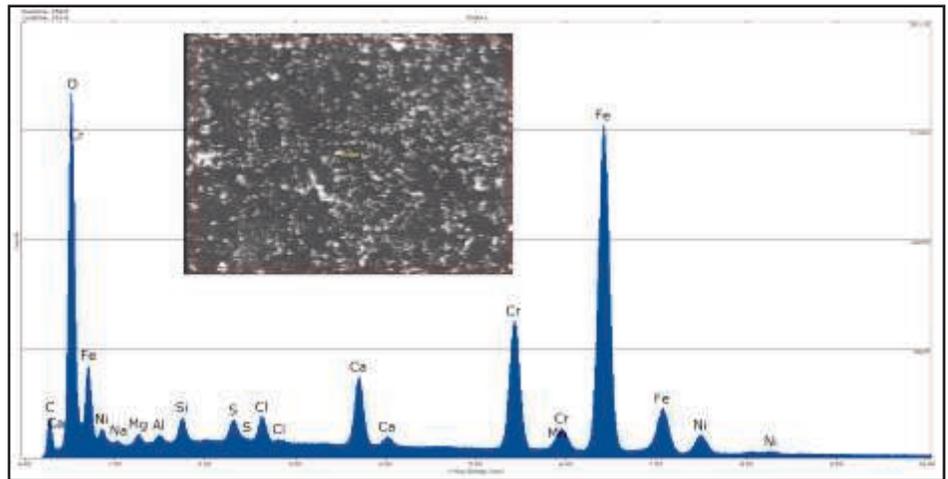
EDS analysis was performed on the primary fracture surface of the failed clevis. This testing was performed prior to the cleaning mentioned in the visual examination above. Two sample areas were selected on the fracture surface for EDS analysis and the resulting spectrum can be seen in Figure 3. Carbon, oxygen, calcium, chromium, iron, and nickel were detected. In addition, small amounts of sodium, silicon, magnesium, sulfur, and chlorine (as chlorides), as well as trace amounts of manganese and aluminum were detected. Many of these elements are constituents of the base metal and native oxide (iron, chromium, nickel, silicon, and manganese). The other elements are likely from the local environment, of which sulfur and chlorine (as chlorides) are corrosives. Table 1 shows the EDS/SQ results.

Figure 3. EDS spectrum for fracture deposit observed on the Failed Clevis. Sulfur (as sulfides) and chlorine (as chlorides) were noted.

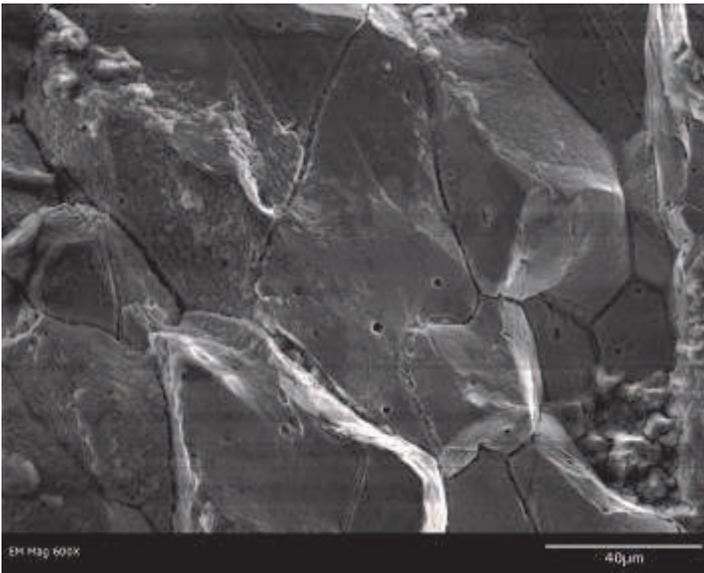
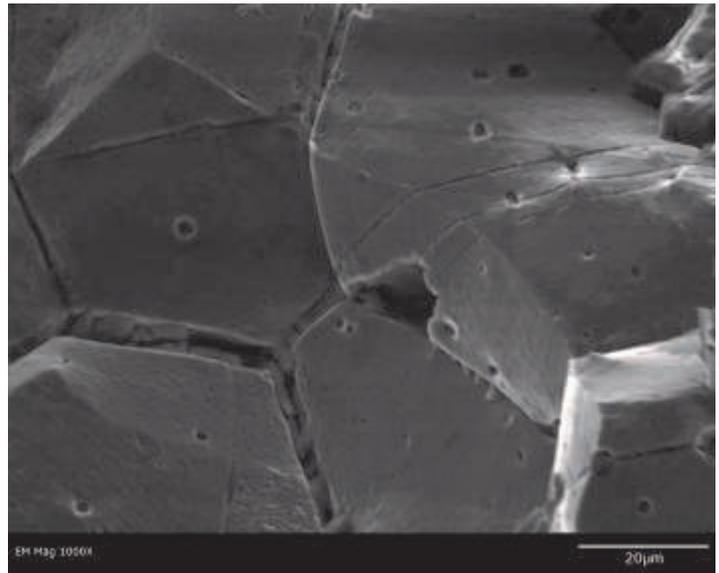
After completion of the fracture deposit EDS analysis, the fracture surface was ultrasonically cleaned in an Alconox® solution. The fracture was then analyzed in the SEM with a focus on the finer fractographic features. The fracture surface revealed a completely intergranular morphology, inferring that the fracture mode was

environmentally assisted (Figure 4). A nonexistent overload area suggests that the nominal stress state was very low.

Figure 4. SEM images show higher magnification of the primary fracture surface of the Failed Clevis. Intergranular fracture morphology was noted.

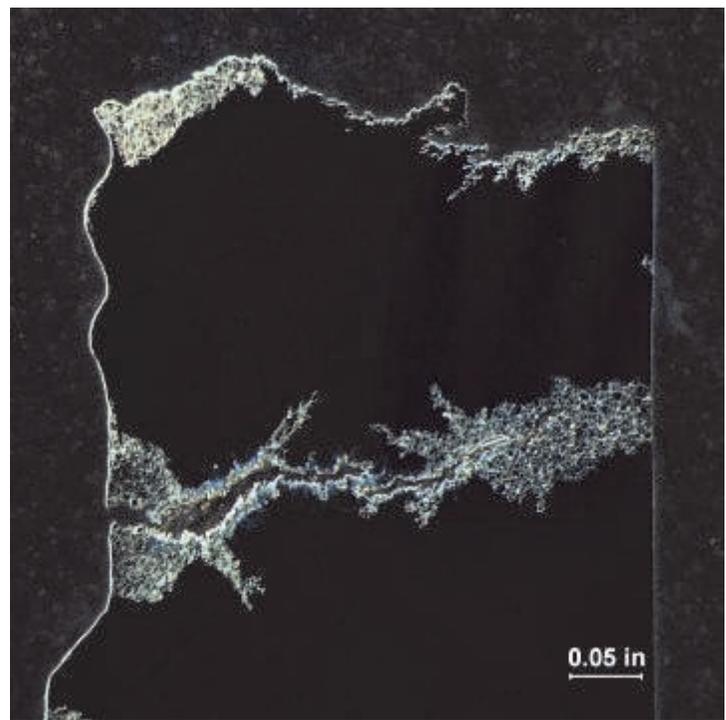
A stereomicroscope image of the primary fracture cross section can be seen in Figure 5, where intergranular attack (IGA) was observed to penetrate deep into the bulk material. Higher magnification images of select regions of the fracture on the metallographic cross section can be

Figure 5. Photograph shows a cross sectional image of the secondary fracture surface on the Failed Clevis. An adjacent crack is also visible in the image. Intergranular morphology was noted.

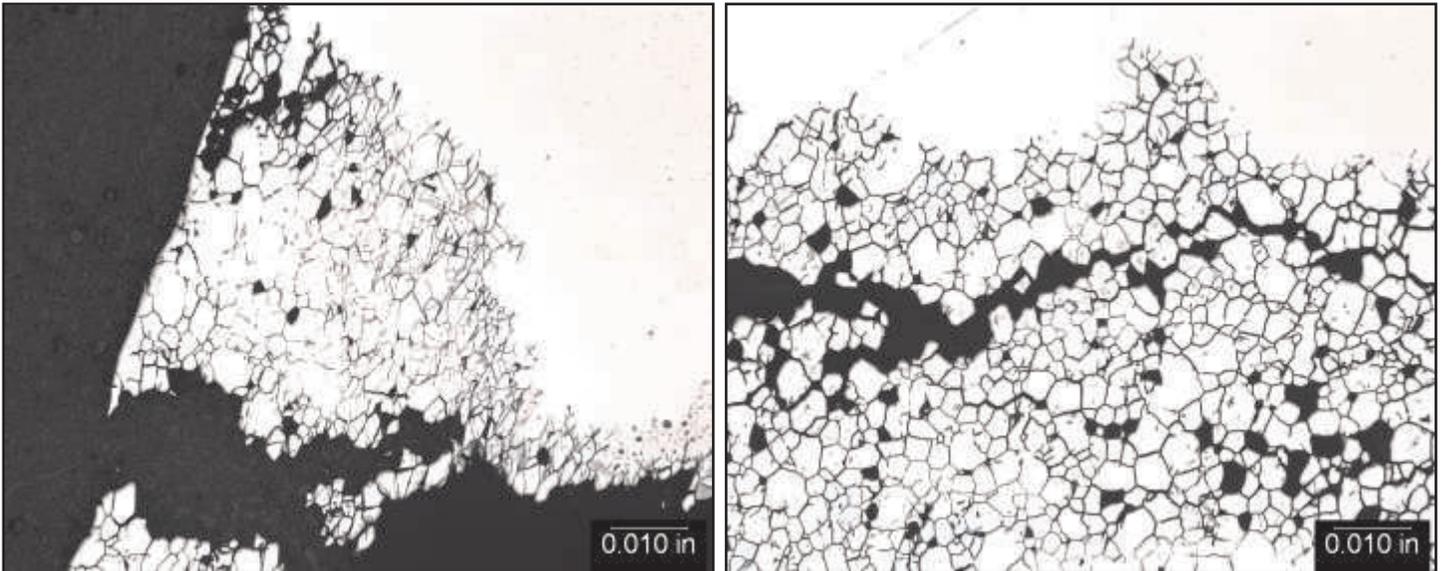
seen in Figures 6. Again, deep, IGA penetration was observed.

Figure 6. Photomicrographs show the secondary crack morphology in the unetched condition. Severe intergranular attack was noted to penetrate into the bulk of the Failed Clevis. Magnification: 50X, Etchant: None

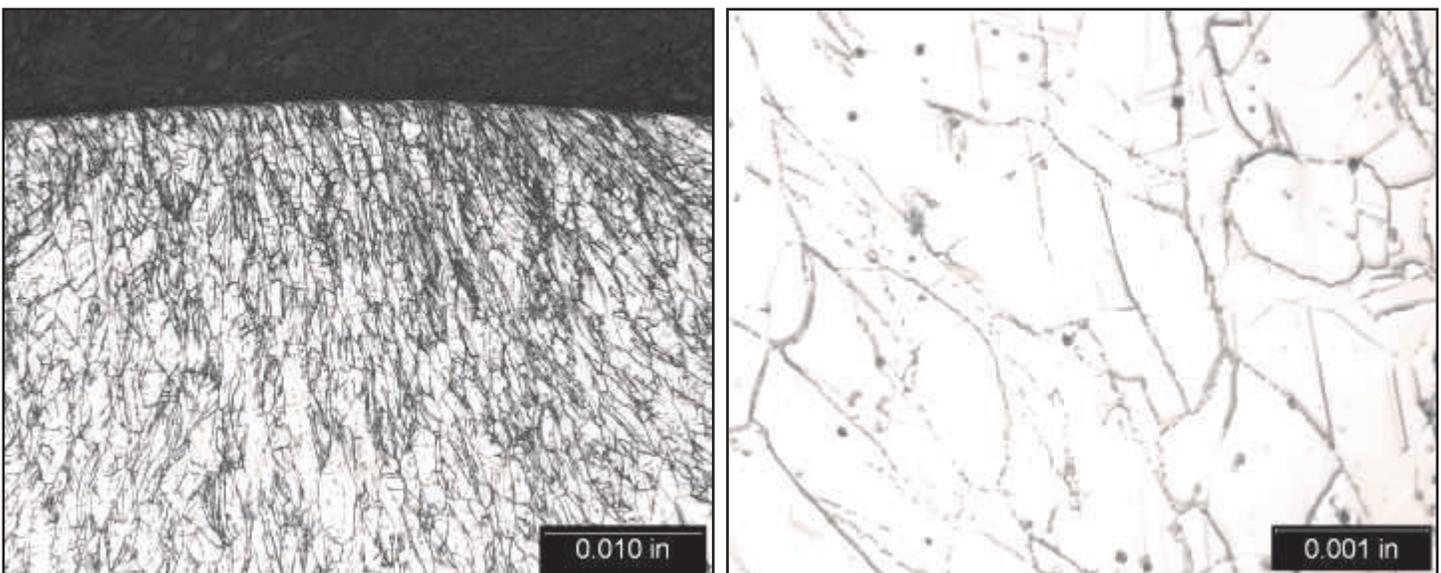
Remote (exemplar), transverse cross sections were observed on both the failed and un-failed clevis samples. The general, bulk microstructure remote from the IGA was evaluated on the failed clevis. The grain structure was variable depending on the location in the cross section. Some areas displayed equiaxed austenite grains and some twinning, whereas other areas displayed regions of high crystalline deformation (plastic deformation from cold or hot working). Higher magnification revealed deeply etched grain boundaries and evidence of sensitized grain boundaries necklaced with carbides (Figure 7).

Figure 7. Photomicrographs show the typical grain structure of the Failed Clevis. The grain structure was heavily worked due to plastic deformation, as manufactured. Carbides were observed to necklace the grain boundaries. (Left) Magnification: 100X, Etchant: Nitric 60 Percent Electrolytic, (Right) Magnification: 1000X, Etchant: Nitric 60 Percent Electrolytic

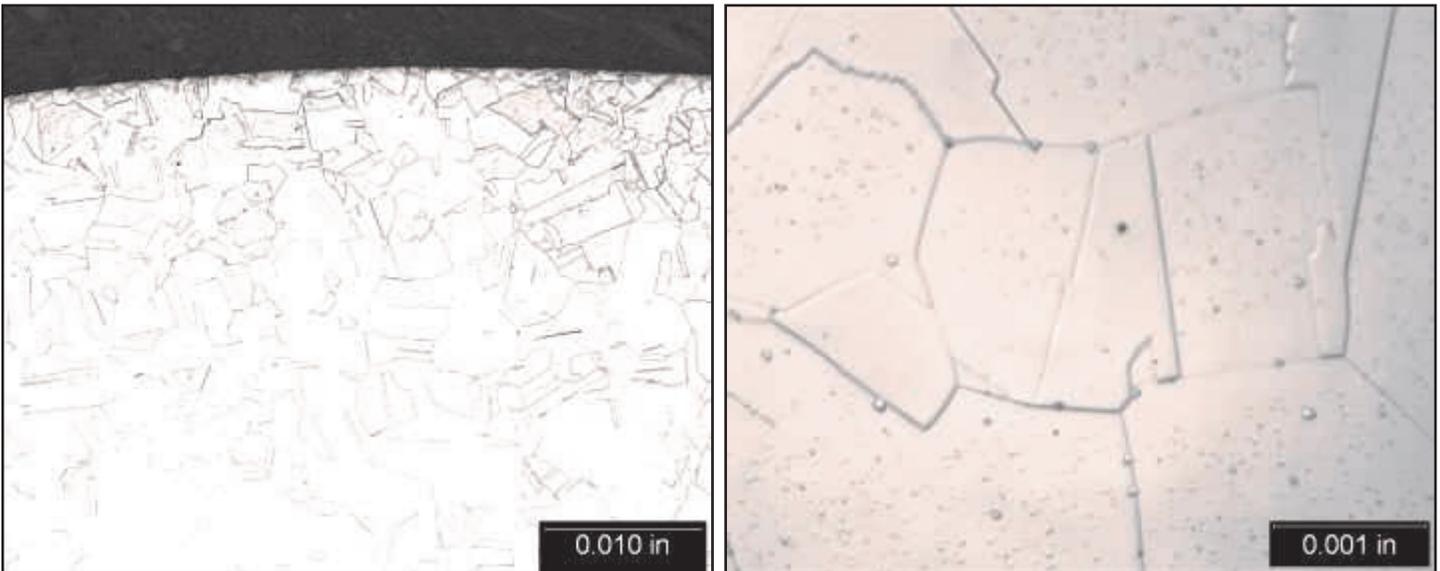
The un-failed Clevis cross section did not exhibit any regions of IGA. Higher magnification images of the bulk microstructure revealed equiaxed grains with some twinning. No evidence of sensitization, such as carbide necklaced grain boundaries, was observed (Figure 8).

Figure 8. Photomicrographs show the typical grain structure of the Un-failed Clevis. Equiaxed, austenitic grain structure was observed through-out. (Left) Magnification: 100X, Etchant: Nitric 60 Percent Electrolytic, (Right) Magnification: 1000X, Etchant: Nitric 60 Percent Electrolytic

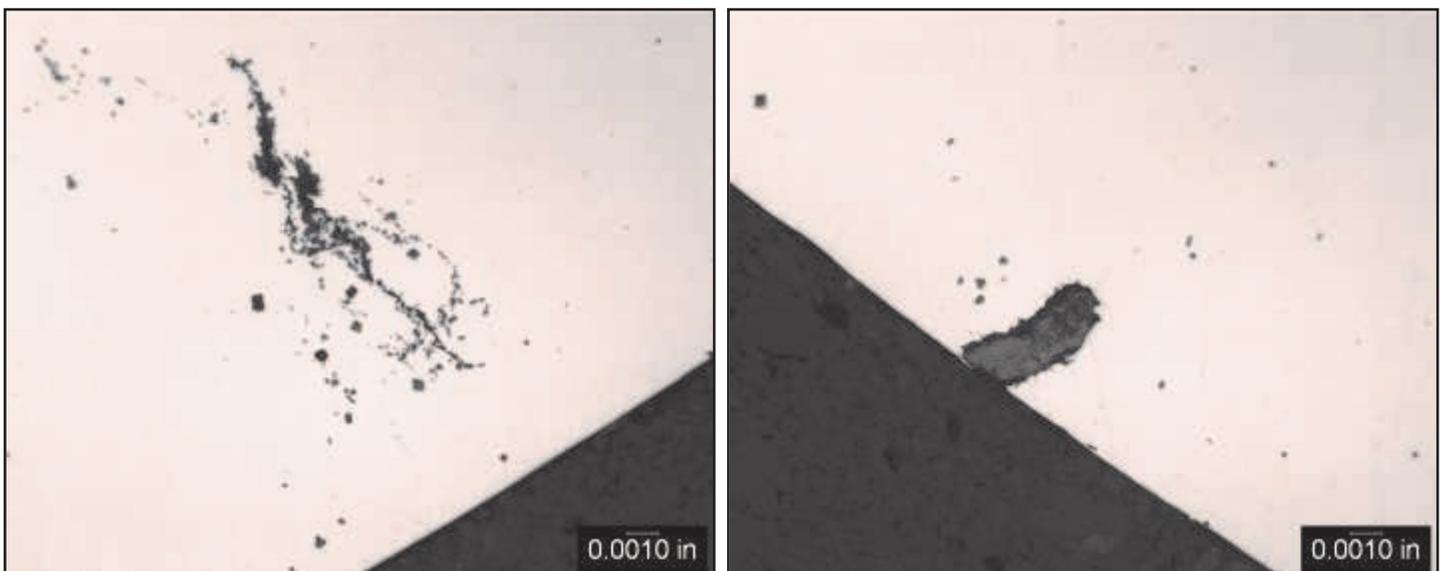
Transverse cross sections were observed on the new clevis sample in the unetched and etched conditions. In the unetched condition, a large inclusion content was observed (Figure 9). In the etched condition, the grain boundaries and carbides were decorated more than the failed and un-failed

Figure 9. Photomicrographs show the high inclusion content observed in the new clevis microstructure. Magnification: 100X, Etchant: None

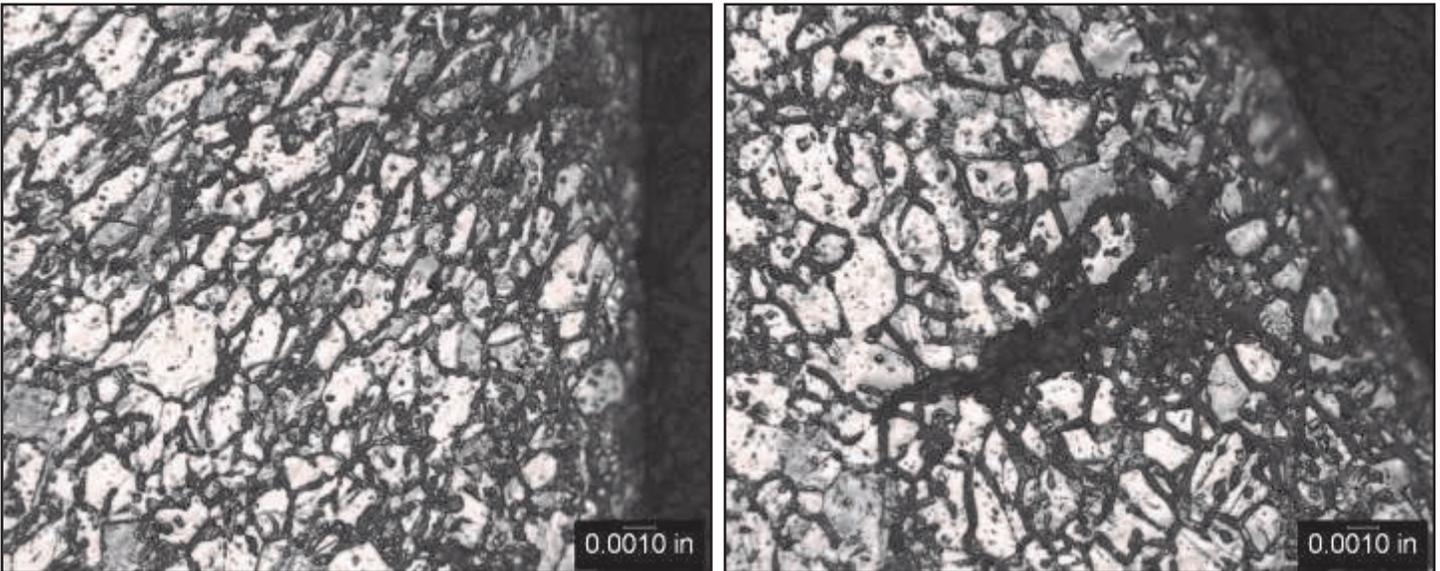
Figure 10. Photomicrographs show the typical ASTM A262 test results on the New Clevis. Ditching was observed in the grain boundaries, indicating susceptibility to intergranular attack. Magnification: 200X, Etchant: Oxalic Acid

Testing per ASTM A262 indicated that the failed clevis and new clevis were indeed susceptible to IGA, and the un-failed clevis was not. The failed **clevis and new clevis both revealed a “ditched”** structure around the grain boundaries that was absent on the un-failed clevis. The ditching is caused by the chromium denuded grain boundaries and the preferential attack of this area by the etchant.
