the Conduit

A quarterly publication from
M&M Engineering Associates, Inc.

Vol. 14, No. 4

HOW TO SPOT HYDROGEN DAMAGE

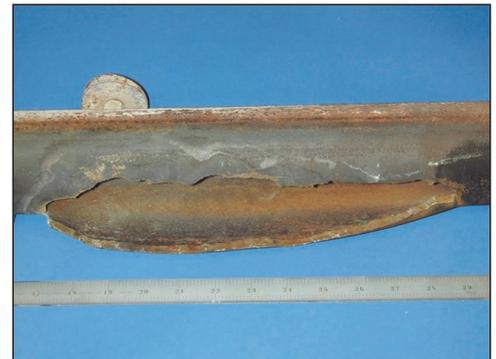
A boiler tripped and was found to have a failed waterwall tube (Figure 1). Plant personnel reported that during tube removal they observed

corrosion on the inside of the tube for approximately two feet below the failure and twenty feet above the failure. The tubes were specified as ASTM A210 with a minimum wall thickness (MWT) of 0.280 inches.

Figure 1. Failed waterwall tube.

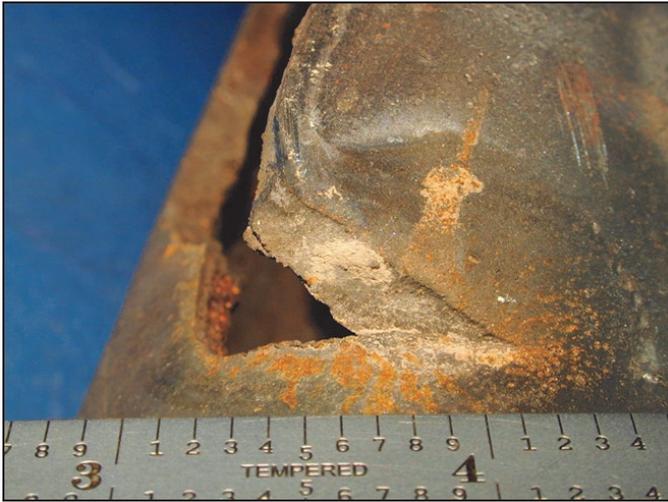
When received in the laboratory, the failure was observed to consist of a long, window-type rupture on the hot side of the tube that was about 11 inches long. The rupture window edges were thick-lipped with significant pitting observed on the internal surface (Figure 2).

Figure 2. Thick lipped edges of rupture window.

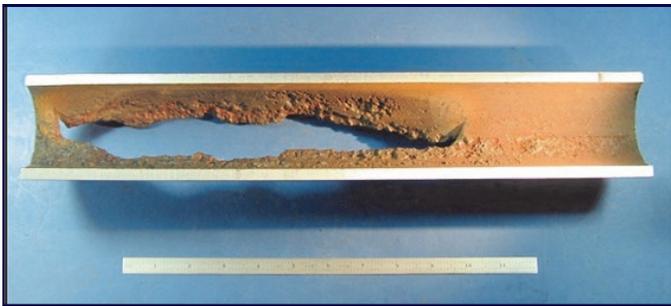
surface (Figure 3 and Figure 4). Significant pitting with heavy deposits was noted on the failure side (furnace side) of the tube. Slight pitting and deposits were noted on the cold side of the tube section.

Figure 3a. Pitting on internal surface at failure.

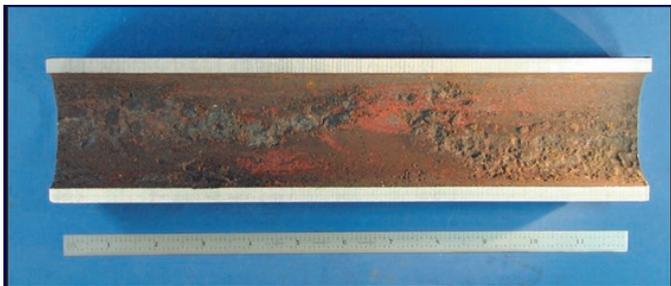
Figure 3b. Pitting on internal surface adjacent to failure.

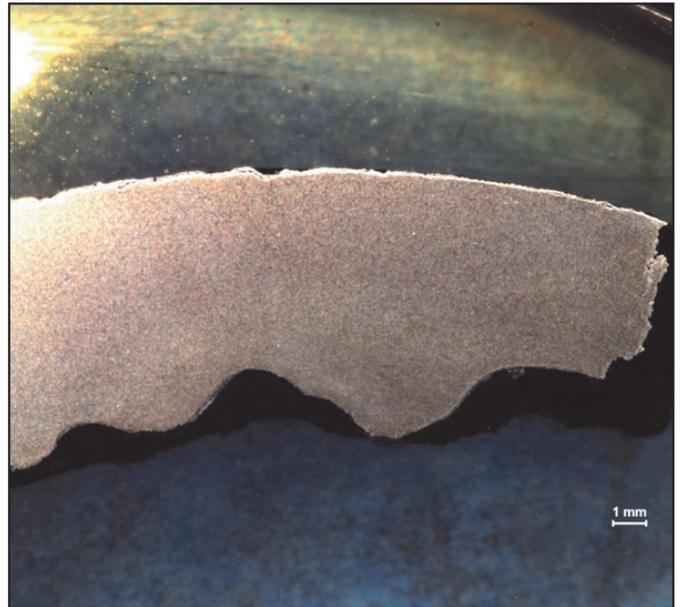
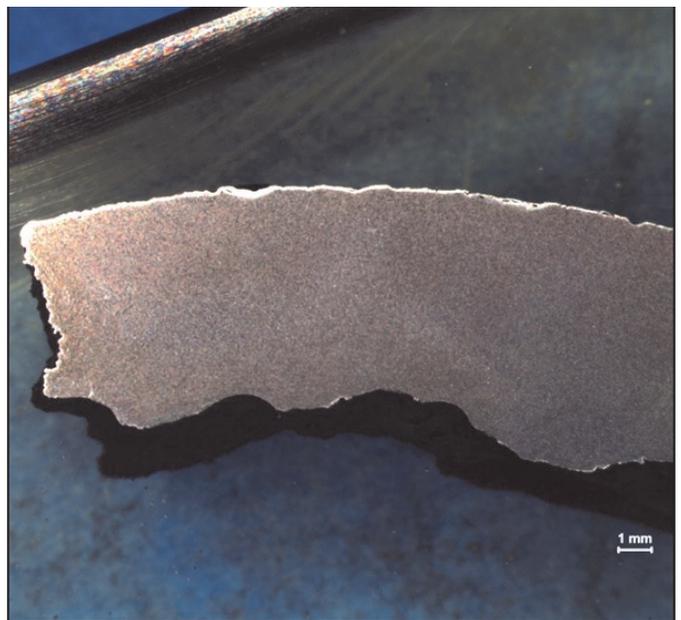
Figure 4. Blunt rupture tips and internal wastage.

The rupture tips were blunt with minimal evidence of plastic deformation (Figure 4). Significant wastage was noted on the internal surface. Gross internal wastage was also noted on the remote cross section in the same location as the rupture. Most of the corroded area remote from the failure was heavily lined with oxide.

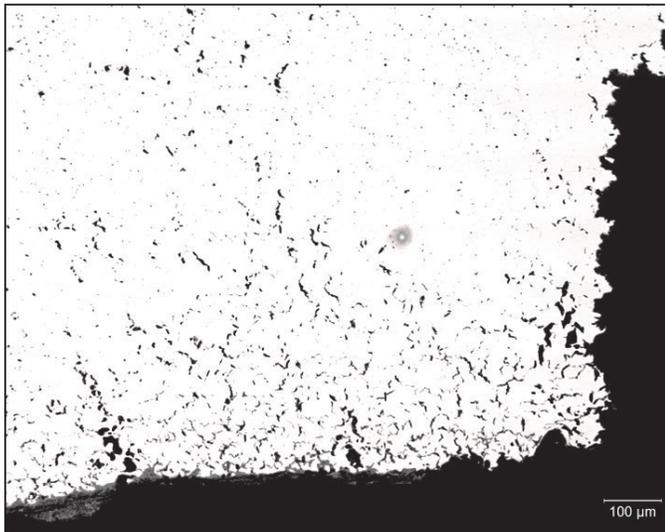
At higher magnification, a significant number of fissures and micro-cracks were noted along the rupture edges and the internal surface near the rupture (Figure 5). These fissures and micro-cracks are typical of hydrogen damage. There was also some decarburization at the rupture, which is another feature of hydrogen damage.

Figure 5. Fissures in the microstructure caused by hydrogen damage.

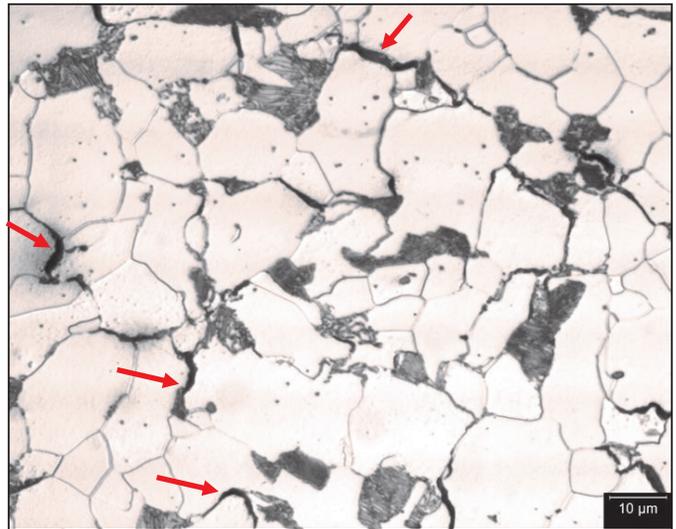
Slightly away from the failure, the typical microstructure of the tube consisted of pearlite in a ferrite matrix, with some fissures at the grain boundaries (Figure 6).

Figure 6. Microstructure slightly away from the failure consisted of pearlite in a ferrite matrix with some fissures at the grain boundaries.

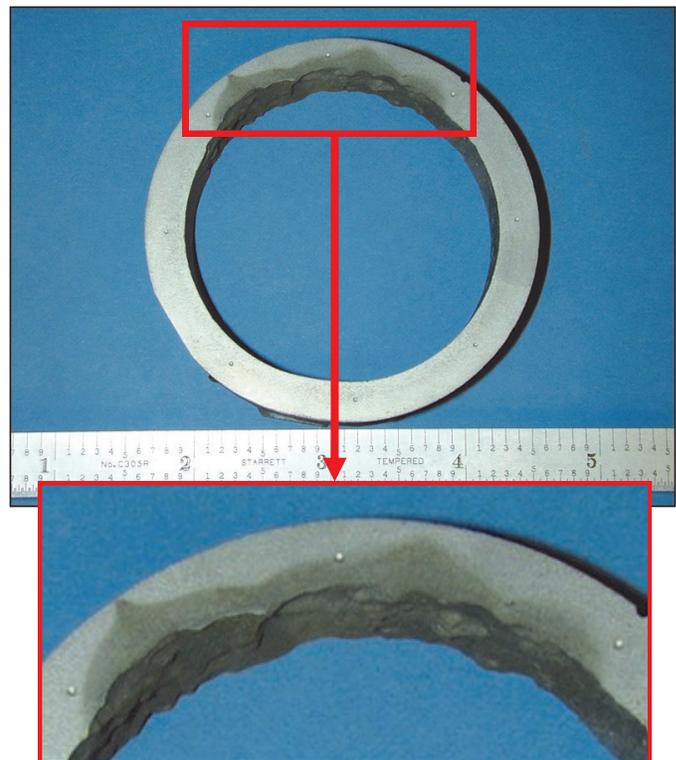
The test was positive for hydrogen damage in a localized area (Figure 7). The tube metal turned dark around the area of wastage, and partially through the tube wall.

Figure 7. Positive hydrogen damage test.

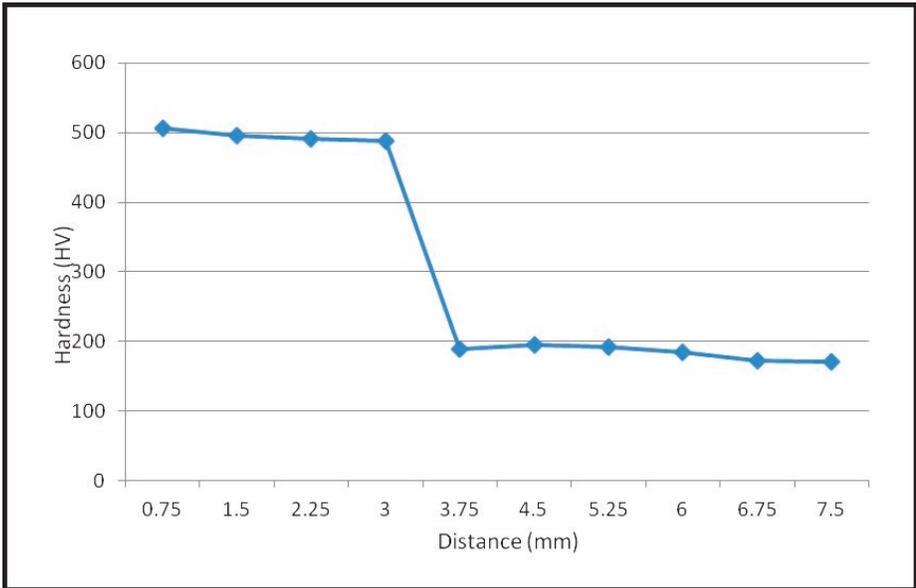
Figure 1 shows the results of microhardness testing in the fusion area between Stellite 12 and 316L stainless steel. As it can be seen, a steep microhardness drop was noted between the base metal and the hardened surface at a distance of approximately 3.5 mm. The hardness drop was close to 300 points in the Vickers scale, which converts to approximately 30 HRC. In addition, the dilution between the overlay (Stellite 12) and the base metal is almost non-existent, as seen in the energy dispersive X-ray spectroscopy map of the fusion line (Figure 2). This suggests that in this particular case, there was an issue in the welding process which caused this low dilution, such as a low temperature prohibiting the base metal and hardface layer from mixing properly.

Figure 1. Microhardness profile of a stellite overlay on 316L stainless steel.

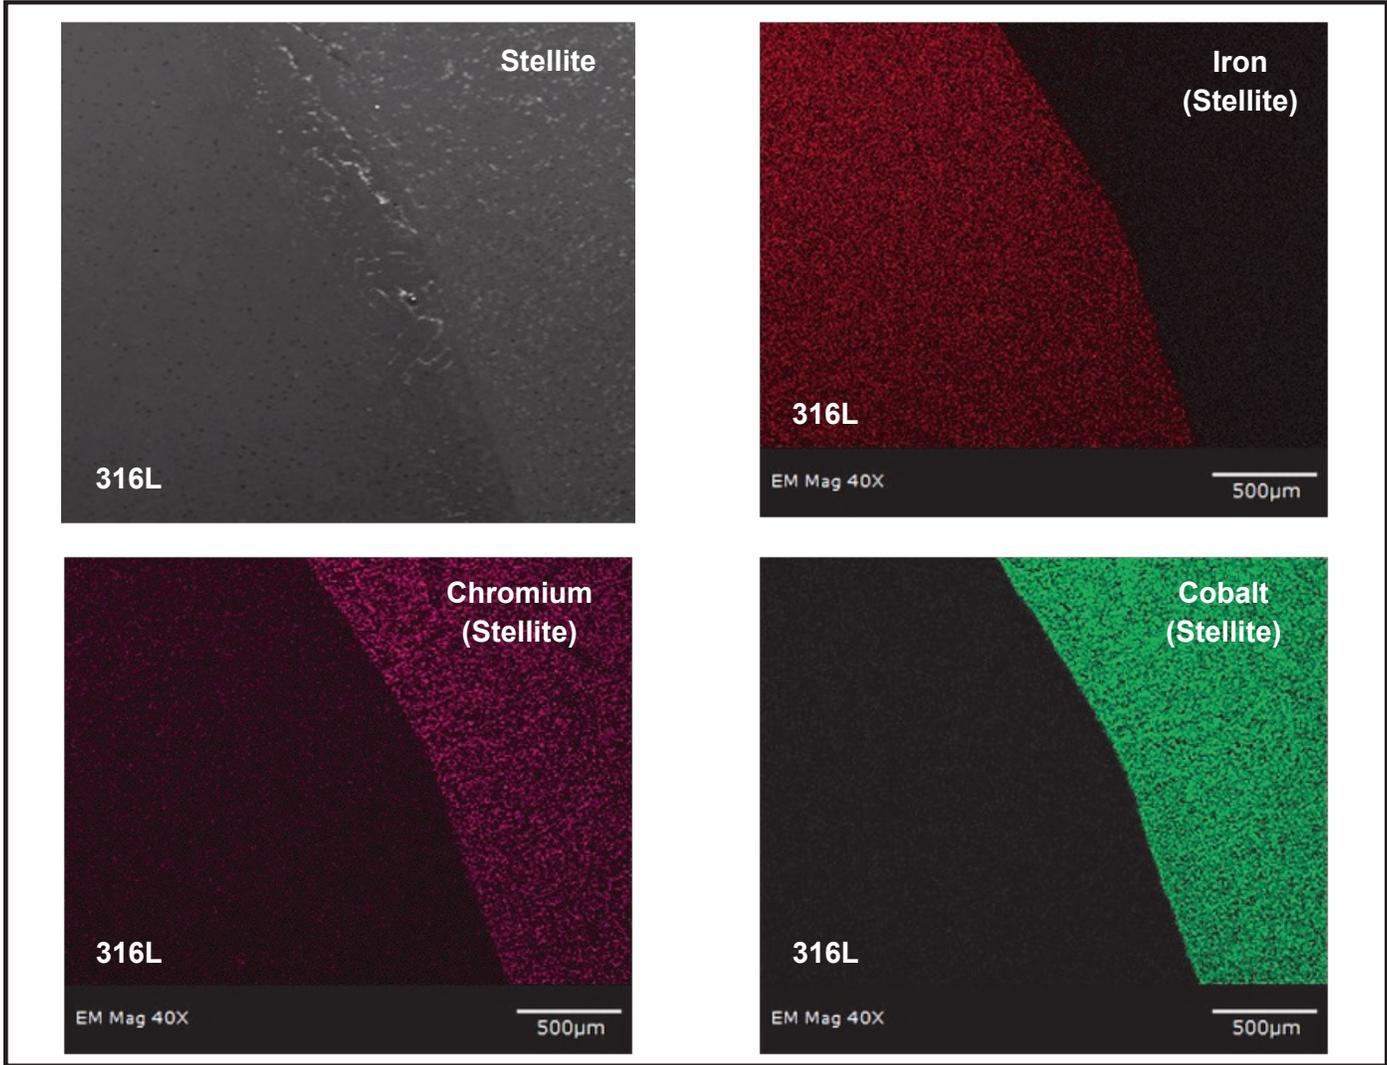
Figure 2. Elemental map showing the lack of dilution between the stellite and 316L stainless steel.

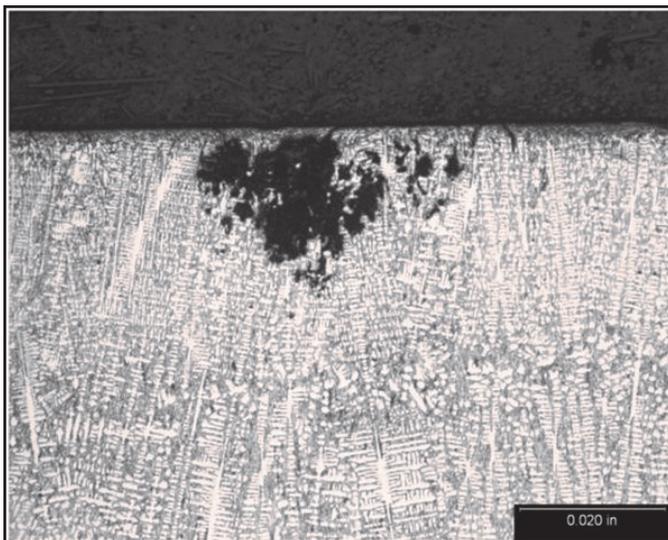
Shrinkage porosity occurs when sections of the overlay layer solidify faster than the material around it and do not have enough metal flow for a complete fill (Figure 3). This generally happens when the weld area is too hot relative to the surrounding area. From another perspective, when the part is not preheated enough, it is quenched too fast and may result in shrinkage porosity. Unsuitable composition and incorrect temperatures can also become factors in causing shrinkage porosity. Shrinkage porosity can also be caused by a combination of the all of the above factors.

Figure 3. Shrinkage porosity at the surface of the stellite layer.

- Slow down the cooling rate
 - A slow cooling rate helps minimize porosity since the bubbles have time to coalesce and escape from the weld pool.
- Reduce shrinkage stresses and distortion

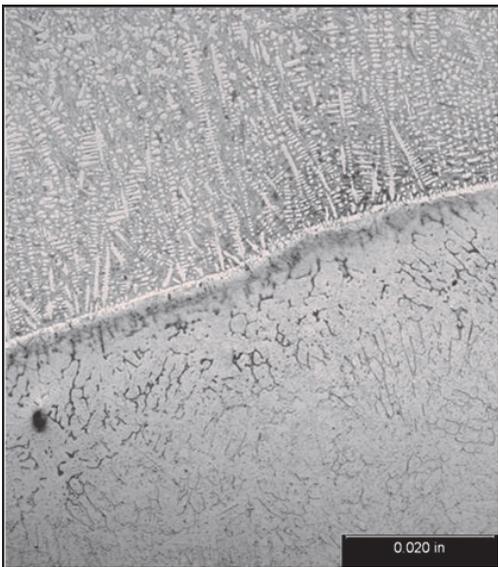
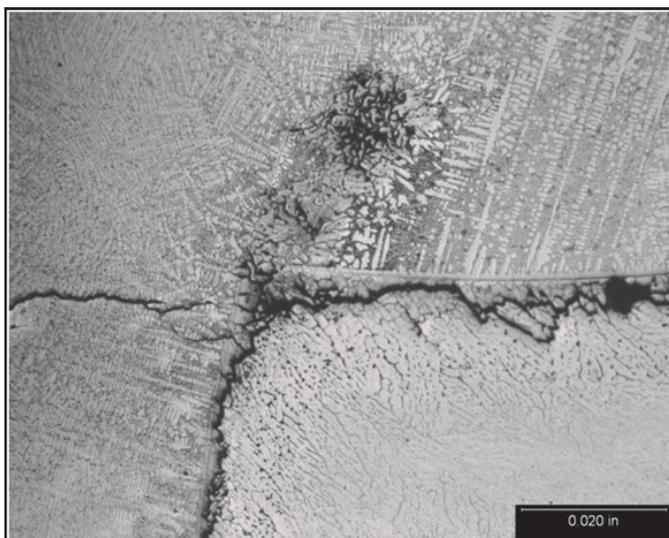
Additionally, the weld and heat affected zone (HAZ) will be prone to Hydrogen Induced Cracking (HIC) if any hydrogen was entrapped during the original overlaying process. In order for HIC to occur, three main factors are required: a sensitive microstructure, stress, and hydrogen. The stress source is caused by the residual stresses along the weld line. Austenitic stainless steels have a sensitive microstructure. If the fusion line becomes sensitized, the fusion line loses its strength due to the hydrogen diffusing into its grain boundaries and becomes brittle (Figure 4).

Figure 4. Porosity and cracking at the fusion line between the stellite overlay and 316L stainless steel.

The PWHT should be performed outside the ranges of 430 - 900°C (806 - 1652° F). Any PWHT performed in this temperature range will cause chromium carbides to precipitate within the grain boundaries (sensitization) and will reduce the corrosion resistance of the alloy. A PWHT, besides reducing the hardness gradient, will stress relieve the weld line and HAZ. This will also result in an increase in fracture toughness.
