Vol. 15, No. 1

PIN HOLE LEAKS IN TUBING

By: Karen T. Fuentes, P.E.
Sr. Principal Engineer

the Conduit

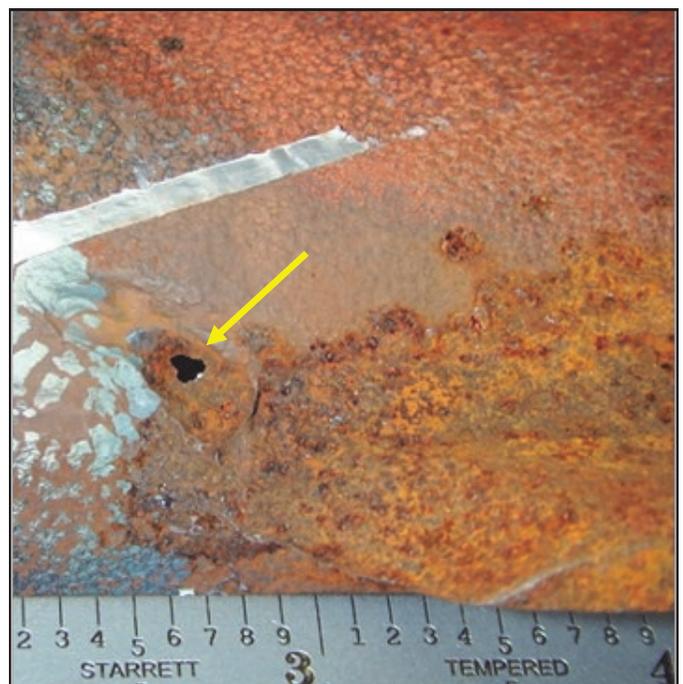
Figure 1. A small leak shown on the internal surface in the tube wall (arrow).

A waste heat boiler was having repeated tube failures. Examination showed that the tubes were failing due to under deposit corrosion (Figure 1 and Figure 2), specifically caustic gouging. There was broad smooth corrosion with little undercutting underneath a heavy, multi-layer deposit on the internal surface in localized areas. The deposit contained a significant amount of sodium. Normally, caustic is soluble and does not concentrate to significant levels under a deposit without the aid of high heat flux. At the hot spot, a fully nucleate boiling condition is not achieved. Once the deposit forms and heat creates the concentrating mechanism, if there is caustic in the boiler water, it can create under deposit corrosion by caustic gouging.

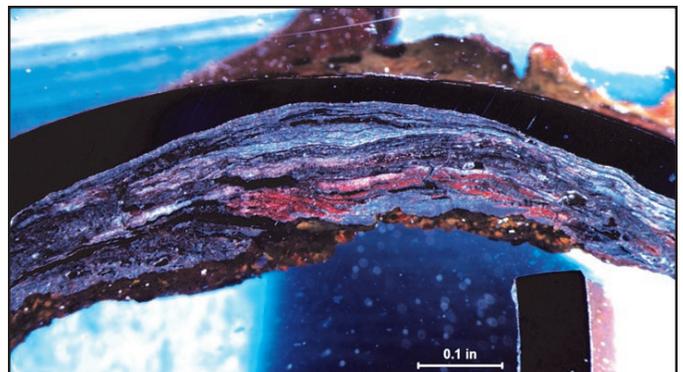
Figure 2. A cross section of tube shown in the area of the leak.

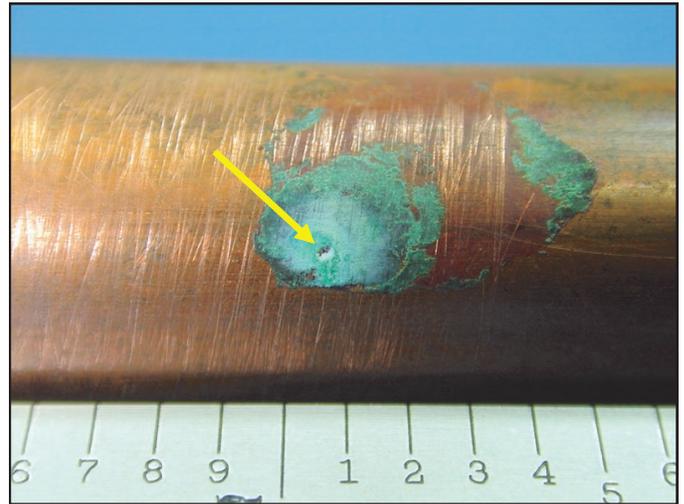
Figure 3. A leak shown in the cold water line on the external surface.

softener. The water was not chlorinated. The areas experiencing the leaks were lines with low flow or stagnant sections of the line. Examination showed that the leaks were due to microbiologically influenced corrosion (MIC) (Figure 3 through Figure 5).

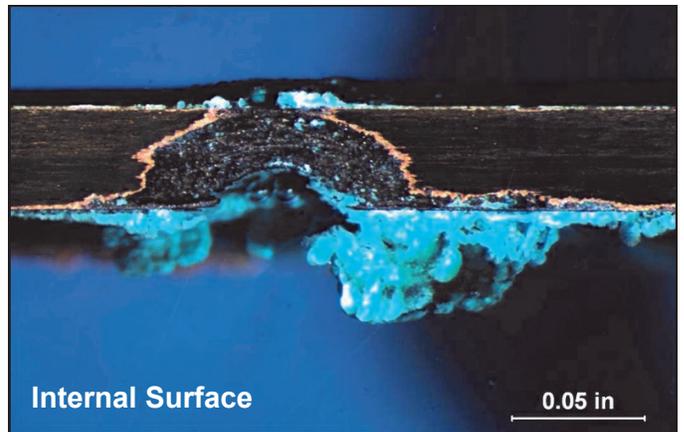
Figure 4. A cross section shown in the area of the leak.

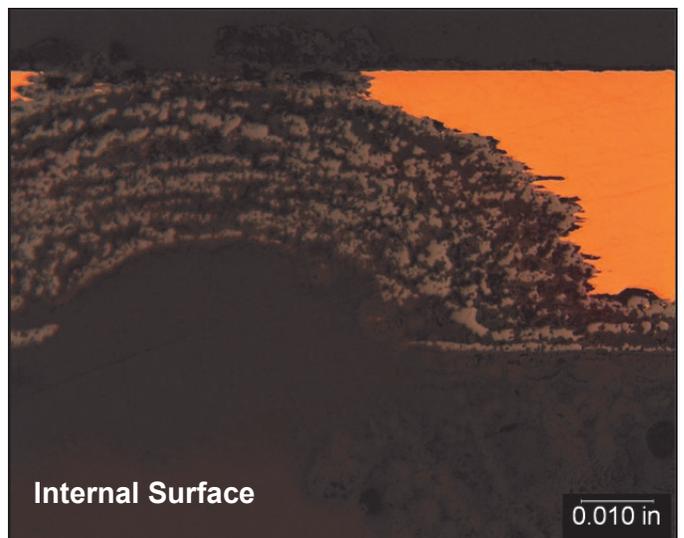
Figure 5. Deposits and lateral attack are characteristic of MIC.

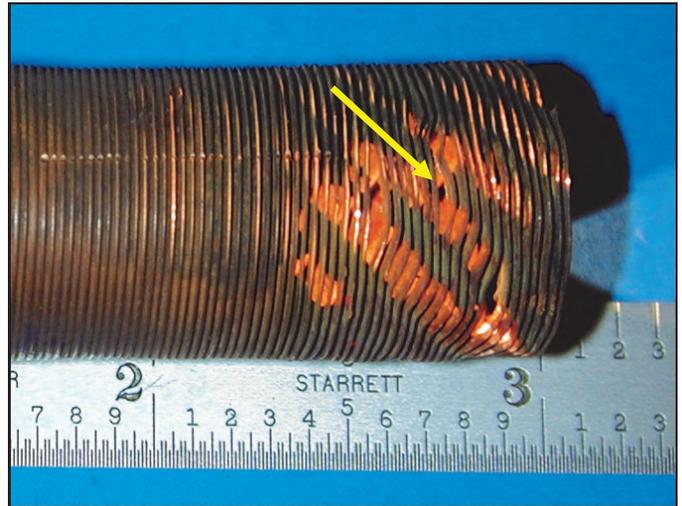
A service contractor added a scale removal chemical (inhibited hydrochloric acid) to the cooling tower for the purpose of cleaning the condenser tubes in a centrifugal chiller, as well as the cooling tower and interconnected piping. The scale removal chemical was allowed to remain circulating in the system overnight instead of a few hours. Shortly after the scale removal, the chiller experienced severely leaking condenser tubes. The tubes were inspected using eddy current inspection method that showed tube wall loss and a pressure test of the tubes showed a significant number to tube leaks. Because of the extended period of exposure to the descaler, the inhibitor broke down and allowed erosion-corrosion of the tubes to occur (Figure 6 and Figure 7).

Figure 6. A leak shown in the externally finned tube.

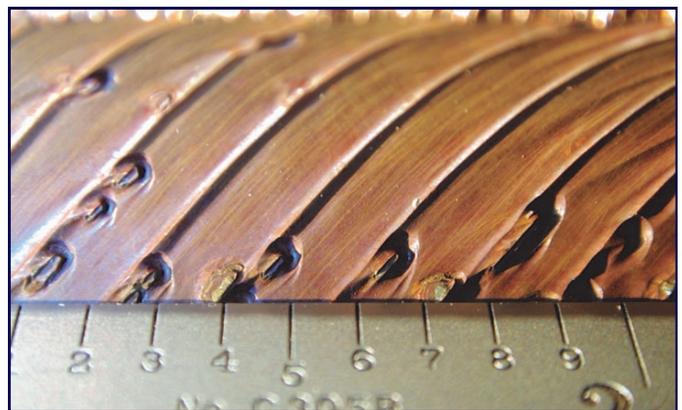
Figure 7. Horseshoe-shaped divots are characteristic of erosion. In this example, corrosion also played a role.

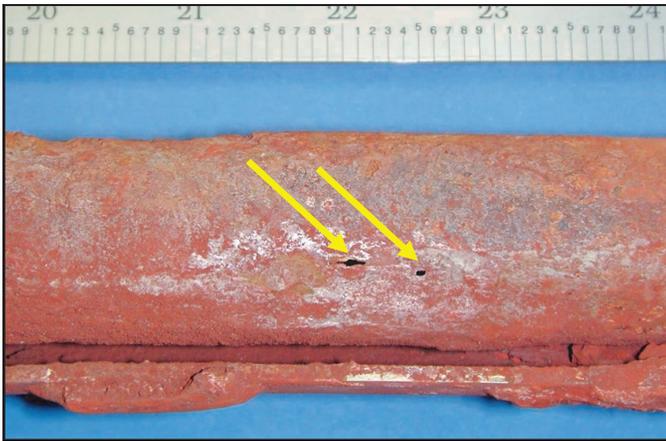
Figure 8. Image shows pin hole leaks in an economizer tube.

A tube sample was removed for analysis after repeated pinhole leaks were experienced in the economizer from a coal burning, circulating fluidized bed boiler (Figure 8). After sectioning the tube, wastage of the tube wall was observed (Figure 9). Analysis of the external deposits identified primarily iron and oxygen (iron oxide), with some sulfur. A white layer of iron sulfate at the tube deposit interface is also typical of dew-point corrosion. White deposits were observed in the leak area.

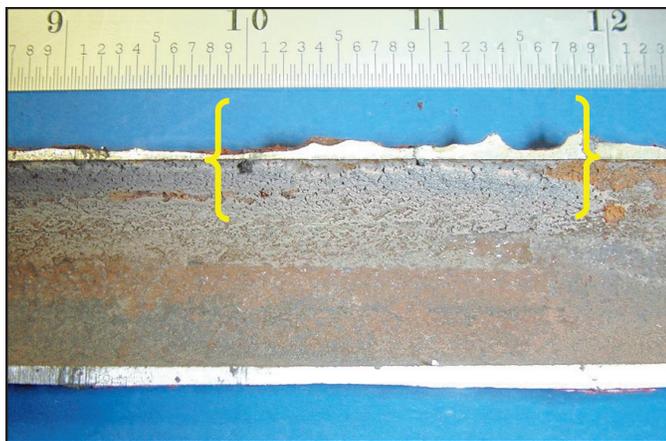
Figure 9. Image shows external wastage of tube in the leak area (bracket) viewed from the internal surface.

compounds. The peak corrosion rate occurs at about 260°F. Excess oxygen is also an important factor as the higher the oxygen level in the combustion process, the more SO_2 will be converted to SO_3 . By controlling excess oxygen to a maximum of 1 to 2%, it is possible to avoid the the formation of fully oxidized sulfur compounds and thereby reduce fouling and tube corrosion.

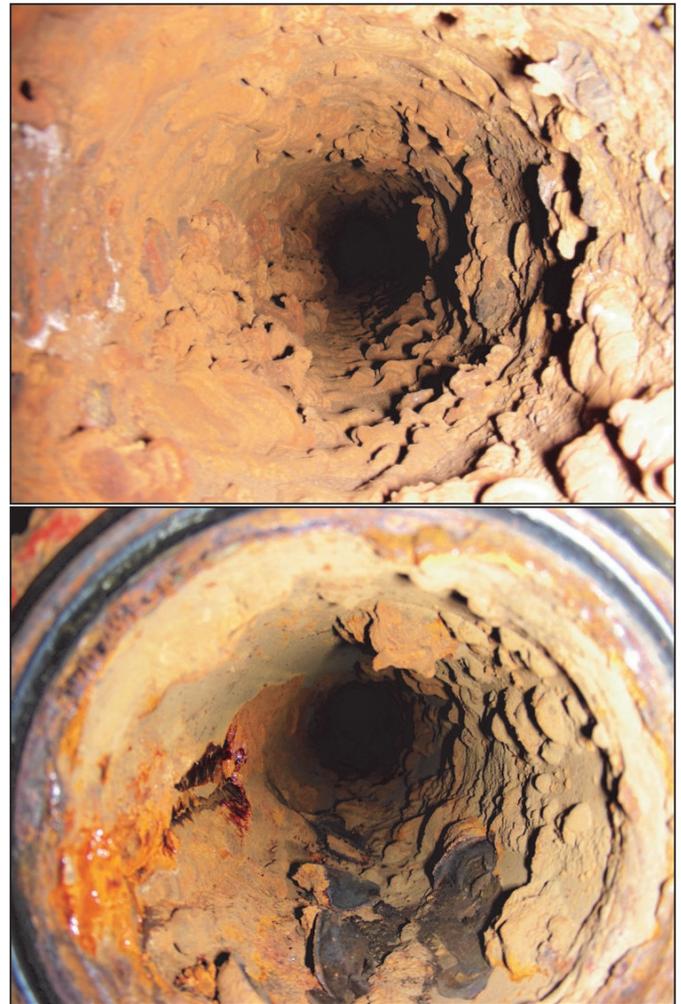
We determined that there was significant oxygen pitting throughout the carbon steel piping system that was responsible for the leaks (Figure 1). The investigation found that the chemical vendor had recommended a molybdate-based chilled water treatment. However, due to

Figure 1. Typical corrosion of chilled water piping at the Case Study 1 facility.

the expense of the molybdate during this time (molybdate prices had skyrocketed), the vendor chose to reduce the amount of molybdate treatment to levels well below what is considered normal. The system also had some leakage which reduced the concentration and increased treatment costs further.

In addition to conventional oxygen pitting corrosion, there was a significant presence of sulfate reducing bacteria (SRB), which were contributing to the corrosion rate.

As a result of the corrosion, much of the 4-inch diameter or smaller steel piping of the chilled water system had to be replaced by copper pipe, copper alloy fittings and valves, and new insulation.

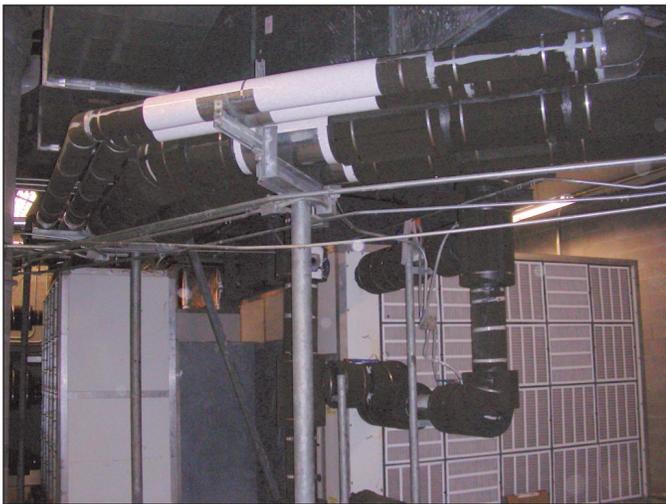
problems in the chilled water loop. Corrosion products broke off and accumulated in narrow portions of the system, behind valves, and plugged off heat exchangers that affected the HVAC system. In this particular system, the air handling units (AHUs) (Figure 2) contained enough deposits to prevent proper operation. Remediation options included mechanical cleaning, chemical cleaning, and complete replacement of the AHUs.

Figure 2. Typical air handling unit (ACU) at the Case Study 1 facility.

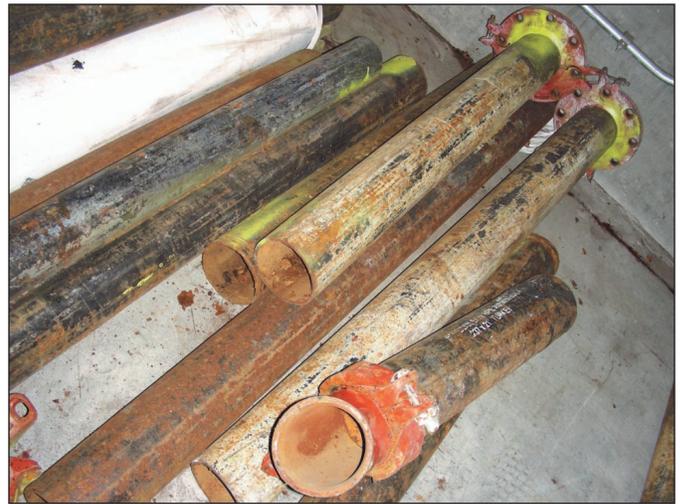
It should be emphasized that in this case, the corrosion was the result of an inadequate water treatment; not the complete absence of it. Also, the corrosion occurred relatively quickly, but did not manifest itself until it progressed so far that significant amounts of the piping and equipment had to be cleaned and/or replaced (Figure 3).

Figure 3. The replacement of piping was already underway when we arrived at the Case Study 1 facility.

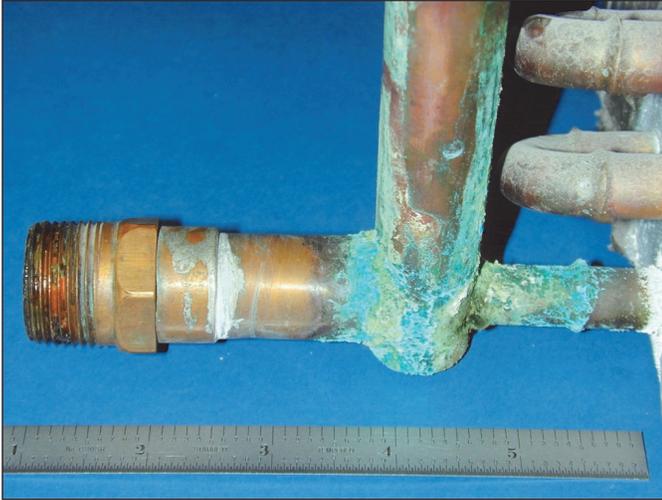
Our investigation found that during construction, the hot water loops had been cleaned of construction debris and left filled with untreated water for testing. Delays resulted in the water remaining stagnant in the system for some time without any additional treatment or monitoring. When it was finally put into service, the chemical company had difficulty establishing and maintaining the passive nitrite chemistry. There were long periods where the nitrite level essentially dropped to zero.

Approximately a year later, the first leak appeared. This was quickly followed by 11 more leaks. Eventually, the leak rate became so significant (inspection found 147 heat exchangers that showed signs of leaking) (Figure 4) that the construction firm agreed to replace all 747 exchangers. In this case, there was a complete lack of treatment during the construction and subsequent commissioning phase. When treatment was eventually started, corrosion already established in the system made it

Figure 4. Corrosion of an unprotected closed loop system after approximately one year.
