the CONDUIT

Fall 2016

Broken Obelisk

[Catherine A. Noble, P.E.](#), Consulting Engineer

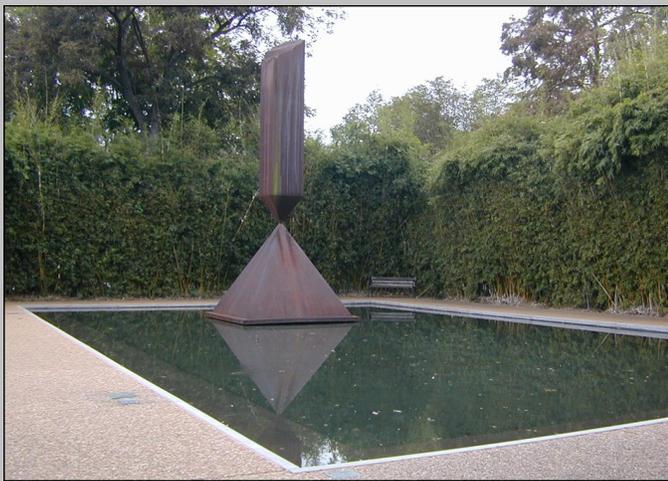
Photograph shows the Broken Obelisk over the reflecting pool in November 2014.

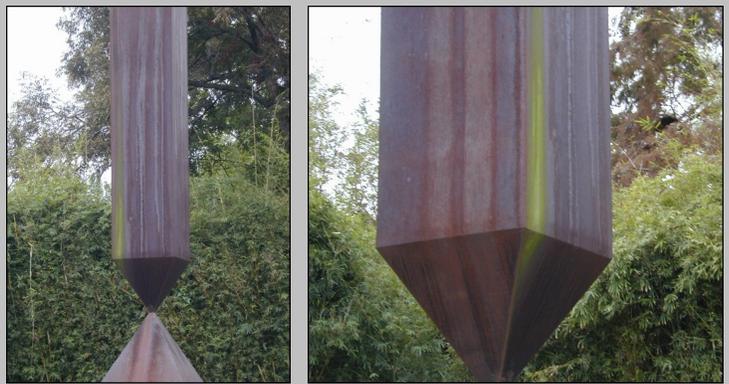
Photograph shows the condition of the obelisk in November 2014.

The Broken Obelisk sculpture was visually examined and photographed during the initial on-site visit. There were several streaks of darker rust down the sides of the obelisk and the middle of each side of the pyramid in line with the obelisk.

It appeared that there was more corrosion than just the typical surface patina of weathering steel, but it was difficult to tell from the edge of the reflecting pool. In addition, there was a green streak near the bottom of the obelisk on the North side. This was likely biological in nature, as there had been reports of bird feces needing to be cleaned off of the sculpture.

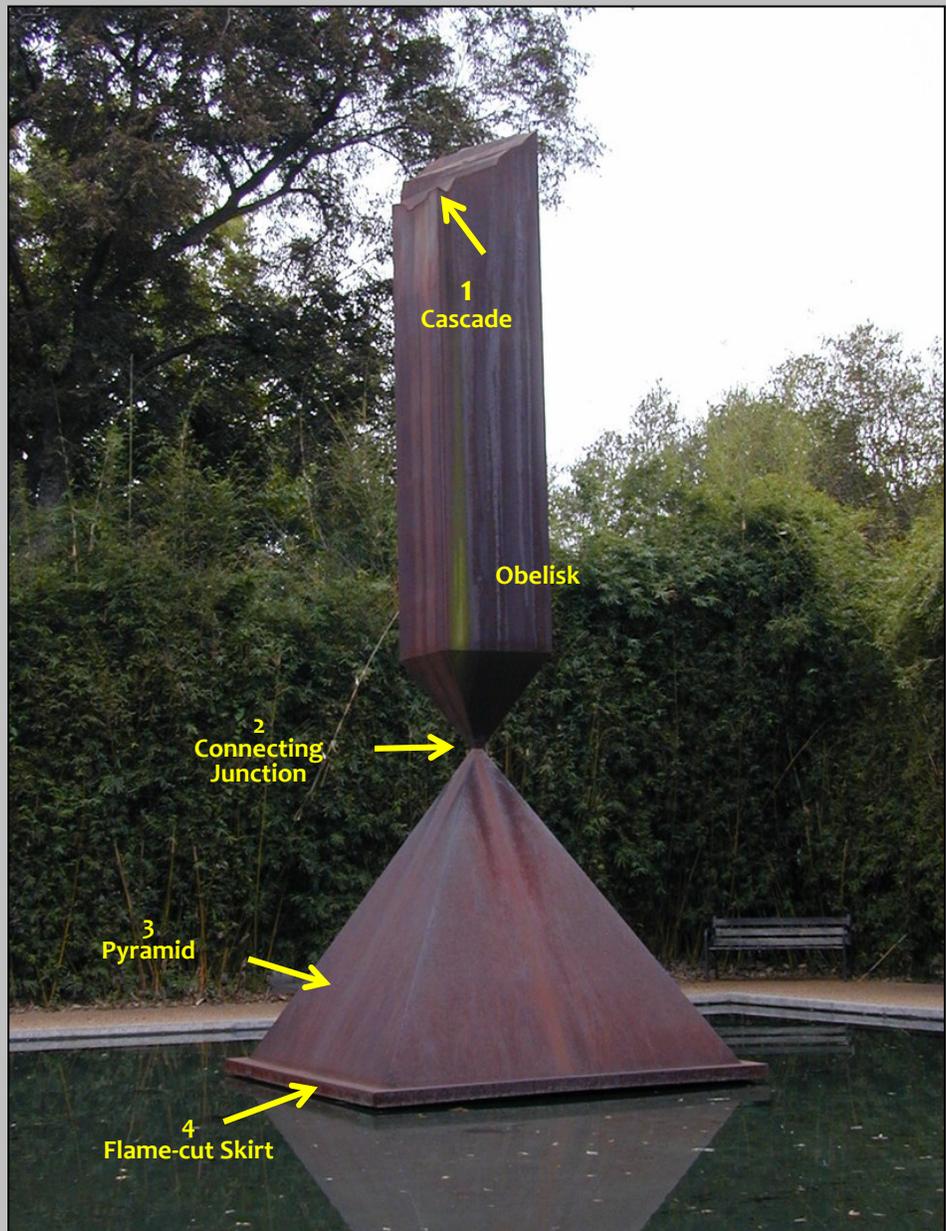
Photograph shows the sections of the sculpture and the four locations where deposits were collected for analysis.

The sculpture was visited again several months later and examined up close using an elevated work platform. Four locations were examined: 1) the cascade (top of the obelisk), 2) the connecting junction between the obelisk point and the pyramid, 3) the bottom of the pyramid, and 4) the flame cut edge of the skirt just above the water line.

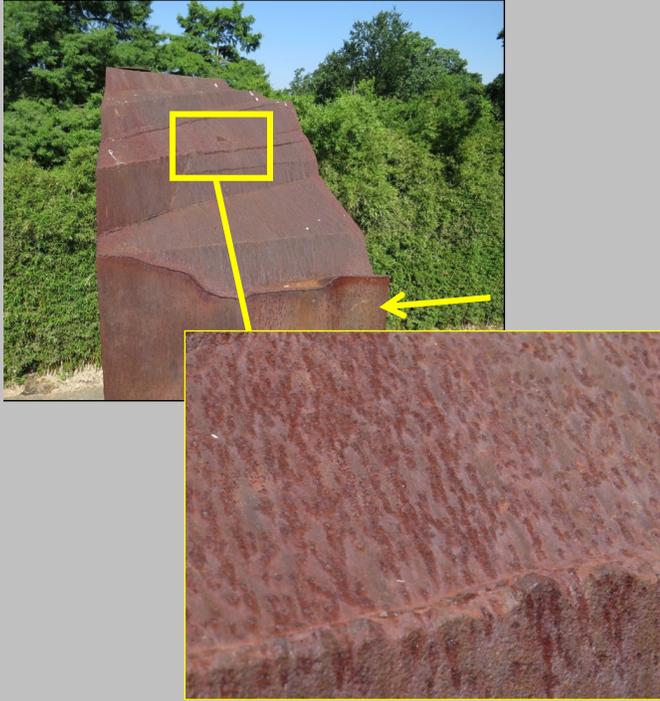
Photographs show the condition of the cascade obelisk. Arrow indicates one of the epoxy patches in the panel.

Along with a general maroon-colored oxide layer, some pitting and corrosion deposits were noted on the cascade. A small hole was noted on the narrow section that was horizontal and welded to the vertical East side. The hole was about 1/10th of an inch in diameter, and this location was selected for deposit collection. In addition, there were two epoxy-patched areas just below the top on the East face of the obelisk. Corrosion had progressed through-wall in these areas that had necessitated patching in between prior restorations.

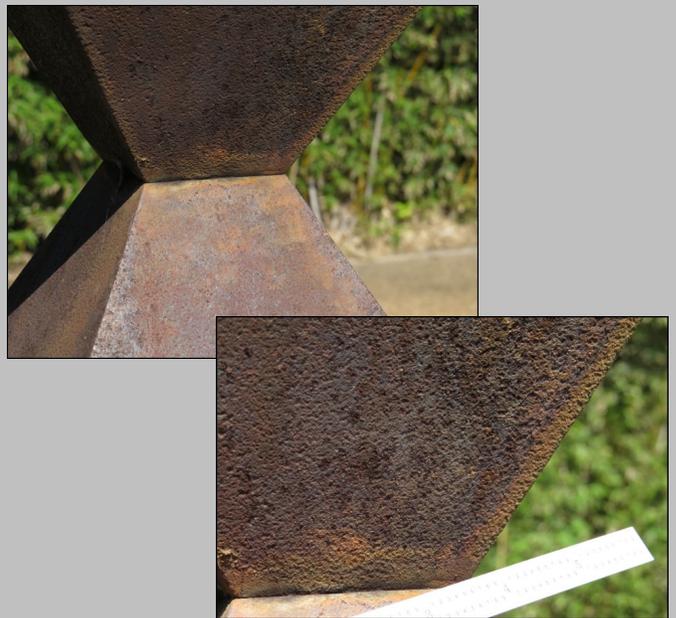
The connecting junction between the obelisk point and pyramid was examined next. The faces on both pyramids had a general maroon and gray color with pitting covering most surfaces. Along the edges of the pyramids and right at the junction, there was a brighter, rust-orange deposit. The streaks down the

center of the pyramid faces that were observed during the previous visual examination were still present, but were somewhat fainter. These were likely due to drainage off of the obelisk.

Photographs show the connecting junction between the inverted pyramid and the base pyramid.

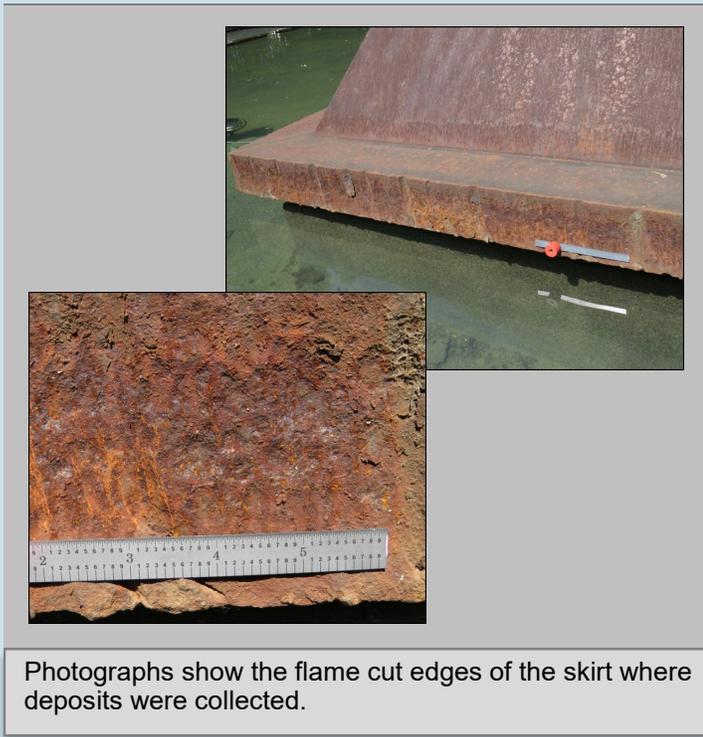
The skirt had the most rust and deposits, making deposit collection much easier. Pitting was present, but it was difficult to distinguish some of this from the texture of the flame-cut edge as part of the artist's design. The water was several inches below the skirt at the time of the inspection.

Photographs show the flame cut edges of the skirt where deposits were collected.

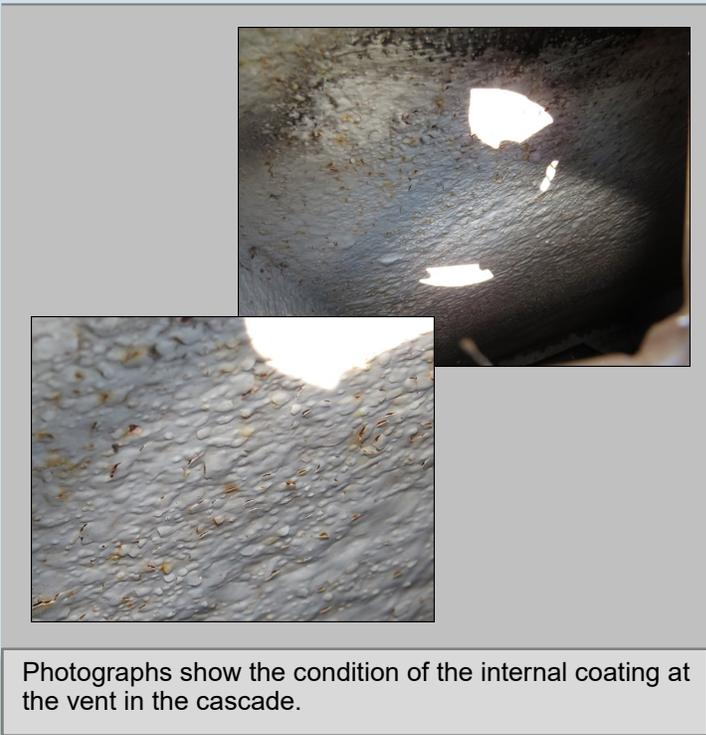
At the upper corner of the cascade, there is a vent with a removable plate. This plate was removed and the interior of the obelisk was also inspected. Multiple blisters with rust along the edges were observed in the coating on the internal surface. Blistering could have occurred due to moisture wicking in between the metal and coating or improper surface preparation prior to the coating application. The coating was installed during the 2005 restoration and was nearing the end of its life.

Photographs show the condition of the internal coating at the vent in the cascade.

Ship-2-Shore Industrial coating had been recommended for the interior and exterior surfaces of all Cor-Ten surfaces along with the stainless steel structural parts. The information available on this coating was reviewed and found to be a suitable coating for the sculpture. It was recommended to strictly follow the manufacturer's recommendations for coating thickness, application techniques, and reapplication schedule based on the service environment. Surface preparation is critical to proper coating adhesion, and surfaces should be as clean as possible before applying any coating. Testing was also recommended to be conducted to ensure that there were not any holidays in the coating, as this could also lead to premature coating failure and accelerated corrosion at any small, anodic holes in the coating.
