the CONDUIT

VOL 18, NO 2

Why is My New Stainless Clarifier Rusting?

[Karen T. Fuentes, P.E., Senior Principal Engineer](#)

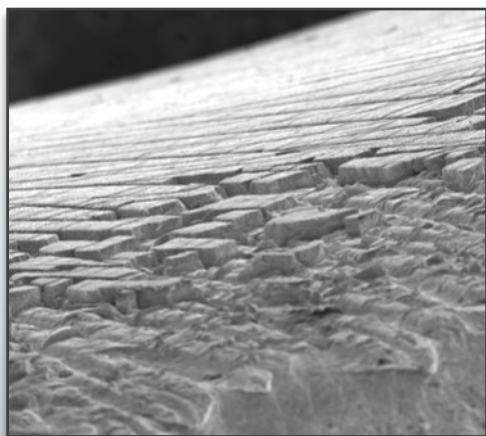
Crazed Oxide:

High-cycle thermal fatigue frequently results from intermittent wetting of a hot surface by liquid having a considerably lower temperature. In such instances, the wetted surface contracts rapidly, whereas the metal below the surface does not; this produces large biaxial tensile stresses in the wetted surface. As the water absorbs heat and evaporates, the temperature of the surface returns to its previous value, and surface stresses are relaxed. After a sufficient number of thermal cycles, a crazed pattern of cracks appears on the surface. Eventually, one or more of the surface thermal fatigue cracks may propagate completely through the section by fatigue or by another mechanism¹.

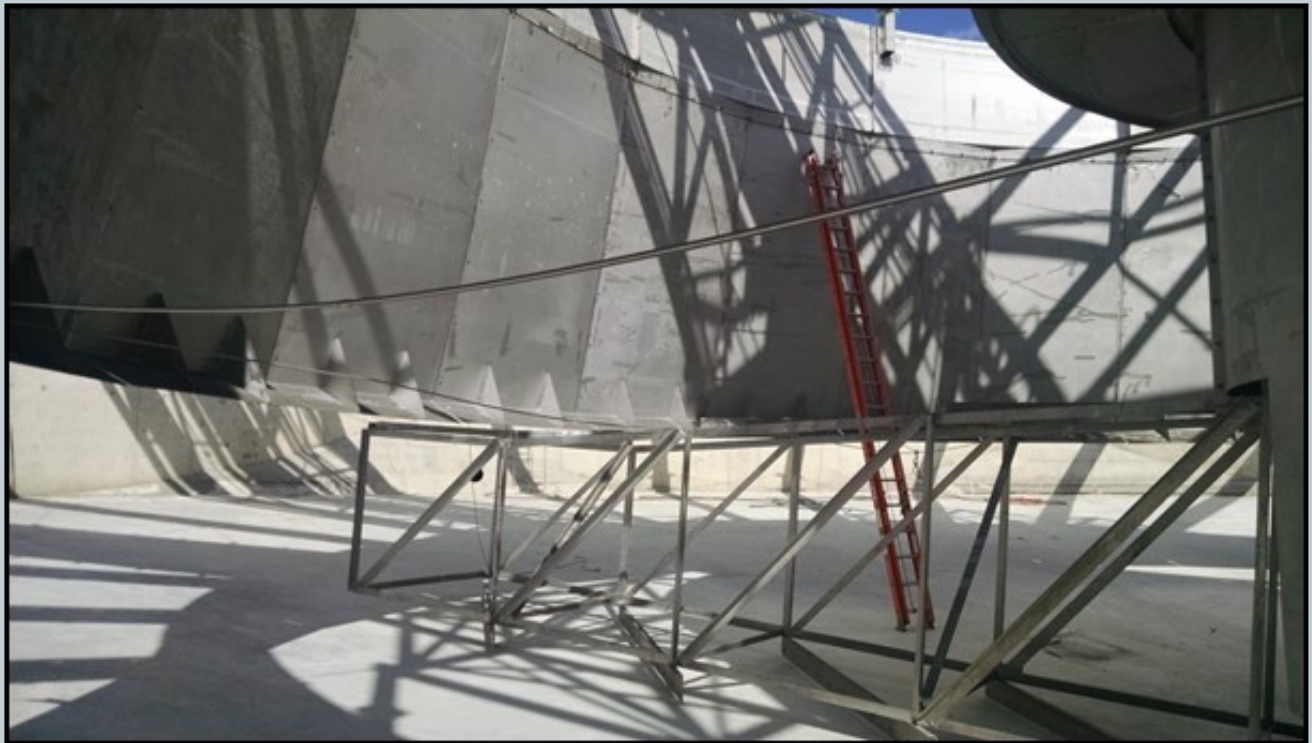
A municipal utility was constructing a new water treatment facility (Figure 1). In the course of the construction of the clarifiers, they were filled with water and emptied a number of times. In one case, the water was in the clarifier for three weeks. When the clarifiers were empty, various stains and other signs of apparent corrosion were identified by the construction firm and municipal inspectors. Reportedly, inspections of the clarifiers were performed according to ASTM 380 and ASTM 967 specifications. The stains on the surface of the stainless steel were suspected to be active corrosion of the base metal, which meant that the clarifiers would not pass inspection. The project contractors spent several months attempting to clean

Figure 1. Photograph shows the interior of a clarifier tank.

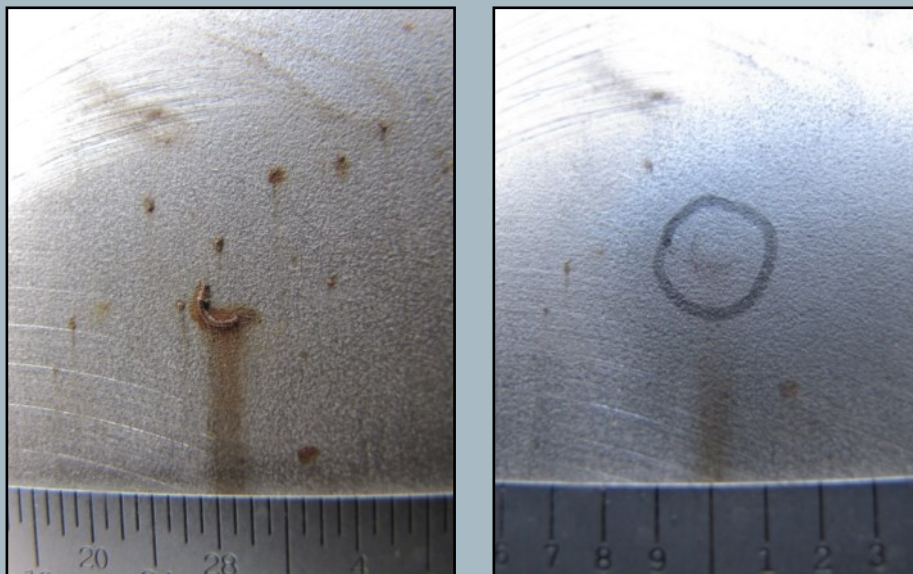
- The spots on the stainless steel were particles of iron that had settled and adhered to the surface of

the stainless steel. These iron particles were actively corroding and causing visual stains on the surface of the stainless steel.

The location is shown untouched (Figure 2-left image) and after abrasive cleaning (Figure 2-right image).

- The stainless steel below the stains was not affected by the corrosion of the iron particles. The passive oxide layer was intact in every case. The stainless steel was not corroding.
- Other stains were caused by dirt and the organic matter in the water that was used to fill the clarifier.

Figure 2. Photograph shows spots on the stainless steel were particles of iron that had settled and adhered to the surface. These iron particles were actively corroding and causing visual stains on the surface of the stainless steel.

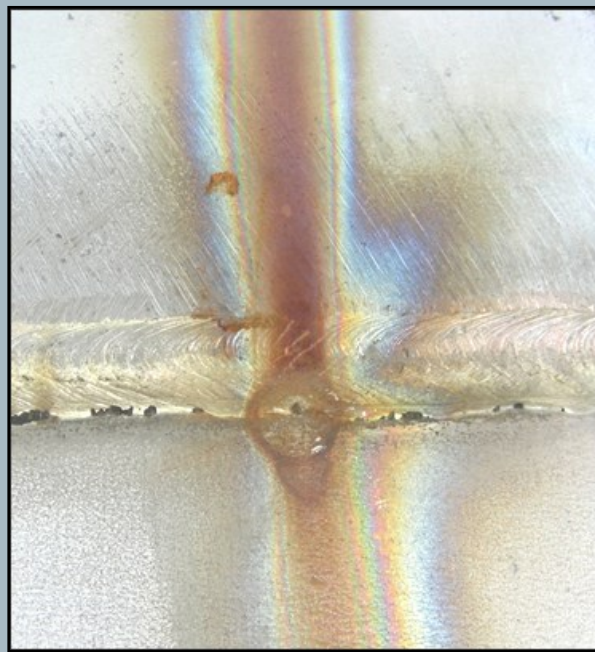
- Some welds that were submerged in the water had areas of slag along the toe of the weld that were causing staining, but the weld itself was not compromised (Figure 3).
- Some rough spots caused by grinding needed to be smoothed to prevent an opportunity for crevice attack.
- The absence of seal welds presented the opportunity for crevice corrosion that was eliminated by adding seal welds.

Figure 3. Photograph shows a weld that was submerged in the water where areas of slag along the toe of the weld were causing staining. The weld itself was not compromised.
