M&M Engineering's Boiler Tube Failure Handbook

Hole—Fireside

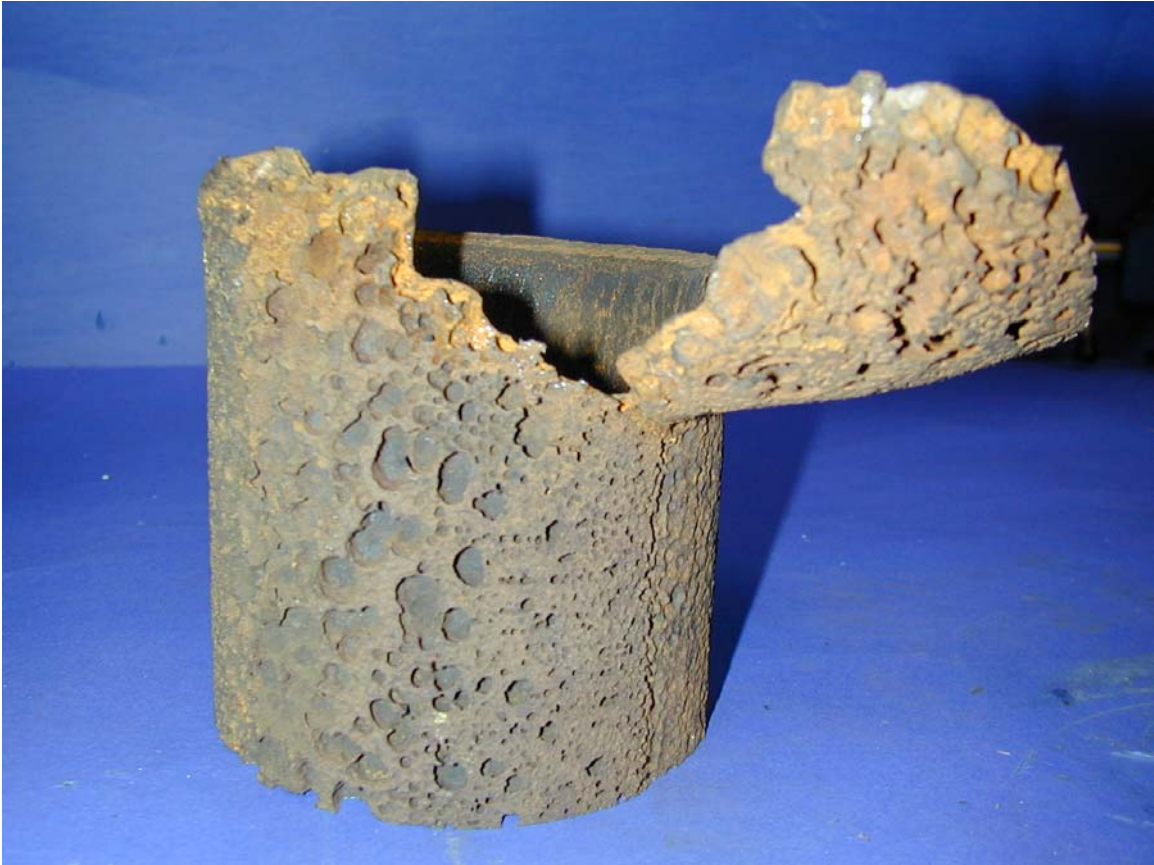
Locations	Furnace Riser
Boiler Type	Cyclone/Power
Industry	Utility

Appearance	Severe pock-marked corrosion on fireside
Mechanism	Corrosion/Thermal Fatigue
Comments	Damage caused direct impingement of waste chemical cleaning solution on riser tube inside cyclone boiler. Tube failure a combination of corrosion and thermal shock.
