# M&M Engineering's Boiler Tube Failure Handbook

## Hole—Fireside

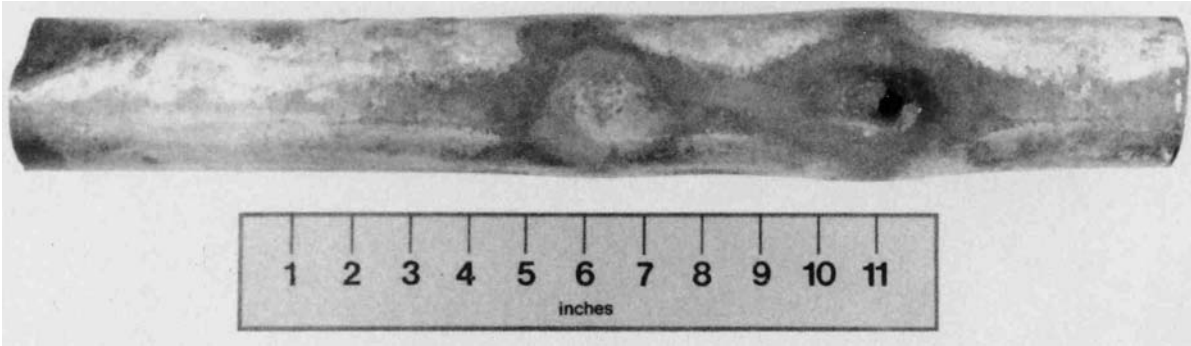
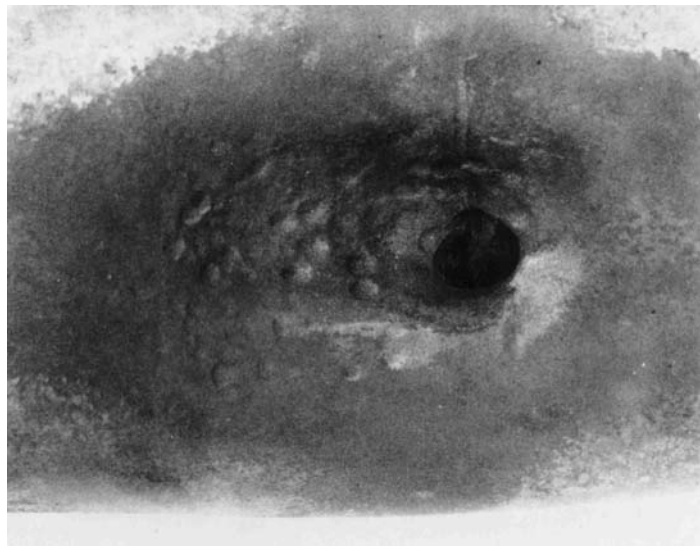
Locations	Reheater
Boiler Type	Power
Industry	Utility

Appearance	Deformation and perforation from the outside in
Mechanism	Mechanical damage
Comments	Damage caused by shotgun slug used to deslag reheater tubes. Similar failure can occur wherever mechanical deslagging is performed.
