M&M Engineering's Boiler Tube Failure Handbook

Crack—In or near weld or attachment—Longitudinal (random)

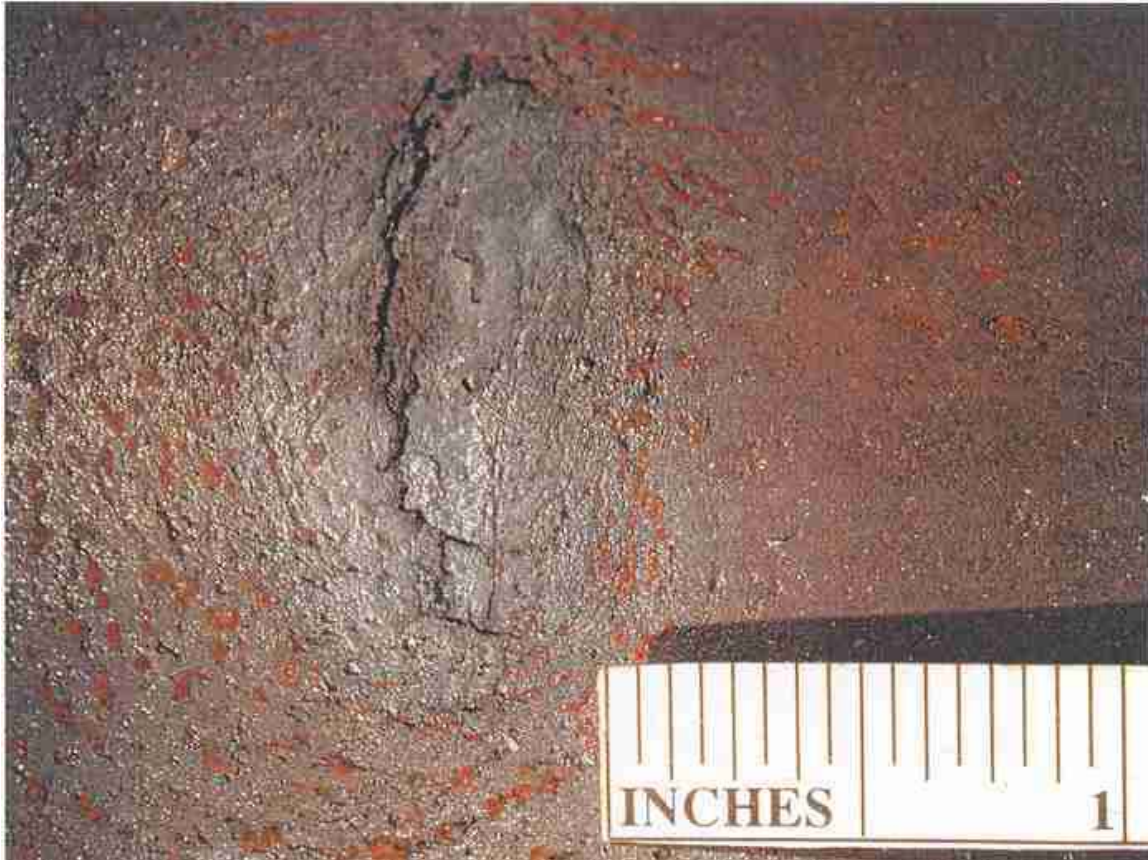
Locations	Waterwall, Economizer
Boiler Type	Recovery
Industry	Pulp and Paper

Appearance	Multiple cracks associated with attachment on outside of tube
Mechanism	Corrosion-fatigue
Comments	External attachment provided a restraint and associated high operating stress. This, together with marginal water chemistry particularly during startup, leads to corrosion-fatigue cracks
