M&M Engineering's Boiler Tube Failure Handbook

Hole—Waterside

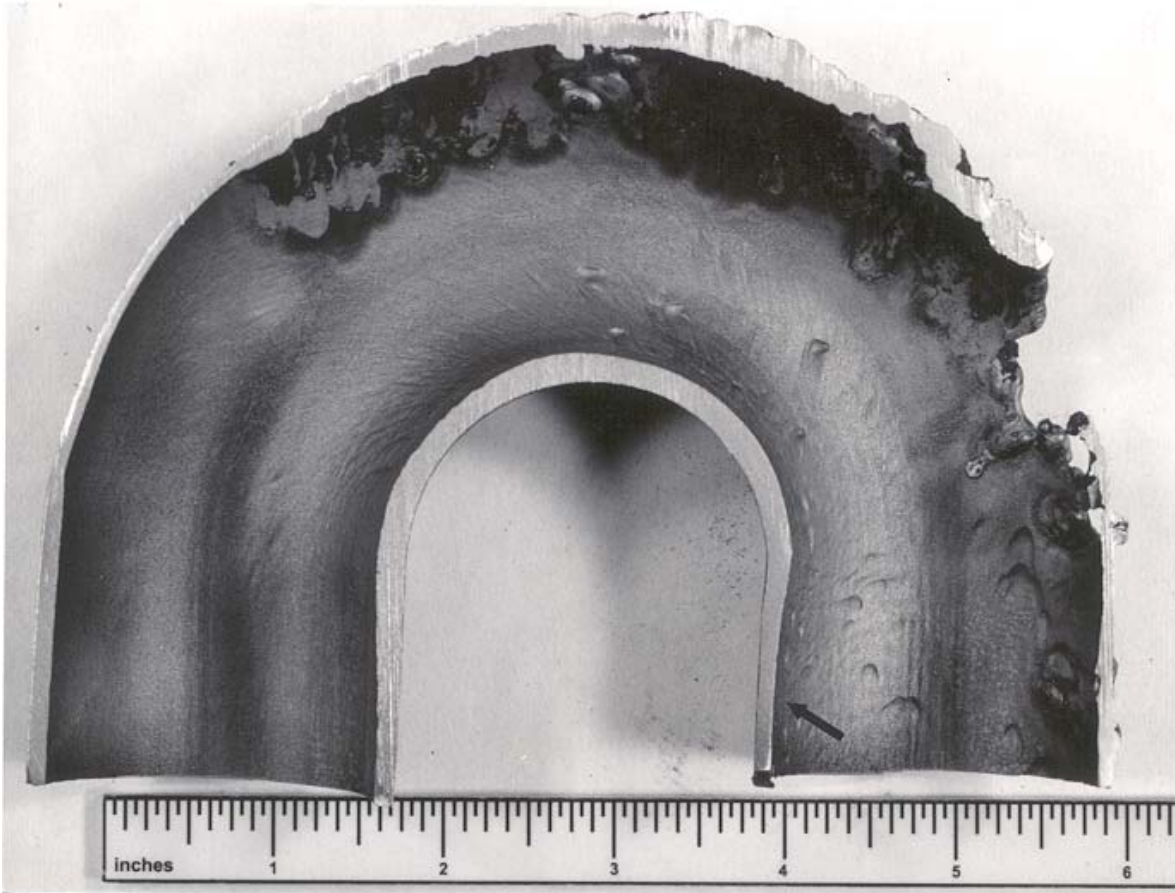
Locations	Economizer
Boiler Type	Power
Industry	Electric Utility

Appearance	Thinning on inside of a u-bend or other change in direction
Mechanism	Flow Accelerated Corrosion (FAC)
Comments	FAC results from a combination of factors including material limitations, design, and water chemistry. Failures are typically catastrophic.
