# M&M Engineering's Boiler Tube Failure Handbook

## Deformation—Thinning

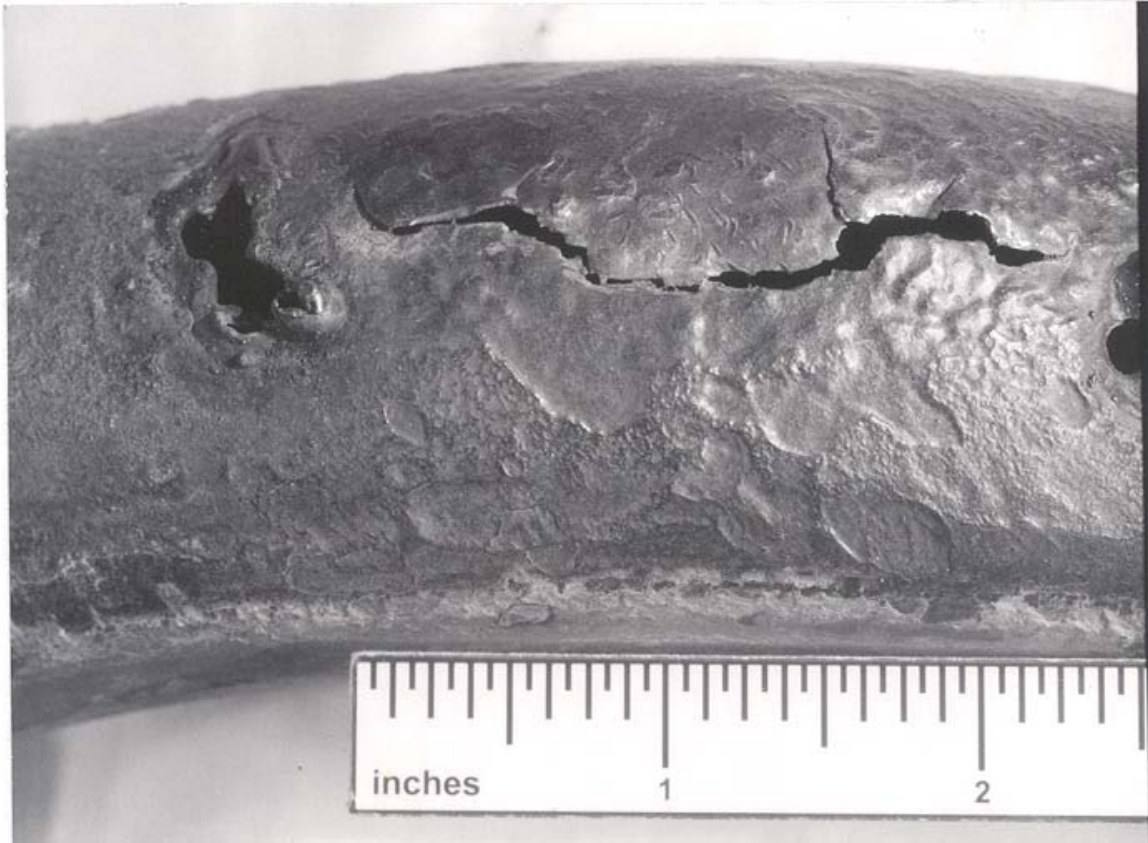
Locations	Reheater
Boiler Type	Power
Industry	Electric Utility

Appearance	External thinning, smooth areas
Mechanism	Fireside Corrosion/Erosion
Comments	Abrasion from fly ash may cause erosion, corrosion may also occur as sulfur deposits become acidic during shutdown or cool gas temperatures. This type of corrosion is more prevalent in oil-fired boilers and in the back-end of the gas path i.e., economizers.
