# M&M Engineering's Boiler Tube Failure Handbook

## Hole—Fireside

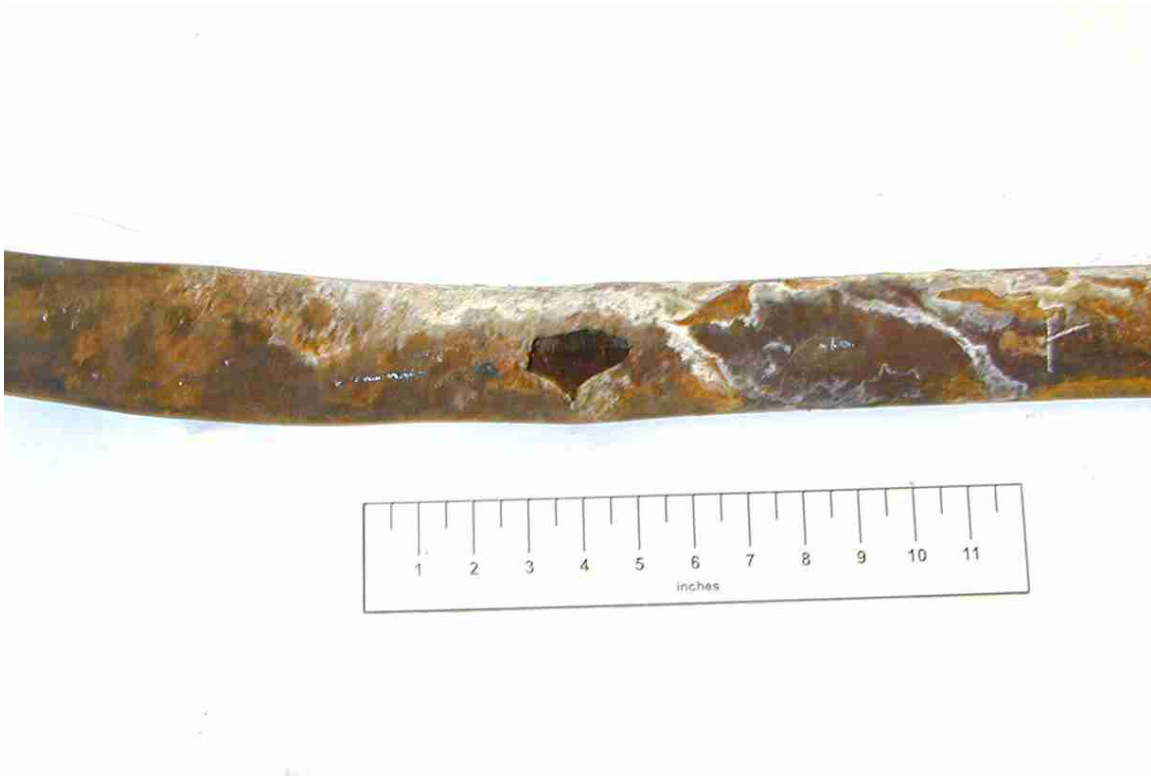
| Locations | Waterwall |

| Appearance | Thinning from the fireside, pockmarks on external surface |
| Mechanism | Fireside corrosion |
| Comments | Corrosion associated with acidic deposits from sulfur in the fuel. |
