# M&M Engineering's Boiler Tube Failure Handbook

## Hole—Waterside

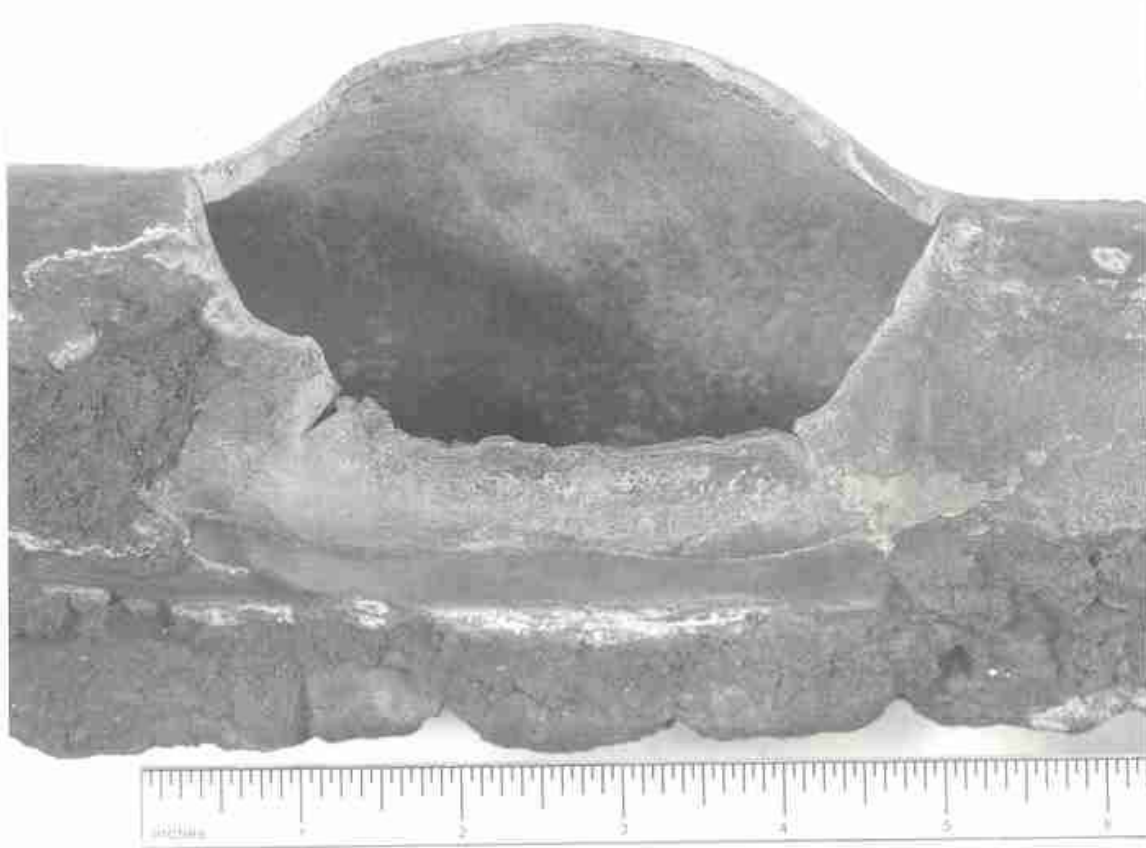
Locations	Water wall
Boiler Type	Power
Industry	Electric Utility

Appearance	Thick-lipped rupture, may be very large window missing or a flap hanging by one edge or a long crack.
Mechanism	Hydrogen damage
Comment	Hydrogen damage is an under-deposit corrosion mechanism. Damage occurs in high heat areas (e.g., above burners). Often associated with one or more low pH excursions in the boiler and/or long-term contamination (condenser tube leak). High probability that other tubes are similarly affected. All affected tubes must be replaced.
