M&M Engineering's Boiler Tube Failure Handbook

Deformation—Bulging

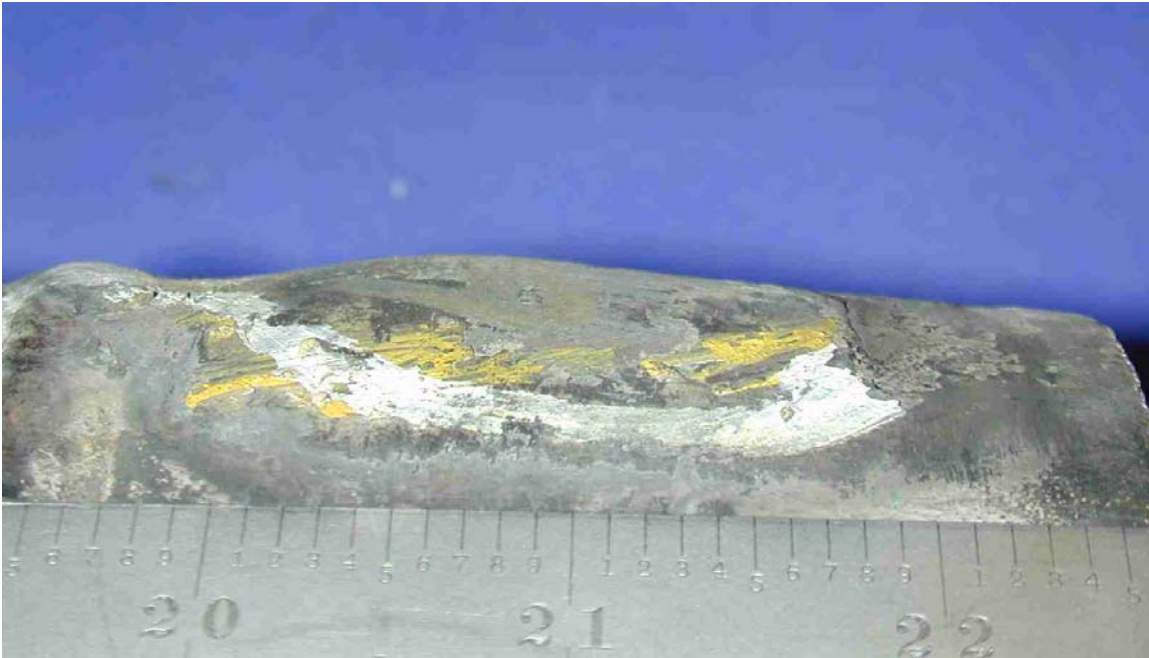
Locations	Waterwall
Boiler Type	Power
Industry	Pulp and Paper

Appearance	Bulging tube adjacent to field weld
Mechanism	Long term overheat
Comments	Boiler tube material has been deformed due to very heavy deposits on the inside of the tube that insulate the tube metal from the boiler water and cause overheating.
