M&M Engineering's Boiler Tube Failure Handbook

Crack—Not in or near weld or attachment—Longitudinal

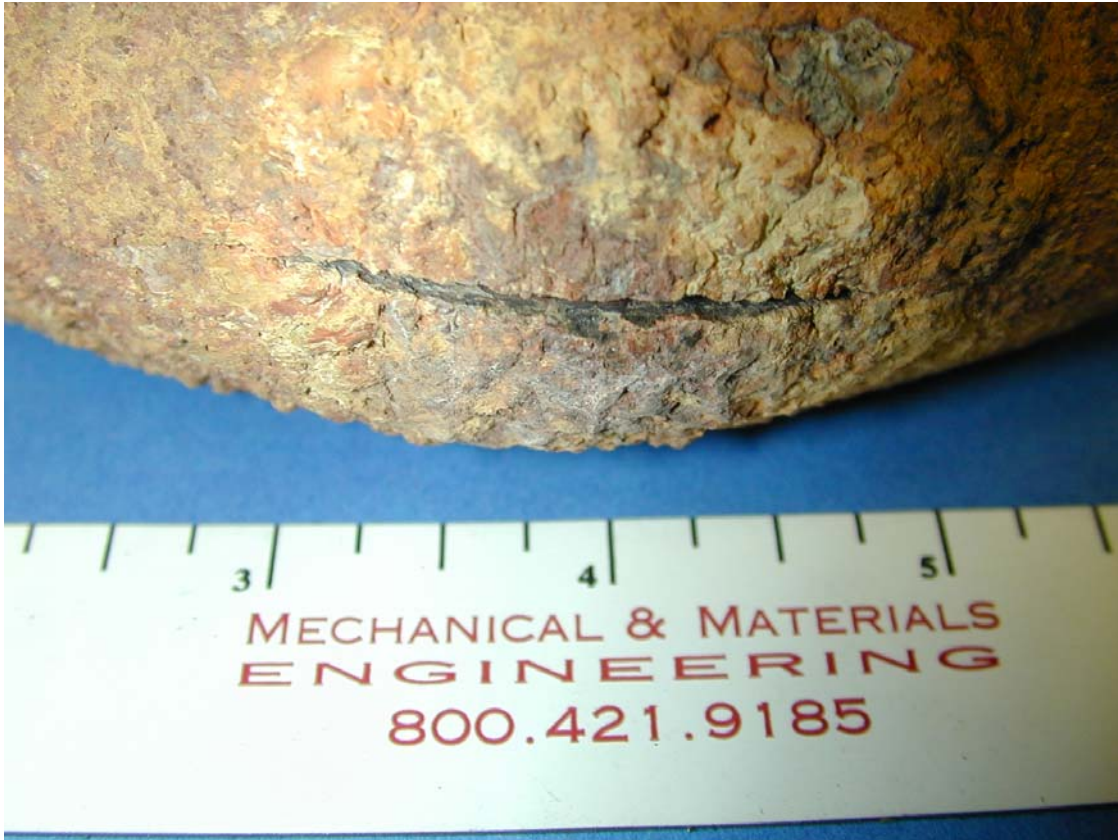
Locations	Superheater, Reheater, Waterwall
Boiler Type	Power
Industry	Electric Utility

Appearance	Longitudinal crack at bend
Mechanism	Long-term Overheat
Comment	Excessive heat often caused hot spots in the boiler or from flame impingement. Excessive internal deposits may also contribute to overheating
