M&M Engineering's Boiler Tube Failure Handbook

Hole—Waterside

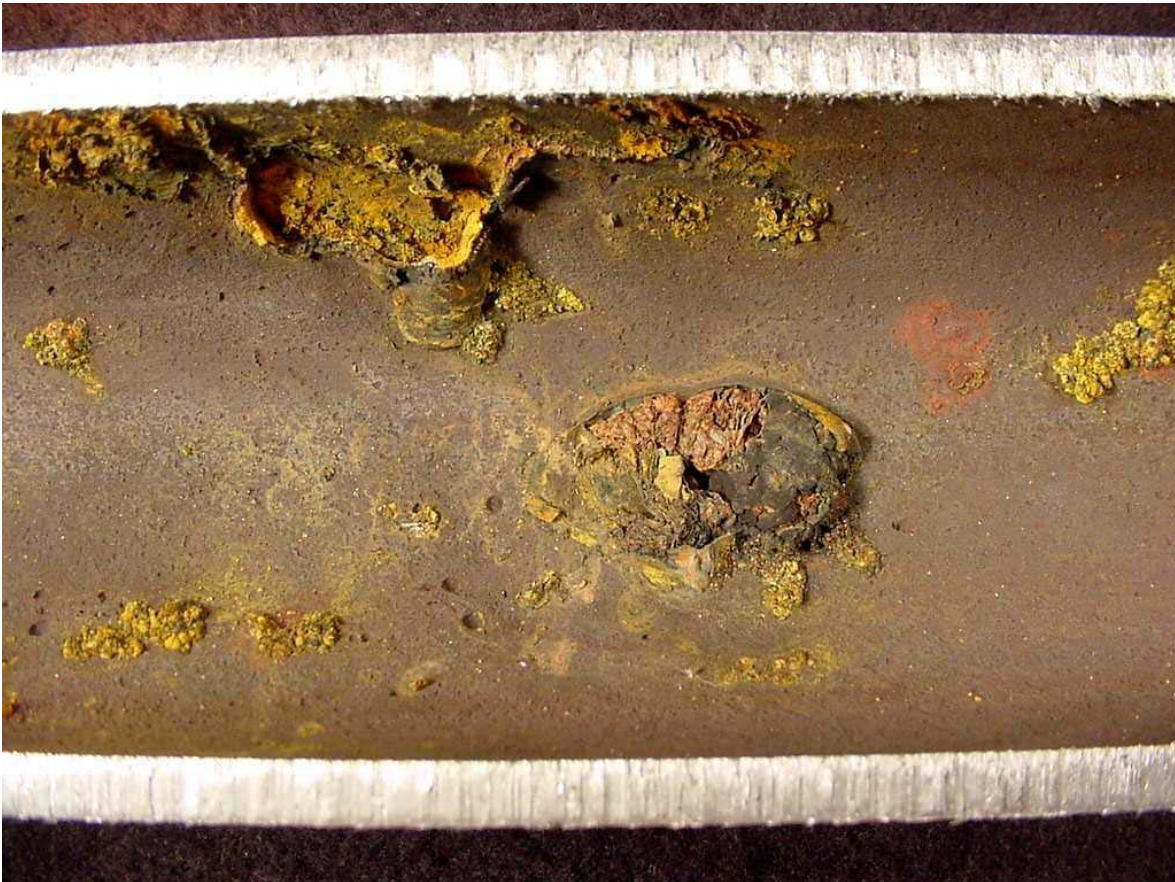
Locations	Waterwall, Superheater, Reheater
Boiler Type	Power
Industry	Electric Utility

Appearance	ID pitting with corrosion tubercles
Mechanism	Oxygen Pitting
Comments	Improper lay-up, poor control of oxygen on startup
