M&M Engineering's Boiler Tube Failure Handbook

Hole—Waterside

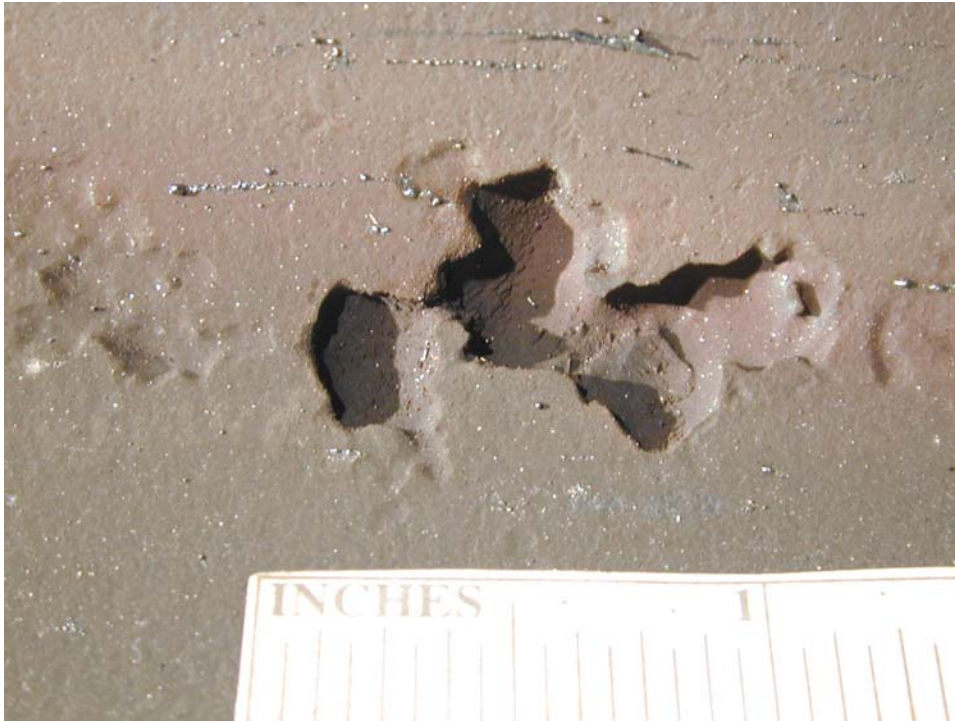
Locations	Water wall
Boiler Type	Power
Industry	Electric Utility

Appearance	Undercut corrosion, multi-color deposits (red, white, black). This is a View of a tube ID following cleaning.
Mechanism	Acid Phosphate Attack
Comment	Under-deposit corrosion mechanism caused by reaction of phosphate with magnetite for form maracite. Most often found in high heat areas of the boiler. Typically associated with boilers suffering phosphate hideout and using disodium phosphate or sodium hexametaphosphate.
