# M&M Engineering's Boiler Tube Failure Handbook

Crack—In or near weld or attachment—Transverse

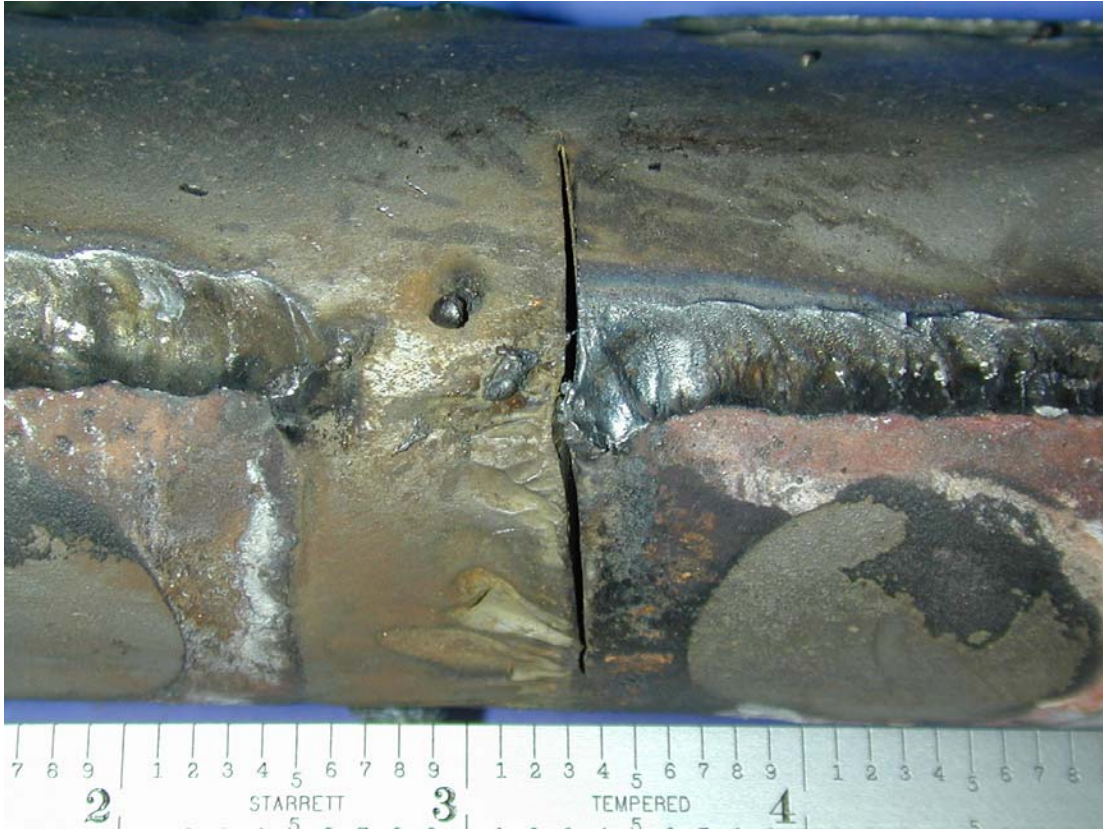
Locations	Evaporator
Boiler Type	HRSG
Industry	Co-Gen

Appearance	Transverse crack near support
Mechanism	Thermal Fatigue
Comments	The fast cycling that occurs in HRSG units can put tremendous strains on restrained tubing creating thermal fatigue.
