M&M Engineering's Boiler Tube Failure Handbook

Hole—Waterside

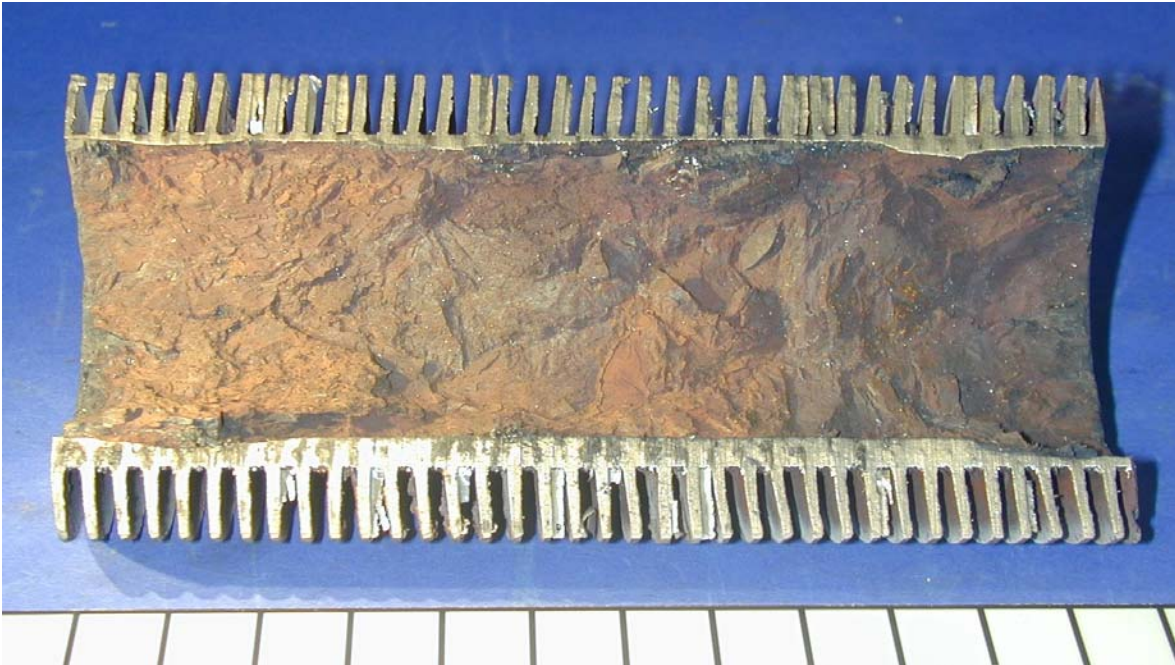
Locations	Evaporator Section
Boiler Type	HRSG
Industry	Co-Gen

Appearance	Severe corrosion on side of tube facing gas turbine/duct burners
Mechanism	Multiple underdeposit corrosion mechanisms including caustic gouging, phosphate attack, and hydrogen damage
Comments	Corrosion caused by a combination of pre-construction deposits, poor chemistry control, and high heat flux from duct burners.
