M&M Engineering's Boiler Tube Failure Handbook

Hole—Material Defect

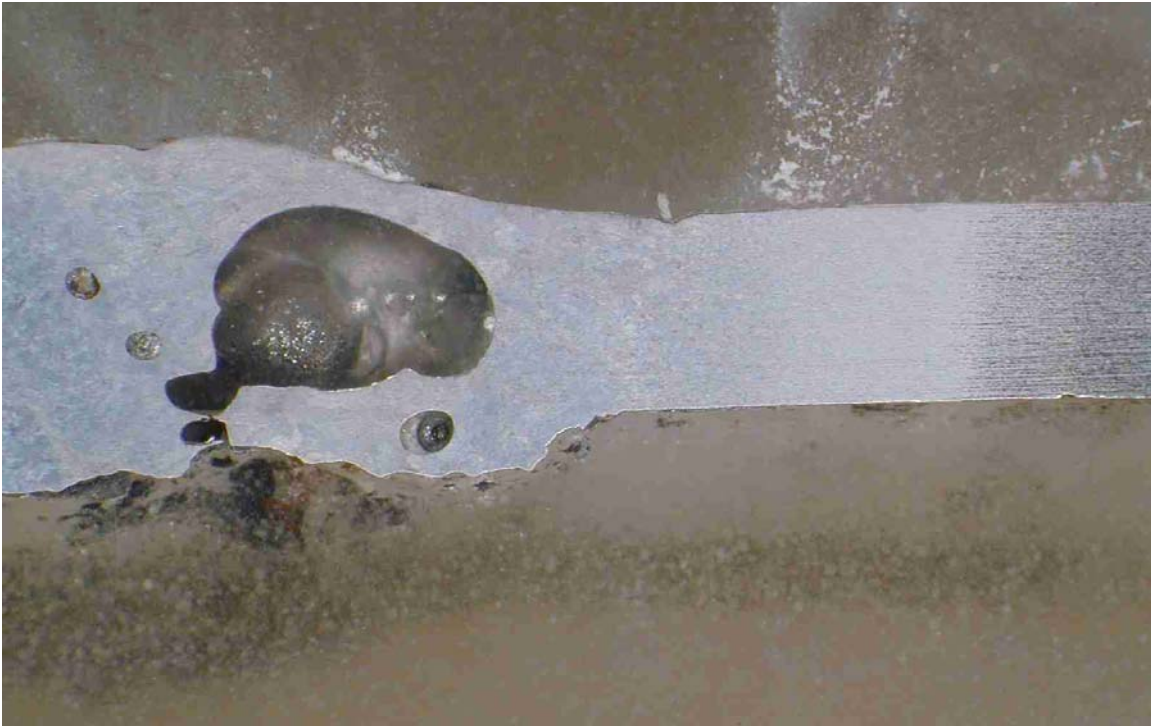
Locations	Superheater
Boiler Type	Power
Industry	Pulp and Paper

Appearance	Porosity in weld
Mechanism	Weld Defect
Comments	Weld porosity may be due to inadequate shield gas flow or contamination on the surface of the material.
