A quarterly publication from M&M Engineering Associates, Inc.

#### Vol. 14, No. 3

## **Failure Mechanisms Working in Collusion**

## Why These Two and Not the Others?

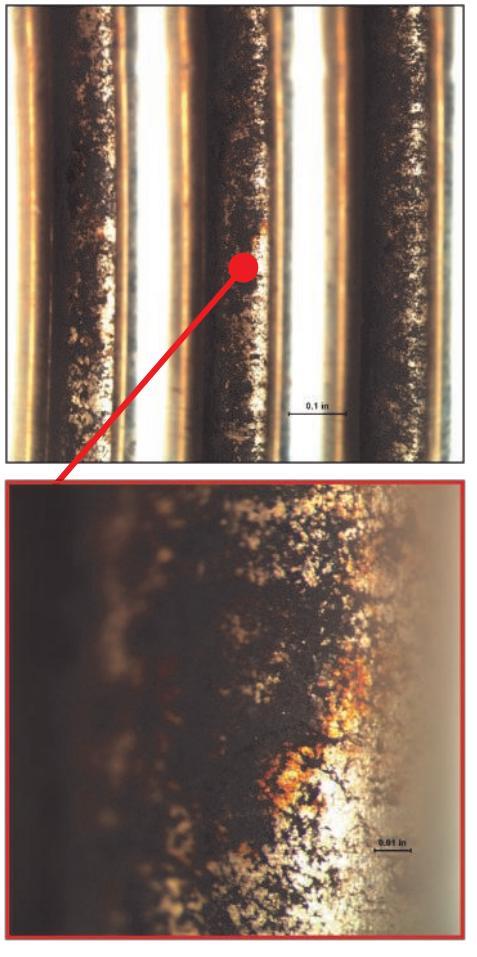
The internal surfaces of the pressure boundary liners were inspected using a stereomicroscope. The larger diameter hose liner had no notable aberrations or deposits. The smaller diameter hose liner contained tenacious deposits biased to one side of the liner (Figure 1).

Figure 1. Photographs show images of the tenacious deposit and suspected corrosion observed on the internal surface of the liner from the smaller diameter hose.

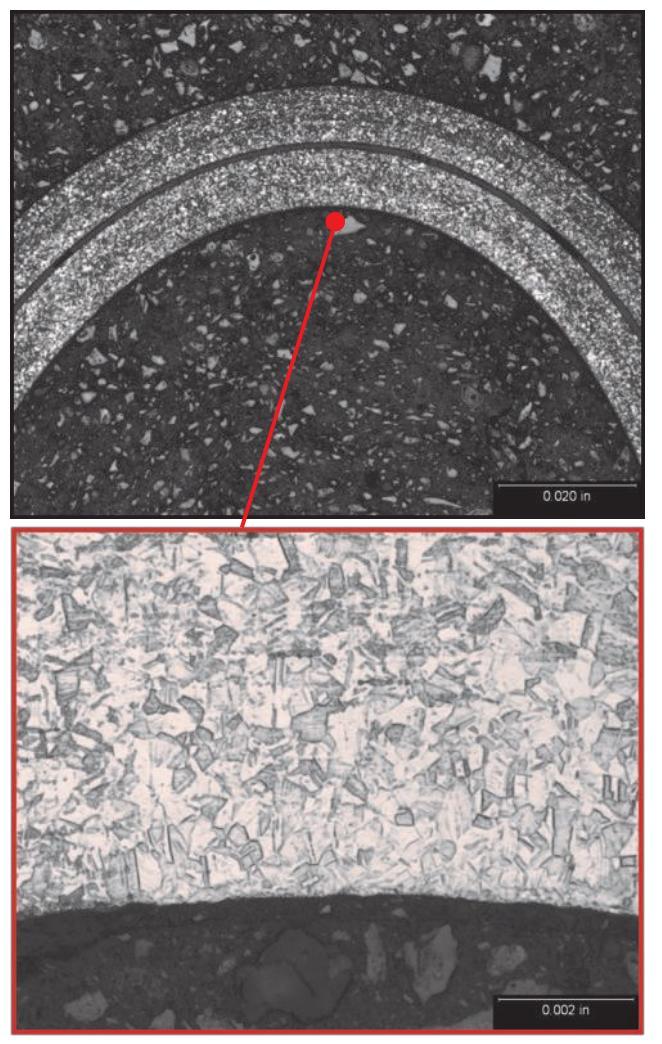
Figure 2. Photomicrographs show the internal surface of the hose corrugations with visible deposits. No corrosive penetration was observed. (Etchant: Aqua Regia)

corrugations with visible deposits and corrosion patina did not reveal any penetration into the base metal (Figure 2). The tenacious deposits and corrosion were superficial.

The conclusion: although some tenacious deposits were observed on the smaller diameter hose, only superficial corrosion was observed. No penetration into the bulk metal was observed. Based on the samples submitted for analysis, no corrosion problems were found and similar hoses were suitable for service.

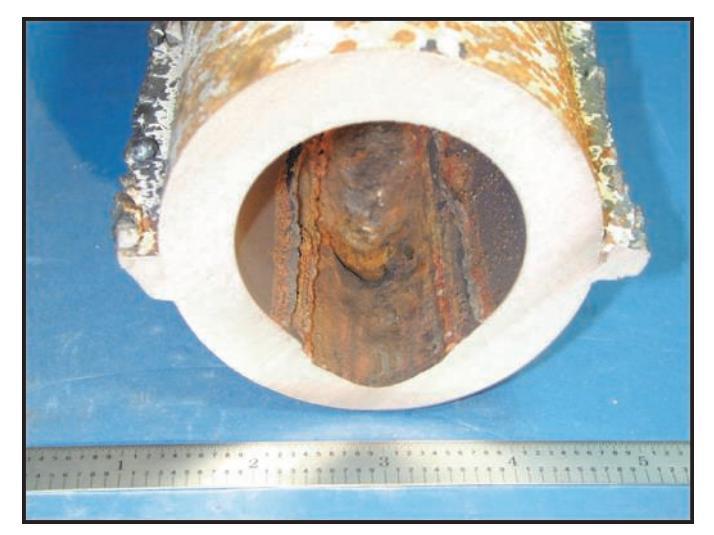
Figure 2. Photograph shows the cross section approximately 2 inches from the blister area. A deep gouge filled with deposit was noted on the hot side (on the top of the tube as-installed).

There were also some patches of green deposit and copper-colored deposits. The gouge was approximately 1.5 inches wide and ran almost the entire length of the tube sample (about 18 inches).

The appearance of the gouge and the deposits was consistent with an under-deposit corrosion mechanism such as caustic gouging.

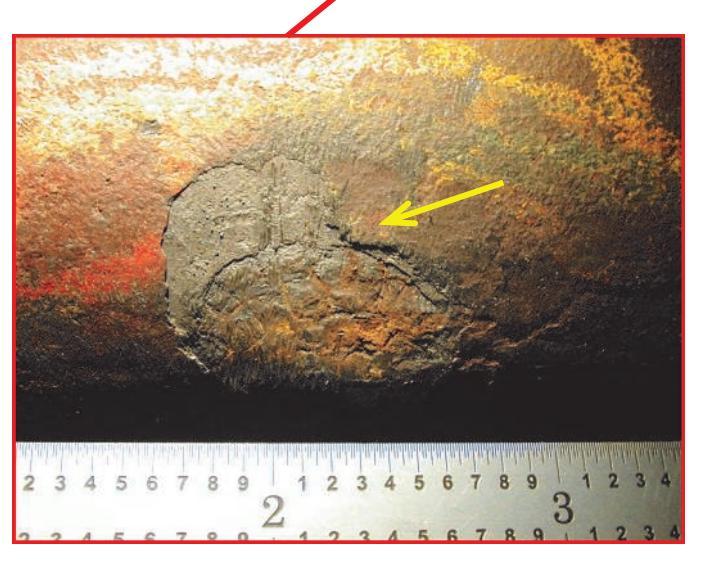
We received a boiler floor tube that contained a bulge and large blister on the hot side, with a likely throughwall failure at the peak of the blister (Figure 1). The tube was sectioned about 2 inches away from the blister to reveal significant thinning and gouging of the tube wall (Figure 2). The tube sections were then split longitudinally to examine the internal surfaces. Heavy, layered deposits that were red, gray, and white in color were noted within the gouge on the hot side (Figure 3).

Figure 1. Photographs show the as-received condition of the floor tube. The failure was on the hot side of the tube (arrow). The tube was installed horizontally, putting the failure at the 12 o'clock position of the tube.

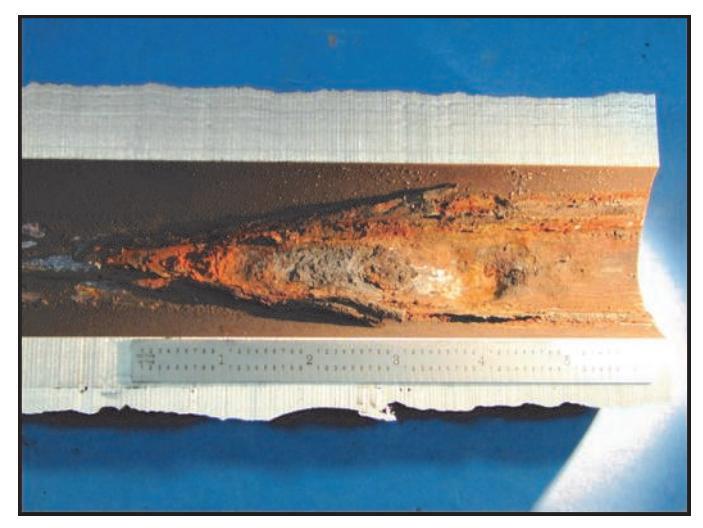
Figure 3. Photograph shows the internal surface of the tube in the failure area with layered deposits.

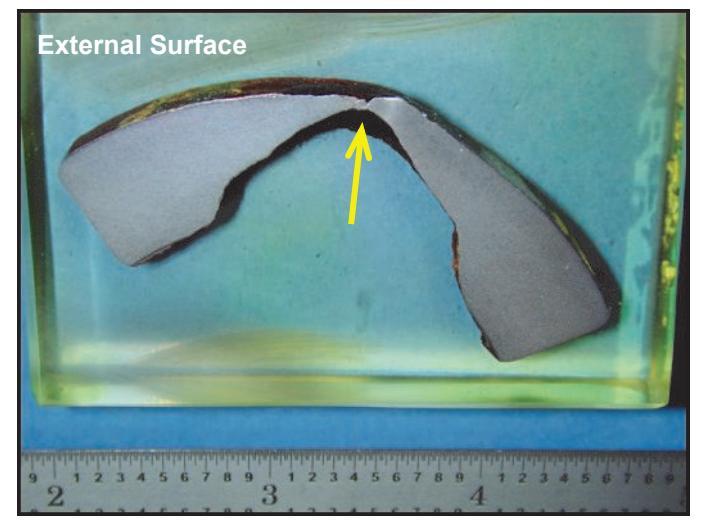
Figure 4. Photograph shows the prepared cross section of the tube, with the failure indicated by an arrow.

Wall thickness measurements at the failure showed thinning of approximately 92%. The wall thickness opposite the failure was in-line with the measurements on the cross section remote from the failure and illustrated the localized nature of the wall thinning.

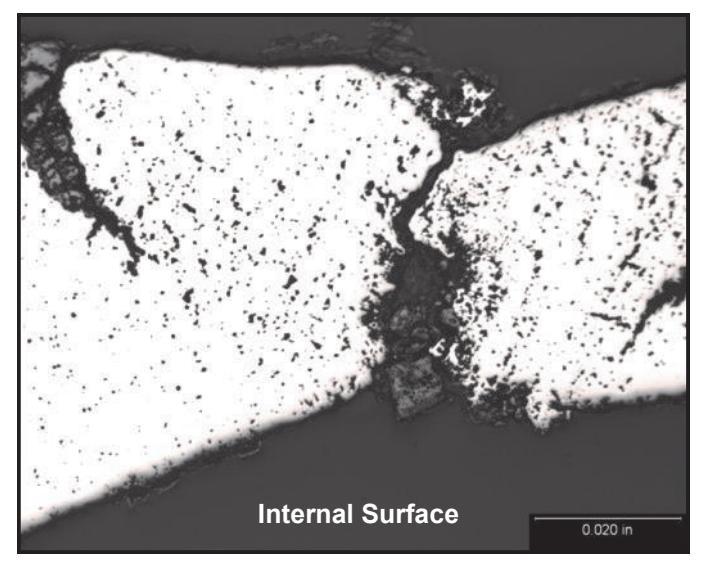
Figure 5. Photomicrograph shows the failure at a higher magnification, where voids were noted. The sample is in the unetched condition.

A cross section was removed through the failure and prepared for metallographic examination (Figure 4). Voids were noted at the failure (Figure 5 and Figure 6). The voids appeared to be due to long term overheating damage. The lack of pearlite combined with spheroidized carbides just slightly away from the failure further supported this conclusion (Figure 7). The tube microstructure away from the failure consisted of banded pearlite in a ferrite matrix and was typical of carbon steel tubing exposed to moderate service conditions.

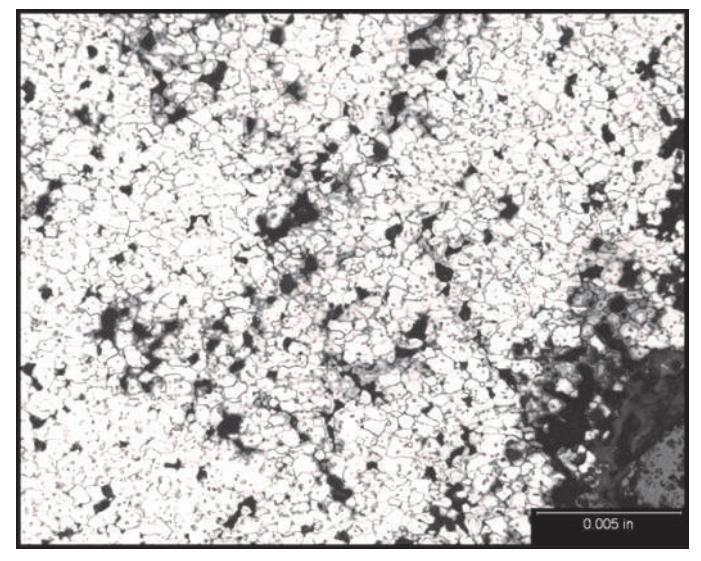
Figure 6. Photomicrograph shows the microstructure at the failure at a higher magnification after etching. (Etchant: Picral-Nital)

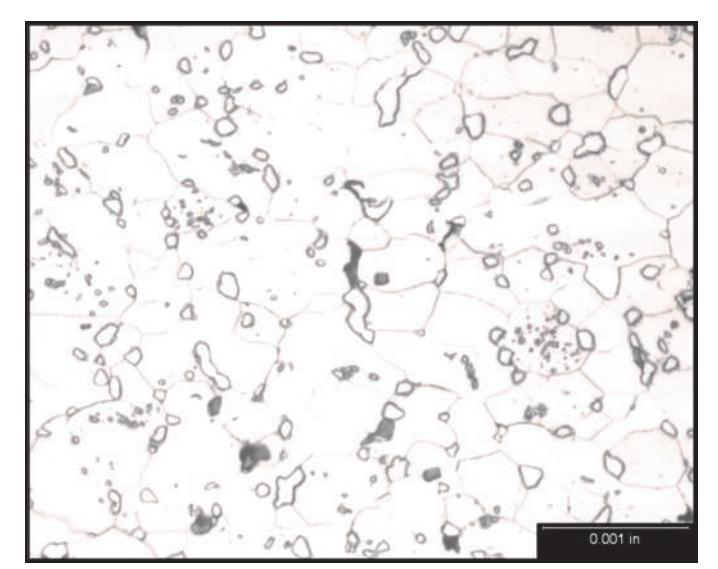
Figure 7. Photomicrograph shows the heat affected microstructure near the failure at higher magnification. Carbide spheroidization was observed slightly away from the failure. (Etchant: Picral-Nital)

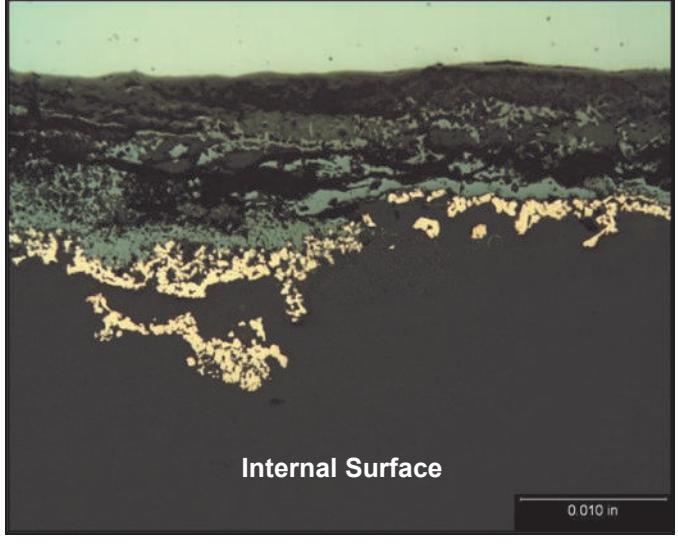
The external and internal surfaces were also examined. A significant oxide/deposit layer was present on the internal surface with a noticeable layer of copper on the top layer of the internal surface deposit (Figure 8). A typical oxide layer was present on the external surface. Thinning of the tube wall initiated on the internal surface and was due to corrosion and oxidation. Away from the failure, a decarburized layer was present on both the internal and external surfaces. Decarburized layers are often produced as a result of tube manufacturing. Their presence indicates that negligible wastage occurred away from the failure.

Figure 8. Photomicrograph shows copper on the internal surface (bright layer) and corrosion of the internal surface into the wall thickness.

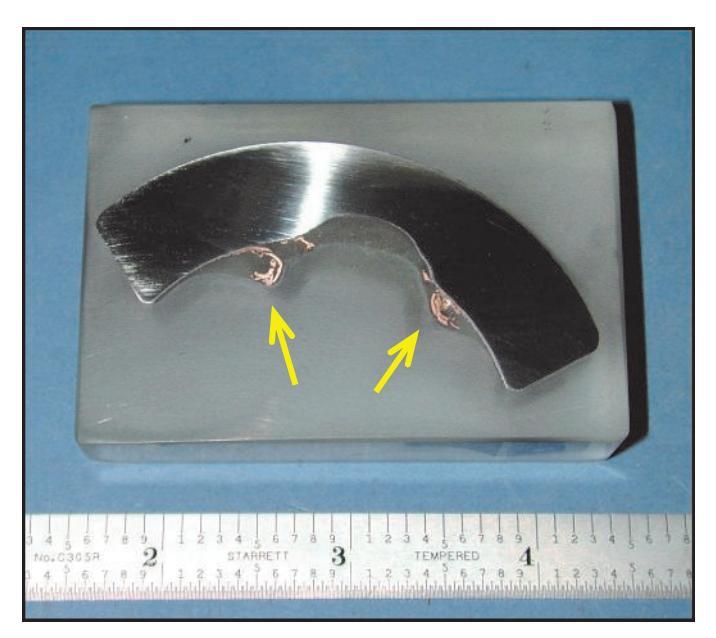
Figure 9. Photograph shows the cross section near the failure after preparation for *in situ* deposit analysis. Significant amounts of copper were noted within the internal deposit (arrows).

ent on the internal surface of the cross section (Figure 9). The deposits within the gouge were analyzed in a scanning electron microscope (SEM) equipped for energy dispersive X-ray spectroscopy (EDS<sup>1</sup>) to determine their elemental composition. In addition to spot checks of various deposit layers, an elemental dot map was constructed of the surface deposit to assess where certain elements in the deposit were concentrating

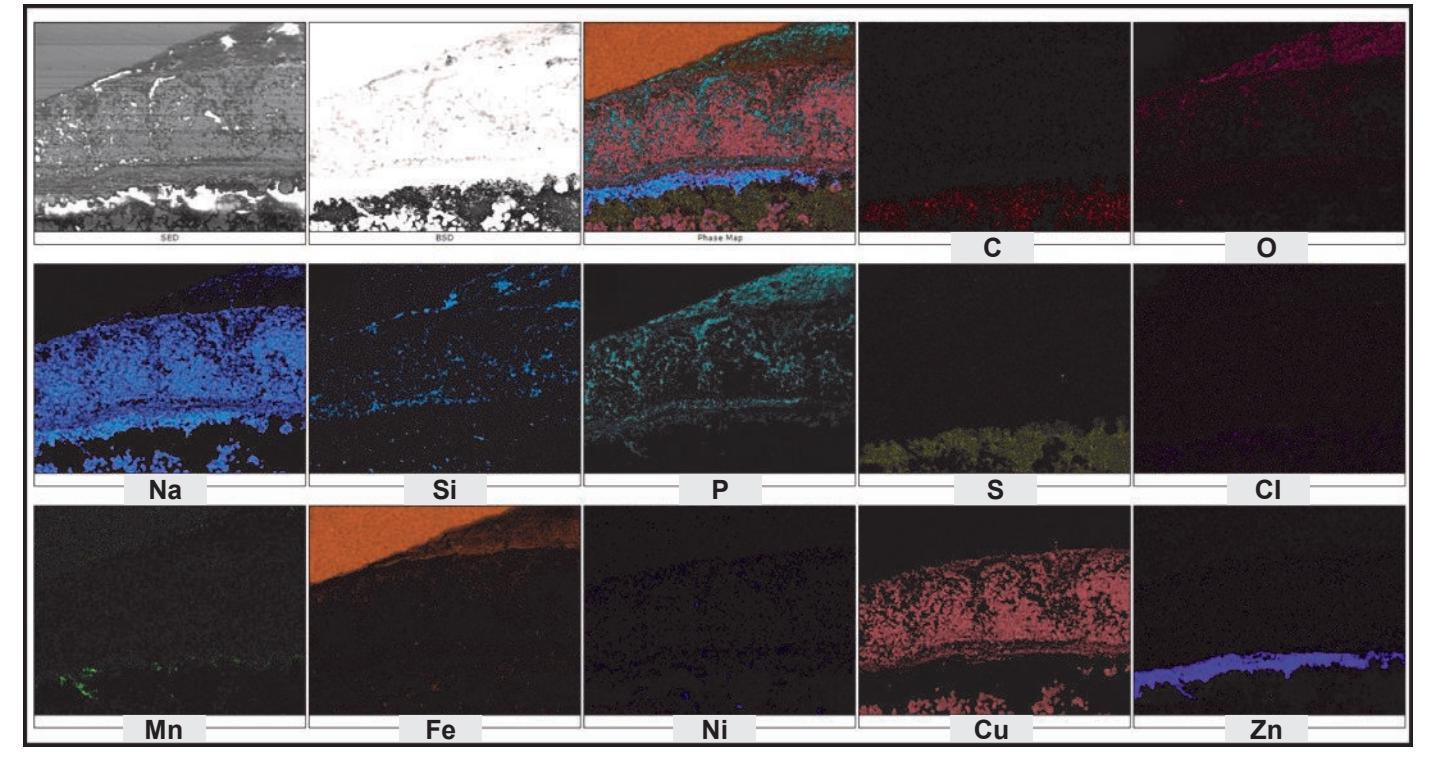
Figure 10. Dot map shows the elemental concentrations within the surface deposit. (115X)

(Figure 10). Sodium, phosphorus, and copper were fairly well distributed throughout the deposit, with phosphorus more highly concentrated in the dark layer immediately adjacent to the tube surface. Iron concentrations were also higher in the darker layer. Sulfur, chlorine, and zinc were mostly present in the thin, lighter layer furthest away from the tube surface.

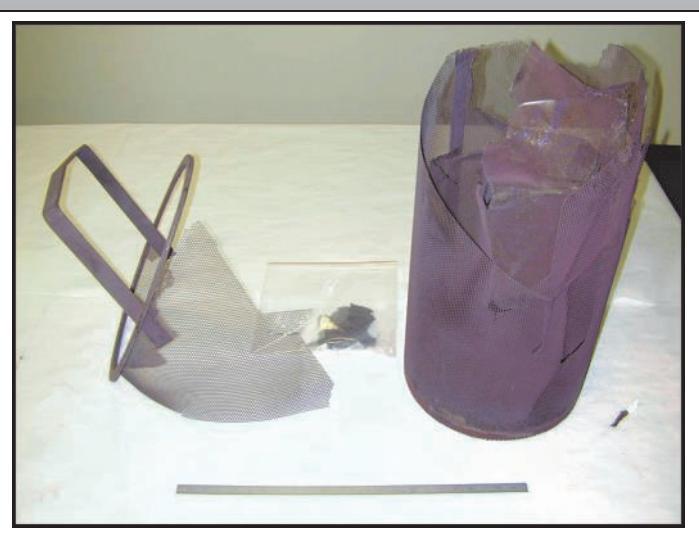
Figure 1. Photograph shows a typical failed strainer basket.

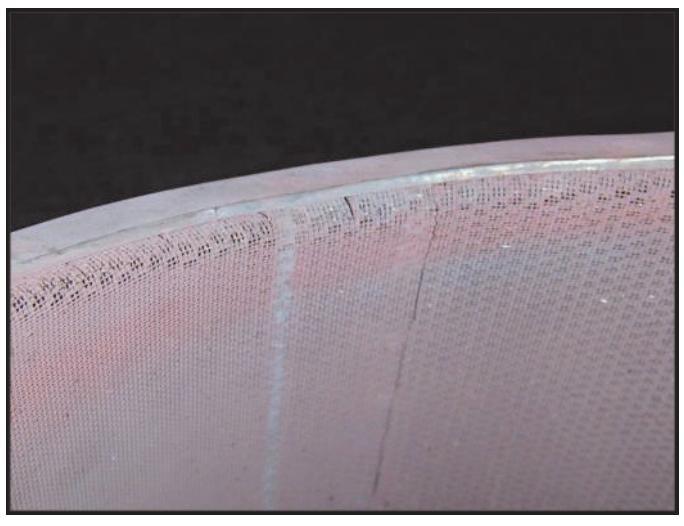
Figure 2. Photograph shows one of the flanges that were stitch welded.

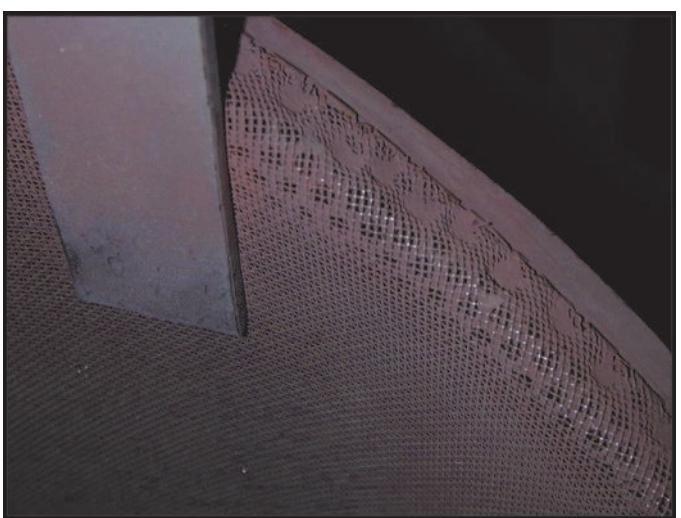
Figure 3. Photograph shows the flange that was spot welded.

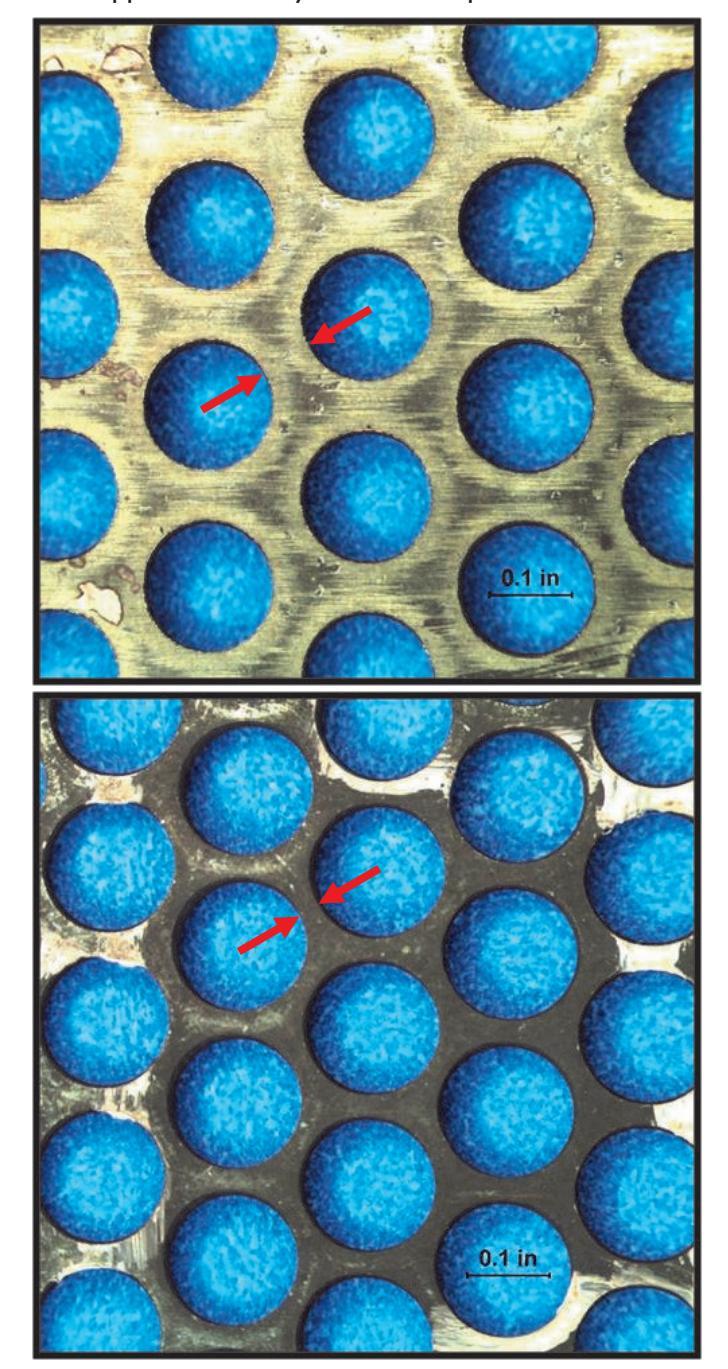
The perforated plates used to construct the two groups of baskets were also different. The perforation diameter was slightly smaller (~2%) for Basket B3 as compared to the other baskets. However, the ligament thickness of Basket B3 was nearly double the ligament thicknesses of the other baskets (Figure 4).

Figure 4. Photographs show that the ligament thickness of Basket B3 was nearly double the ligament thicknesses of the other baskets.

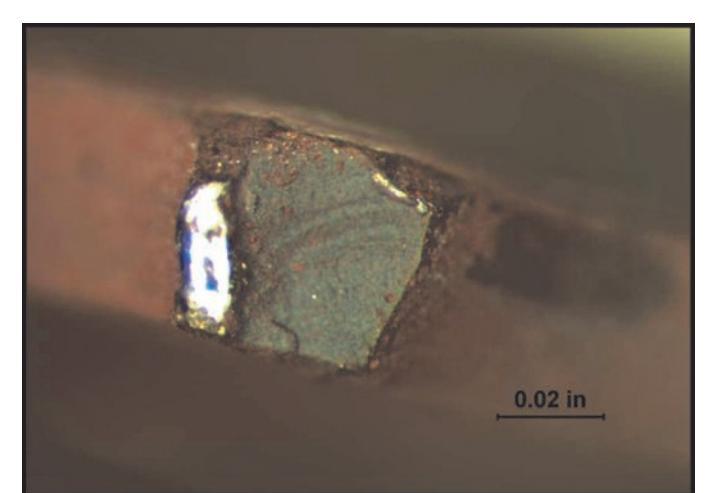
played "beach marks" indicative of progressive crack propagation such as fatigue (Figure 5).

Figure 5. Photograph shows the fractured ligaments displayed "beach marks" indicative of progressive crack propagation such as fatigue.

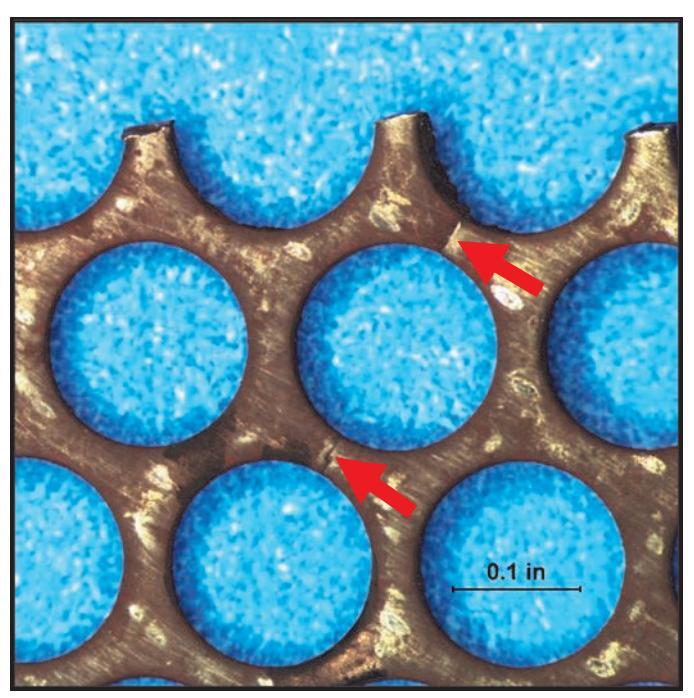
The loose fragments that were submitted along with the four strainer baskets were examined at low magnification and many displayed cracks (Figure 6). The cracks were relatively straight, tight, and did not show any evidence of plastic deformation, indicating that they too were likely progressive in nature.

Figure 6. Photograph shows a loose fragment that was examined at low magnification. Many of the fragments displayed cracks (arrows).

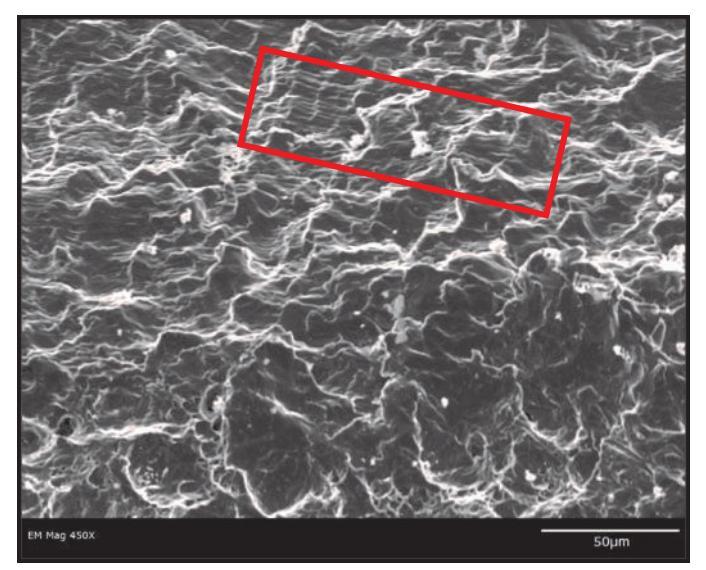
post-failure rubbing. However, there were a few areas where non-shiny fractured ligaments were observed. It was believed that these fractures would be more representative of the failure mode. Coupons were removed from Baskets B2 and B4 for examination at high magnification using a scanning electron microscope (SEM). High magnification examination revealed areas with horizontally oriented striations (Figure 7). The striations are indicative of fatigue crack propagation.

Figure 7. SEM image (boxed area) shows areas with horizontally oriented striations.

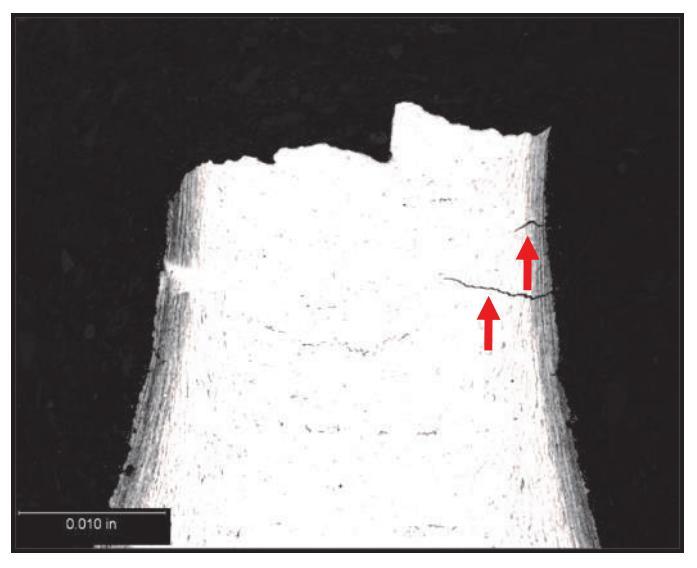
Samples from all the baskets were prepared for metallographic examination followed by examination using an metallograph (Figure 8). This was done in order to evaluate the fracture morphology corresponding to the cracked ligaments and to identify any anomalies. Examination of the fractured ligaments showed that the fracture surfaces primarily had a transgranular (across the grain) morphology (Figure 9). Secondary cracks having a transgranular morphology were also noted. In addition, small pits along the perforated surface were observed. (At many locations, it appeared that the secondary cracks originated from the small pits.)

Figure 9. Photomicrograph shows that the fracture surfaces primarily had a transgranular morphology. Secondary cracks were also noted (arrows).
