## Combustion Turbine Compressor Hygiene and Component Longevity

By John Molloy, P.E.  
Senior Consulting Engineer

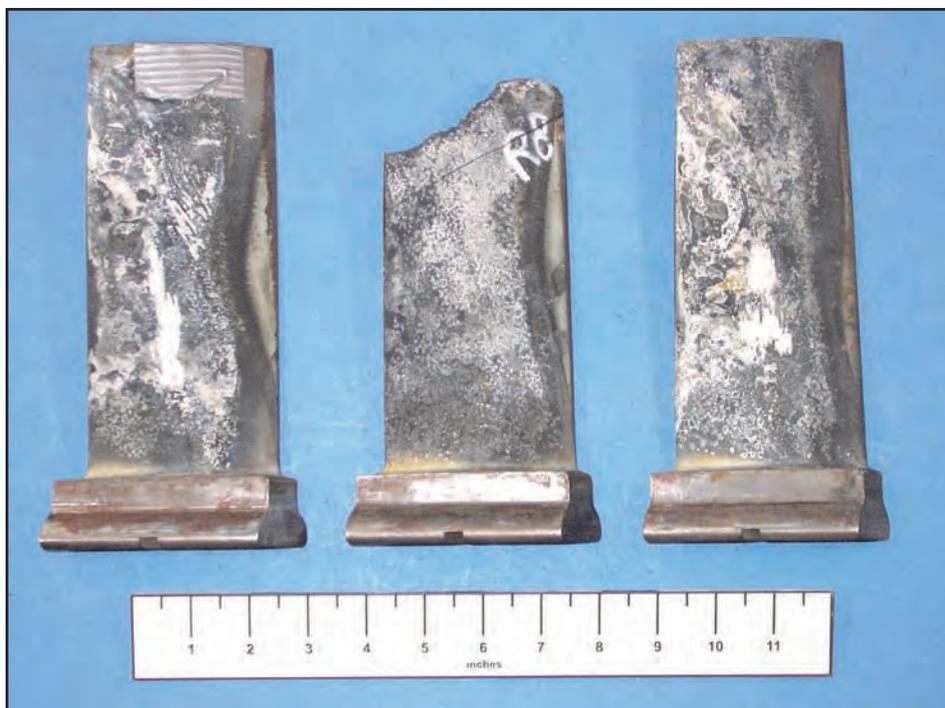
Figure 1. SW501D5 compressor blades with fractured tip and heavy deposits.

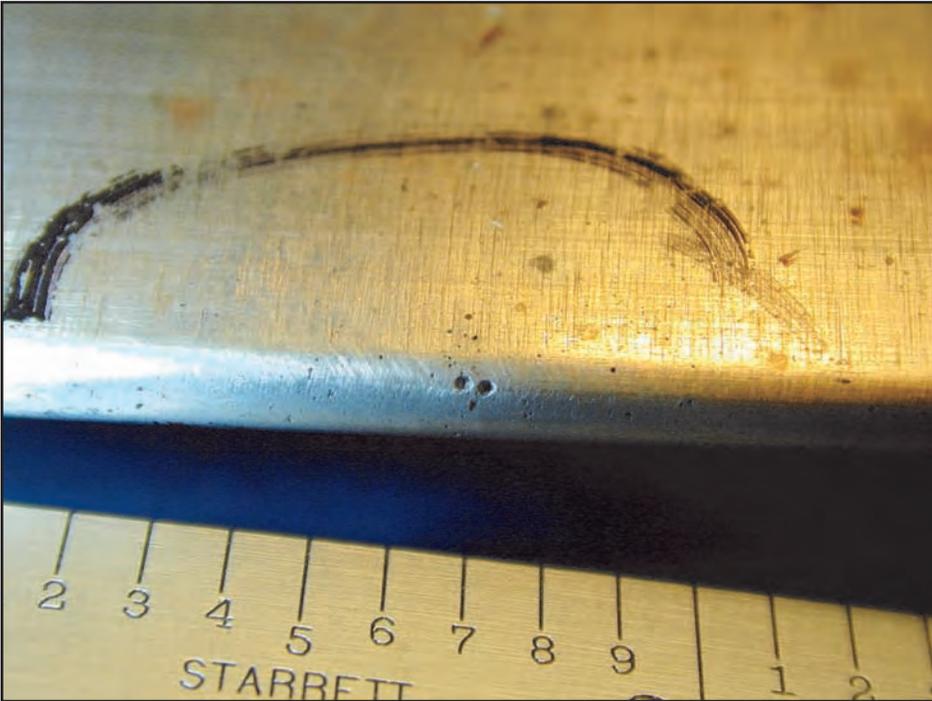
Figure 2. Pitting observed on the leading edge of GE 7FA compressor blade.

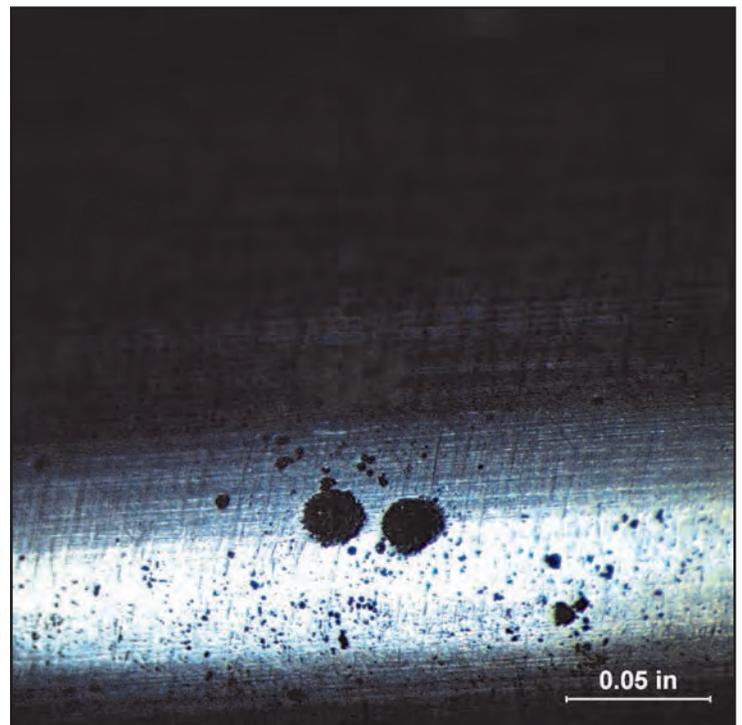
Figure 3. Closer view of pitting on GE 7FA compressor blade.

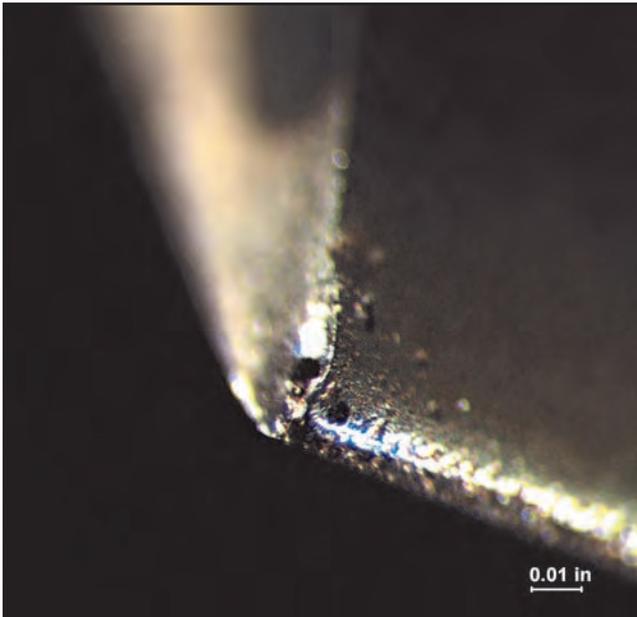
Figure 4. Leading edge pitting from airborne chlorides and adjacent fracture surface on GE 7FA vane.

The quality of air entering the compressor is highly variable, but nevertheless dependent on geographic location. Coastal regions have an obvious problem with humid, chloride laden atmosphere. Units in this particular environment are especially vulnerable to chloride pitting. Special inlet ducting and tailored filtration may provide some level of protection.

Local environments, established by the proximity of inlets relative to cooling towers or the use of sodium hypochlorite for microbial control of cooling tower water, can result in a chloride-laden influent to the unit. In this case the solution may be as simple

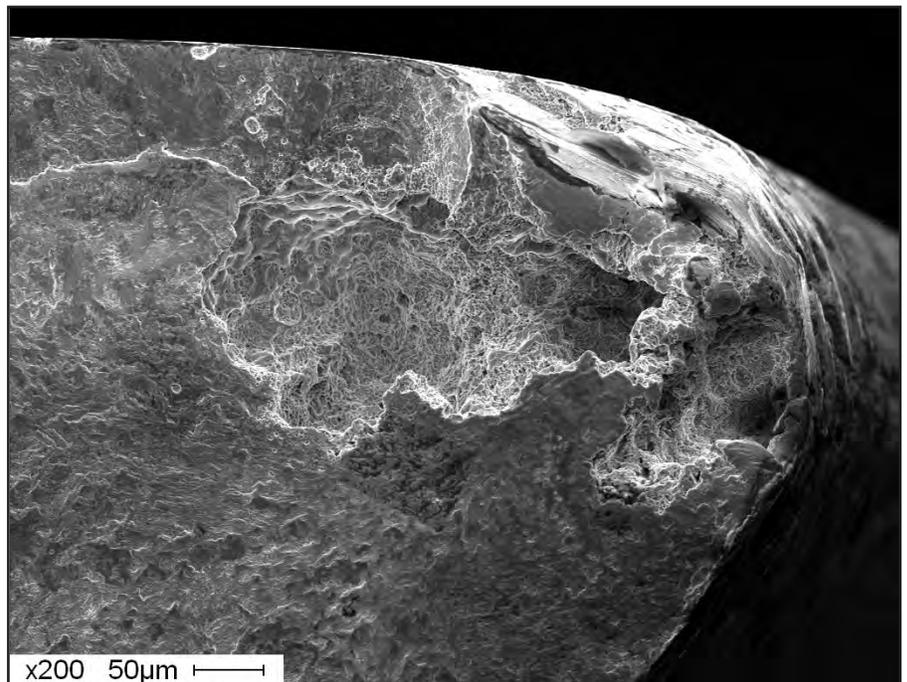
Figure 5. Closer view of leading edge chloride pitting and resultant fracture on GE 7FA vane .

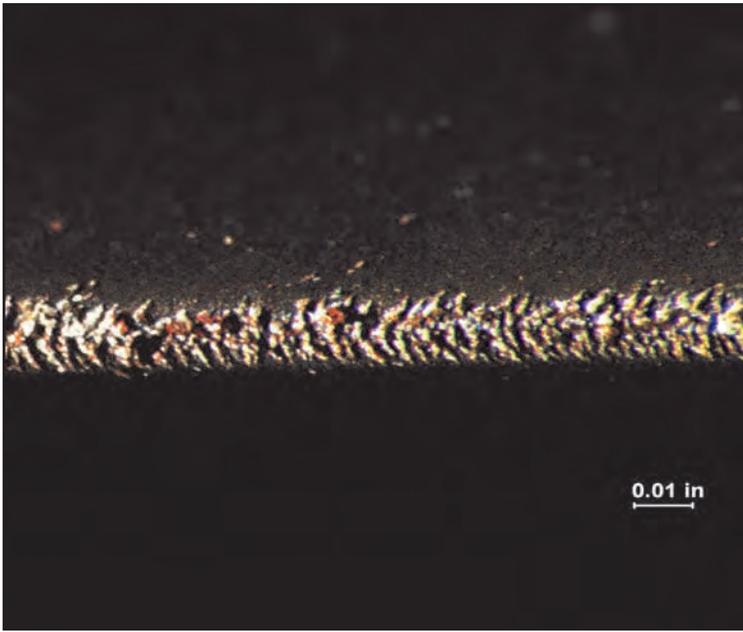
Figure 6. Leading edge erosion provides nucleation sites for additional pitting.

On forward blades and vanes, M&M Engineering has also observed a combined effect of leading edge erosion and pitting. The erosion is most often the result of on-line water washing, but can also be the result of improper filtration selection. The roughness of the eroded leading edge is an ideal area for compressor deposits to become deeply embedded.

water. As mentioned, on-line water washing can cause leading edge erosion if the droplet size is not controlled, or leaking occurs during operation.

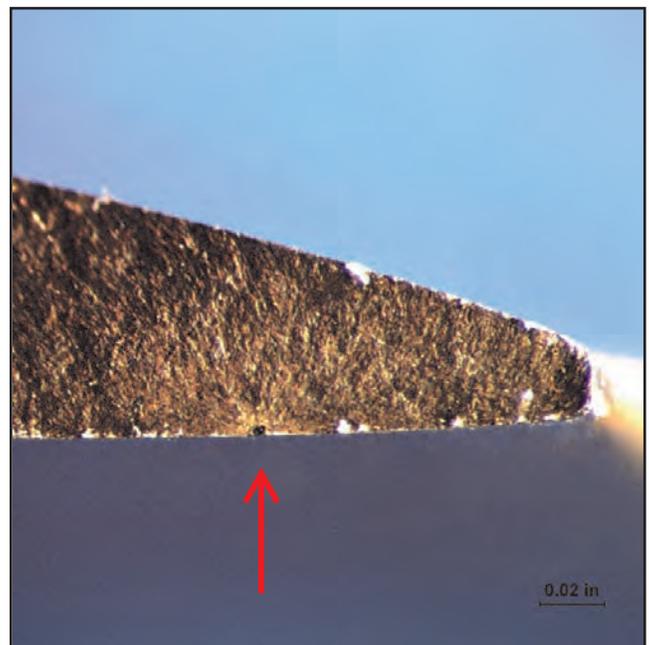
Figure 7. Image shows a GE 7EA vane fracture that originated at a corrosion pit on the suction side of the airfoil.

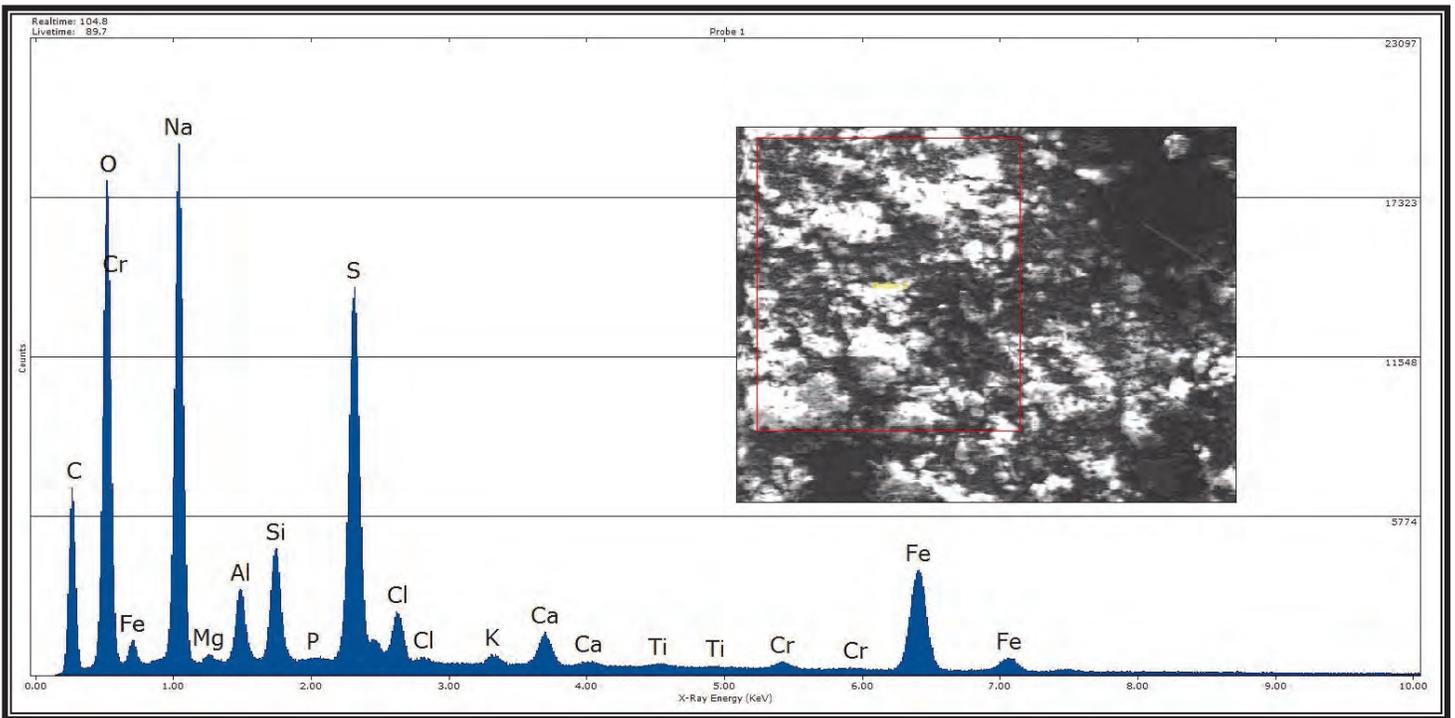
Figure 8. EDS spectrum shows typical compressor deposits. Sodium, sulfur and chlorine indicate potentially corrosive compounds in the deposits.

Energy Dispersive Spectroscopy (EDS) provides qualitative elemental analysis of materials under scanning electron microscope (SEM) examination based on the characteristic energies of X-rays produced by the electron beam striking the sample. The relative concentrations of the identified elements are determined using semiquantitative, standardless quantification (SQ) software.

deposit. The corrosive species are most often sulfur and chlorine-containing compounds, but pitting can also occur simply from the presence of oxygen under the deposit. The pitting is proof of corrosive deposits, and trace amounts of corrosive species identified by EDS at the bottom interface of the pits identifies the active corrodents so that treatment can be fine-tuned for that species.

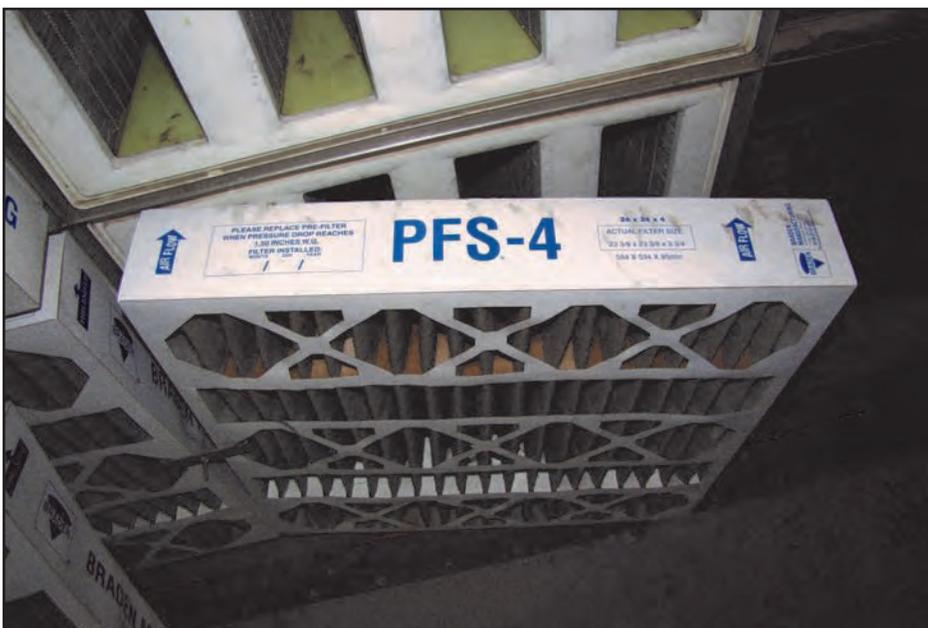
Figure 9. Image shows a pre filter used to collect the majority of airborne particulates. This would not be the appropriate filter in a moist environment. Braden also manufactures the PFS-4P for high moisture environments.

as Gore® Conical and Cylindrical Filters Pairs) and more aggressive offline water washing with a cleaning solution tailored to the deposits. Second, the presence of water (i.e. moisture) must be reduced. Water washing should be followed by operation to ensure all moisture is evaporated. Water repelling filtration (such as Gore® filtration media) may reduce some of the water ingestion during wet weather, and may also prevent some of the influent from cooling tower drift (Gore® filtration media is quite expensive, so a cost-benefit analysis may be required to justify the additional expense). Long idle or layup periods should be combined with closure of the bellmouth and with a dry air source (heater or dehumidifier) to ensure that corrosive deposits are not activated. Mist eliminators and auto-close stack dampers are also beneficial, and should have some effect on reducing the ingress of moisture into the combustion turbine unit.

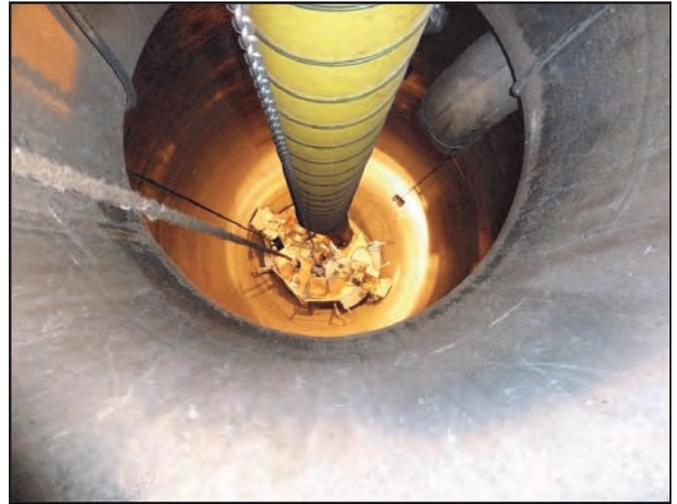
**Figure 1.** Batch digesters require protective overlay weld installed periodically. This welding requires on-site metallurgical quality assurance to confirm the correct alloy, overlay thickness and weld quality.

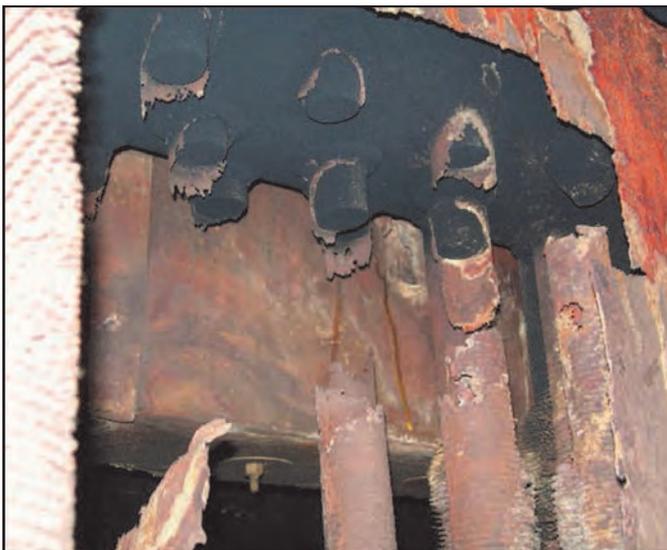
**Figure 2.** HRSG finned tubes burned away after plugging for thinning.

Heat recovery steam generators (HRSG) have limited access, finned tubes, and tightly packed headers. Therefore, HRSG's have their own set of inspection and examination needs. Thinning due to flow accelerated corrosion (FAC) and cracking due to corrosion or fatigue can be hard to find in such tight spaces.

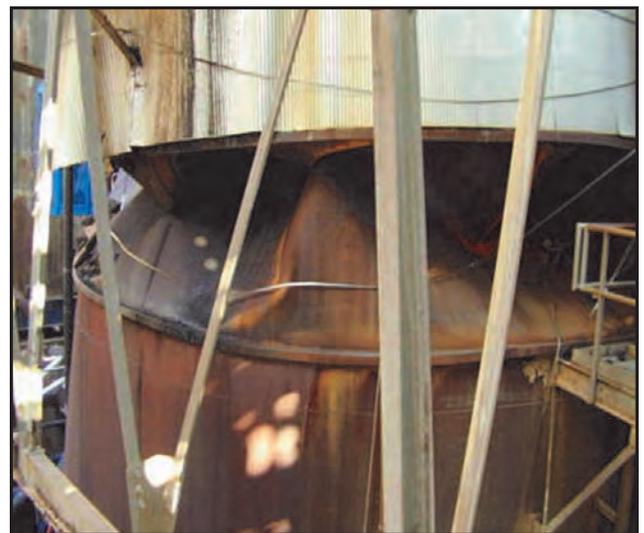
**Figure 3.** Vacuum sucks! A tank with an inward wall collapse required an on-site failure investigation to help determine the cause and repairs required.

Pressure vessels and tanks, their non-pressurized brethren, can have both internal and external corrosion problems, as well as issues with corrosion cracking and erosion. Even just locating the damage takes knowing where to look. Pressure vessels are
