Corrosion of Galvanized Piping in Domestic Water Systems

By Catherine Noble
Senior Engineer

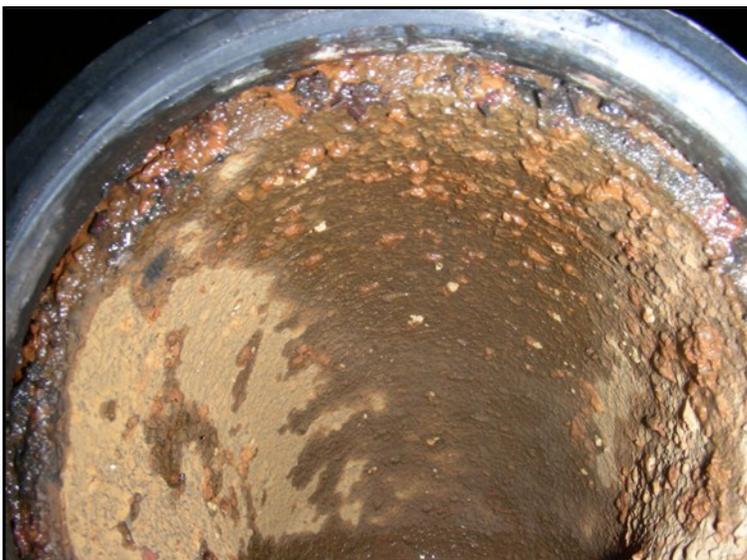
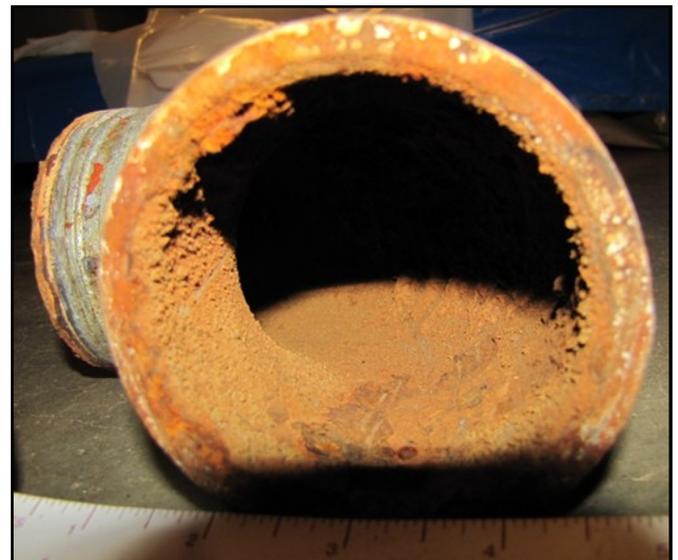
Figure 1. Photographs show examples of corrosion in galvanized piping in hot, softened water service.

pipe sections. This is due to the lower cost of galvanized pipe compared to copper or other materials. The degradation of the galvanized piping in a soft water system can occur in a short period of time, and problems can arise in as few as two to five years after a new installation (Figure 1). This degradation is a major issue that should be addressed.

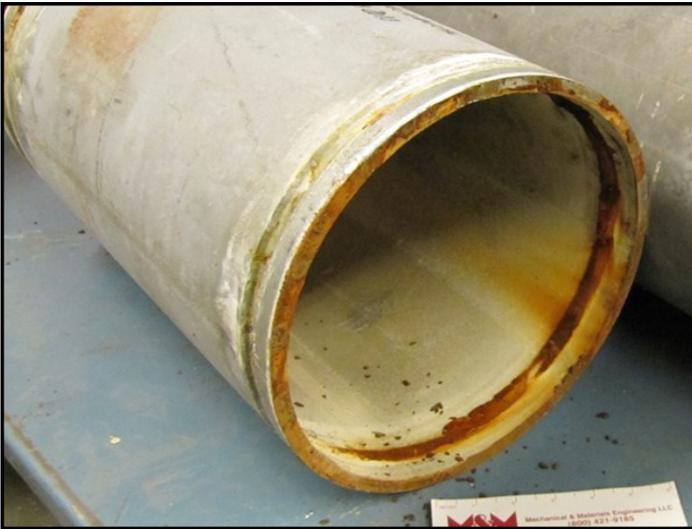
Figure 2. Photograph shows corrosion along a rolled joint at the end of a galvanized pipe

Another issue with using galvanized piping is that the pipes are often threaded or seam rolled in the field during installation. This destroys the galvanized layer wherever the machining or rolling takes place. Sometimes these areas are covered over with zinc-rich paint or primer after forming, but this does not provide as much protection as the original zinc coating. Therefore, corrosion often occurs first at threaded fittings, seams, or rolled grooves in the galvanized pipe (Figure 2).

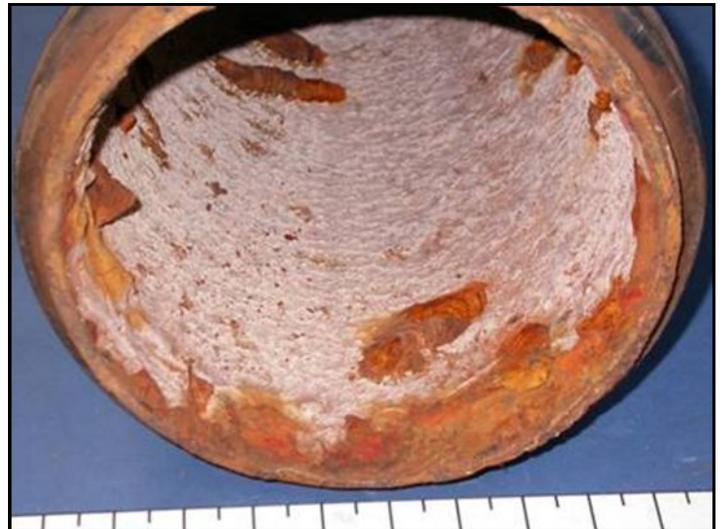
Figure 3. Photograph shows galvanized pipe that was examined after six years in service. This sample was from the cold, softened water line prior to the heat exchanger, but after the circulating hot water return. Pitting was significant.

Figure 3 shows a water pipe from a hotel with internal corrosion that led to multiple complaints about

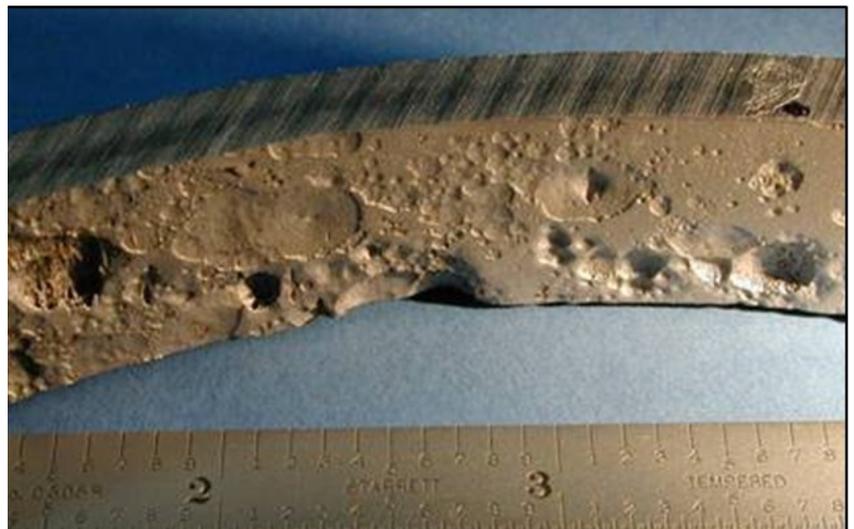
Figure 4. Photograph shows condition of internal surface of galvanized pipe after cleaning.

rusty water. Severe pitting was noted on the internal surface of the pipe (Figure 4 and Figure 5). In addition, most of the piping samples had no remaining galvanized layer present, particularly after the softener. This system was only six years old, and much of the piping had to be replaced. Figure 6 shows a pipe from hot, softened domestic water service in a stadium. Much of this piping system had internal corrosion, and failures had also occurred. This pipe was only two years old, and thousands of feet of piping were replaced in the facility.

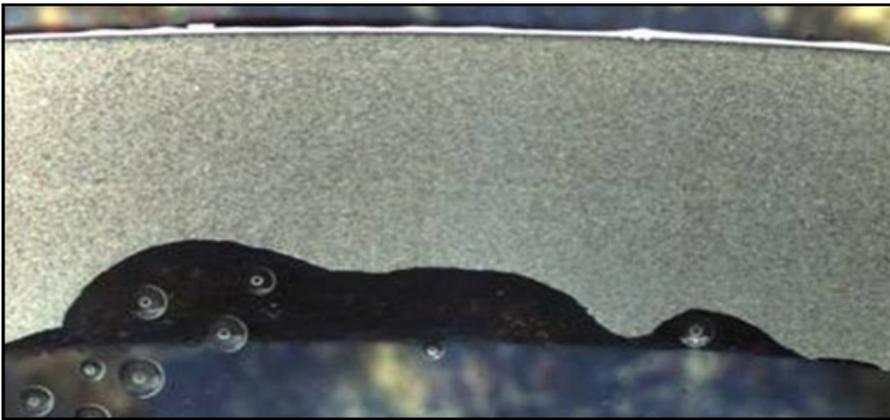
Figure 5. Photograph shows severe pitting in a cross section of the galvanized pipe.

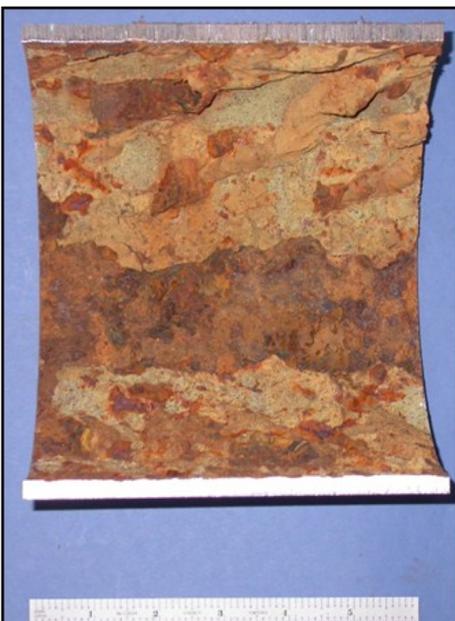
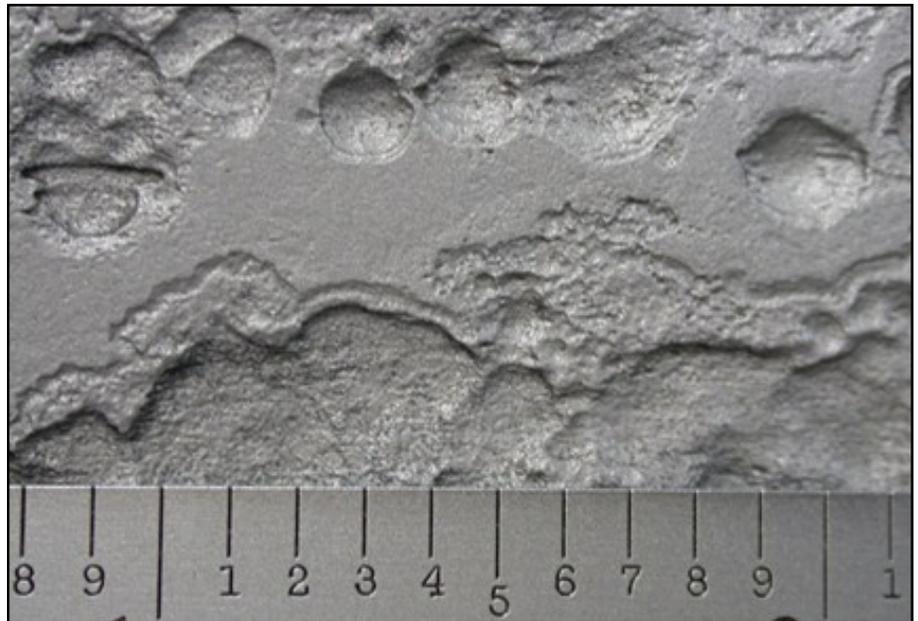
Figure 6. Photographs show galvanized pipe from a hot, softened water line that was examined after two years in service. Pitting was significant on both sides of the pipe, but worse on the bottom of the pipe (shown here).

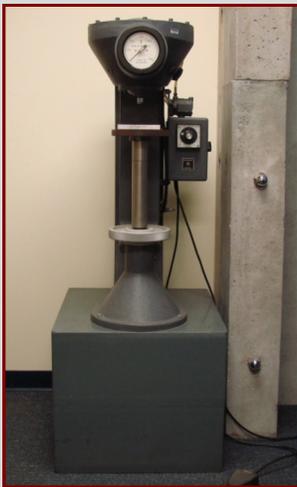
Brinell Hardness Tester

We've added a new capability to our laboratory: Brinell hardness testing. Invented in 1900 by the Swedish engineer Johan August Brinell, the Brinell hardness test is often described as the oldest hardness test in common use today. Most Brinell hardness tests are performed using a 3000 kg test force and a 10mm diameter tungsten carbide ball, although soft metals are usually tested using a 500 kg test force. The indenter ball makes a smaller indentation in a hard metal and a larger indentation in a soft metal. The lower 500 kg test force is used on softer metals to avoid embedding the indenter into the test material, which could happen if the 3000 kg test force were to be used instead. To determine the Brinell hardness, the diameter of the indentation is measured and the Brinell hardness number is calculated using a simple equation that includes the load, the diameter of the indentation, and the ball diameter. The Brinell

indentation is much larger than the indentation from a Rockwell B scale or Rockwell C scale hardness test, which makes it more useful for measuring the hardness of castings and forgings, which can have large grain sizes and non-uniform microstructures. Rockwell hardness testing of these products can result in a wide variation in hardness readings due to the small size of the indentation. Adding Brinell hardness testing to our laboratory allows M&M Engineering to obtain more appropriate hardness measurements for a wider variety of materials.

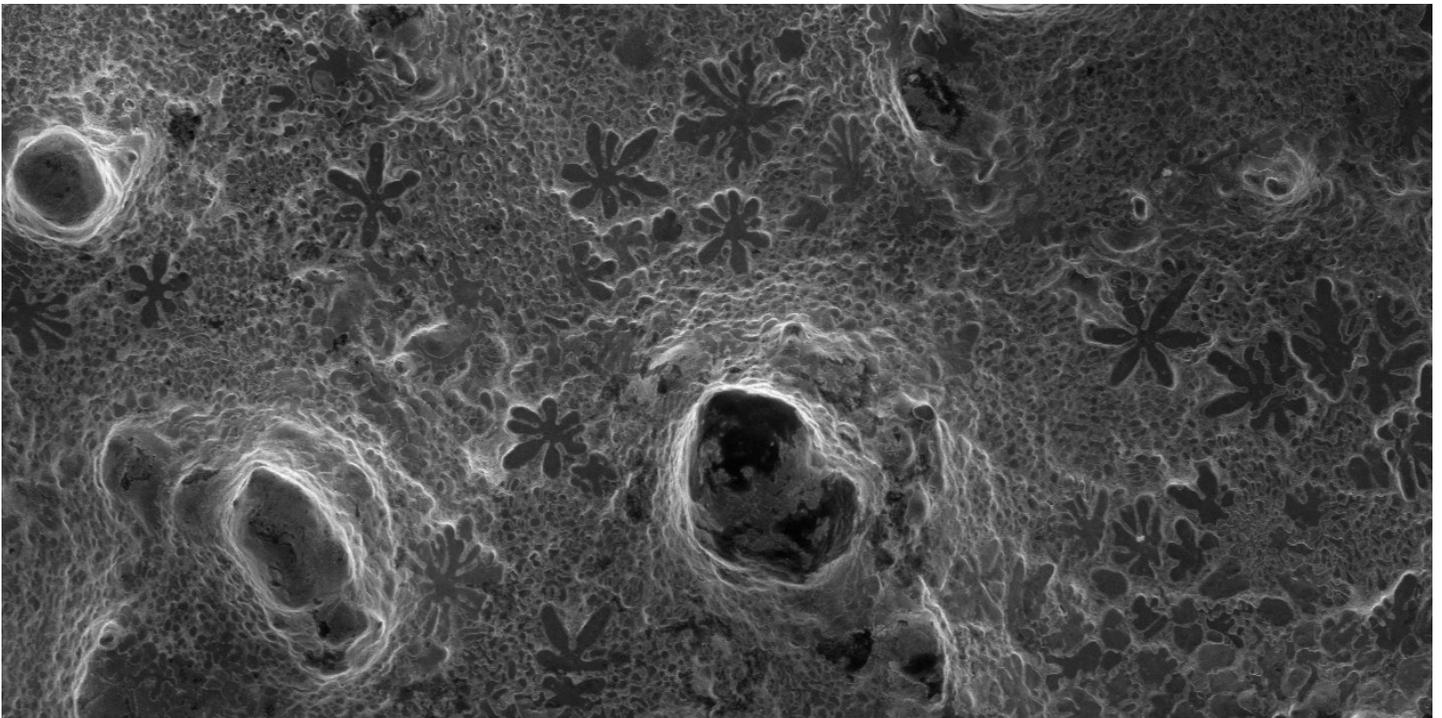
Dendrites in cross section, fracture surface on copper motor mount . 100x
