the conduit

Summer 2005

How Long is it Safe to Keep a Portable Air Carrier?

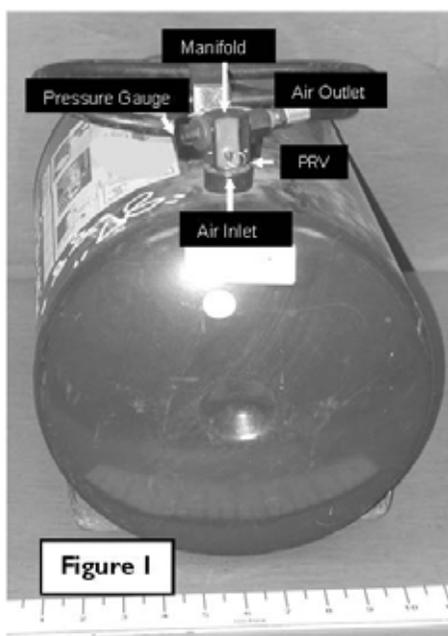
Some states require that PACs sold within their jurisdiction be "Code" PACs; that the tanks conform to the requirements of the ASME Pressure Vessel Code and bear "U-Stamps." Other States permit "Non-code" PACs like the one shown in Figure 1. Both Code and Non-Code tanks use the same manifold design threaded into a 1/2-NPT socket welded to the shell of the PAC Tank. The manifold accommodates a pressure gauge ranging from 0-psig to 160-psig with the zone above 125-psig marked "danger," an ASME pressure relief valve, a Shrader valve allowing filling from a service station compressor, and hose with a Shrader fitting to dispense the compressed air. A code version of the tank would have a threaded inspection port in the center of each head as well as a drain plug underneath the tank. Table 1 shows that while some non-code PACs are made from thinner steel than code tanks, many non-code units are made with steel thickness conforming to Code requirements.

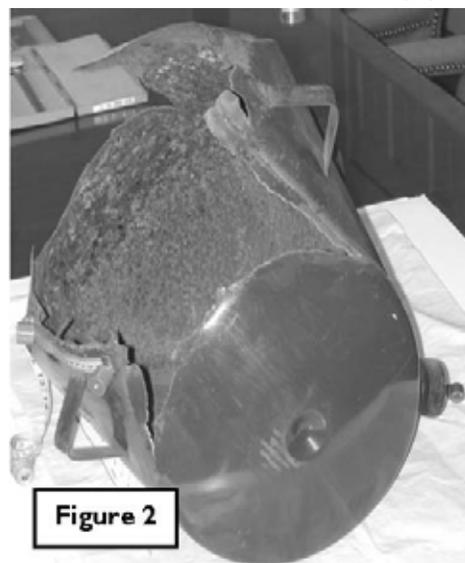
By 2002, at least twelve instances of catastrophic rupture (Figure 2 and Figure 3) were known to have occurred in PACs manufactured prior to 1991. In each case, the catastrophic rupture occurred while

the portable air carrier was being pressurized.

The cause of rupture was determined to be internal corrosion along the bottom or 6 o'clock axis of the PAC tanks. The corrosion occurs because, unlike commercial grade compressed air, the air from service station compressors, particularly the coin-operated variety, contains compression condensate (water). M&M Engineering concluded that pin-hole leaking, the most common failure mode, occurred when the corrosion included significant pitting. In contrast the tank would catastrophically rupture when the corrosion was more uniform in nature.

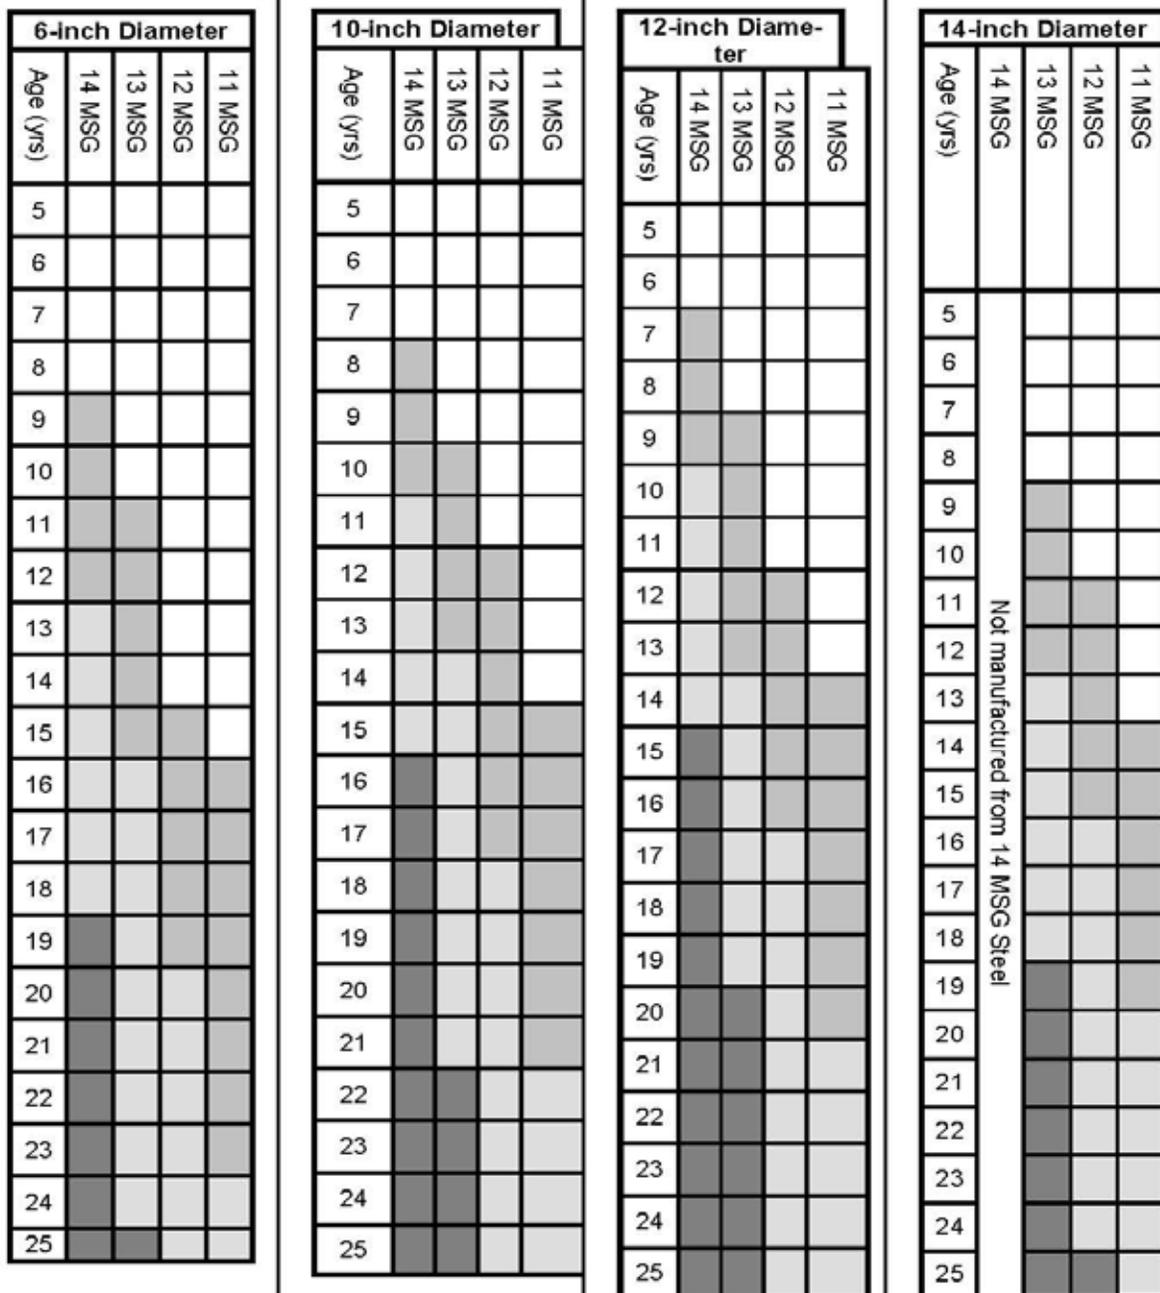
Figure 4.

Figure 4 (facing page) shows the service years in which the probability of any given PAC undergoing catastrophic rupture.

Probability of Catastrophic PAC Failure Due To Internal Corrosion

M&M Engineering developed an empirical extreme-values model from which the probabilities of catastrophic rupture of different diameter PACs with various thicknesses of carbon steel sheet were calculated. Calculations were made based on corrosion rates developed by inserting electrical resistance atmospheric corrosion sensors into actual PACs and containing distilled water simulating condensate, and monitoring the

corrosion rate over 100 days. Monte-Carlo simulations were then run to determine a statistical probability of catastrophic failure.

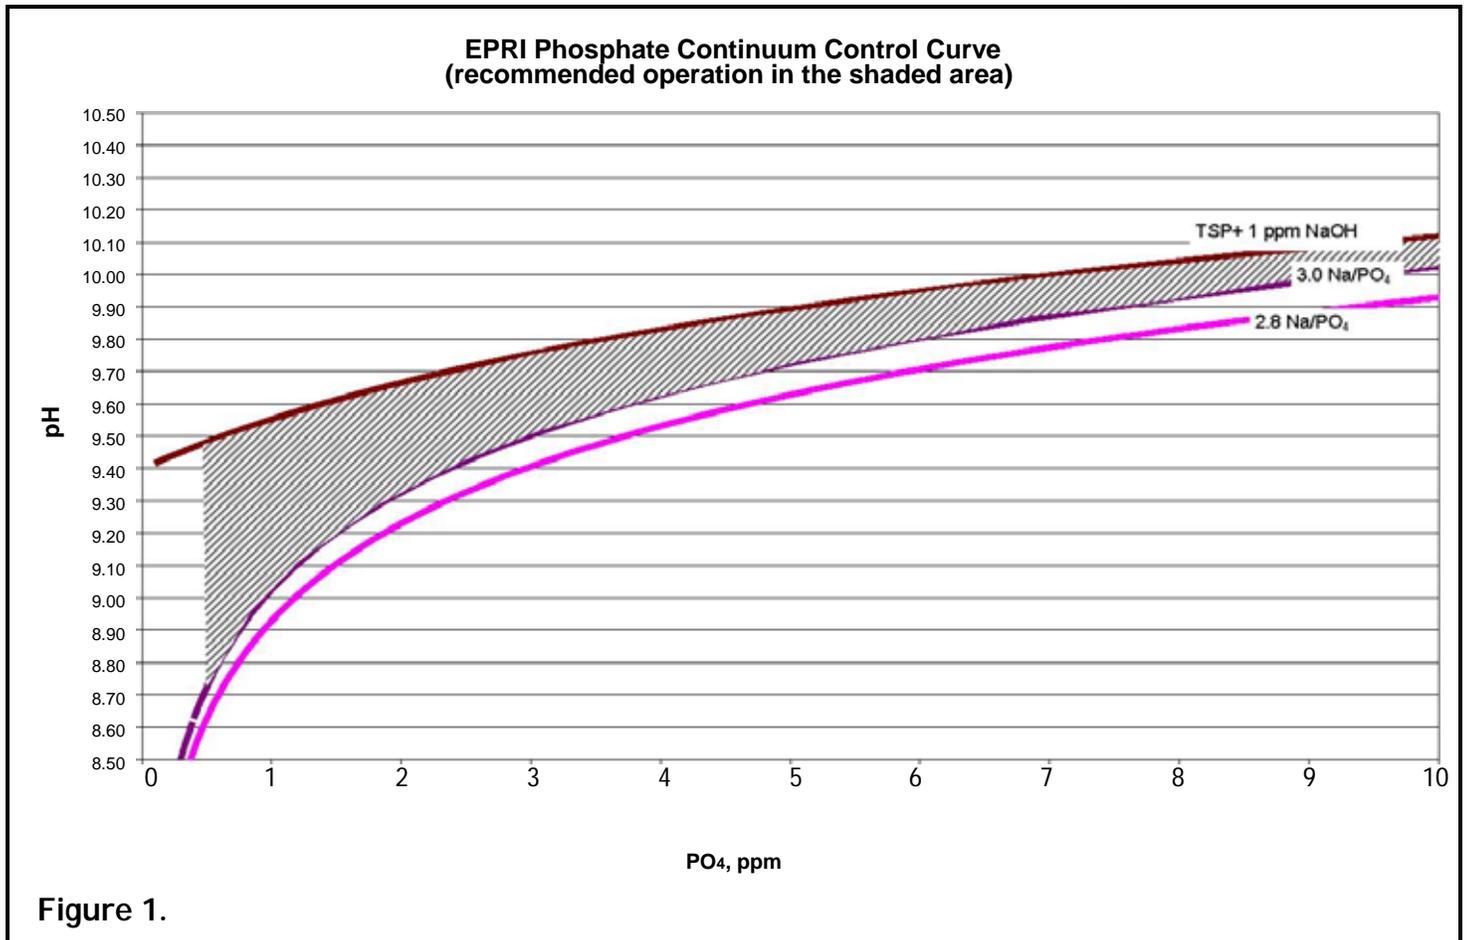
Figure 1.

The current EPRI recommendations for high level phosphate treatment are shown in Figure 1 (previous page). It allows a small amount of caustic in the boiler. Current limits extend from a sodium:phosphate ratio of 2.8 to 3.0+1ppm caustic. This is combined with the recommendation that only trisodium phosphate be used as a source of phosphate to treat a boiler. The recommended phosphate concentration is still low, typically less than 10-ppm, but with a higher sodium:phosphate ratio, the capacity to neutralize small amounts of acidic contaminants is improved.

Industrial boilers can benefit from the EPRI guidelines even if they operate at lower pressures (<1200-psig). If they use demineralized water makeup, the congruent phosphate treatment program should work well for these boilers; add only trisodium phosphate as a phosphate source. Sodium hydroxide can also be used but only to maintain the pH in the 3.0 + 1ppm NaOH range. Excessive sodium hydroxide in the boiler is not needed and may be harmful.
