the Conduit

Winter 2007-2008

Stress Corrosion Cracking in an Ethanol Plant

By David Daniels

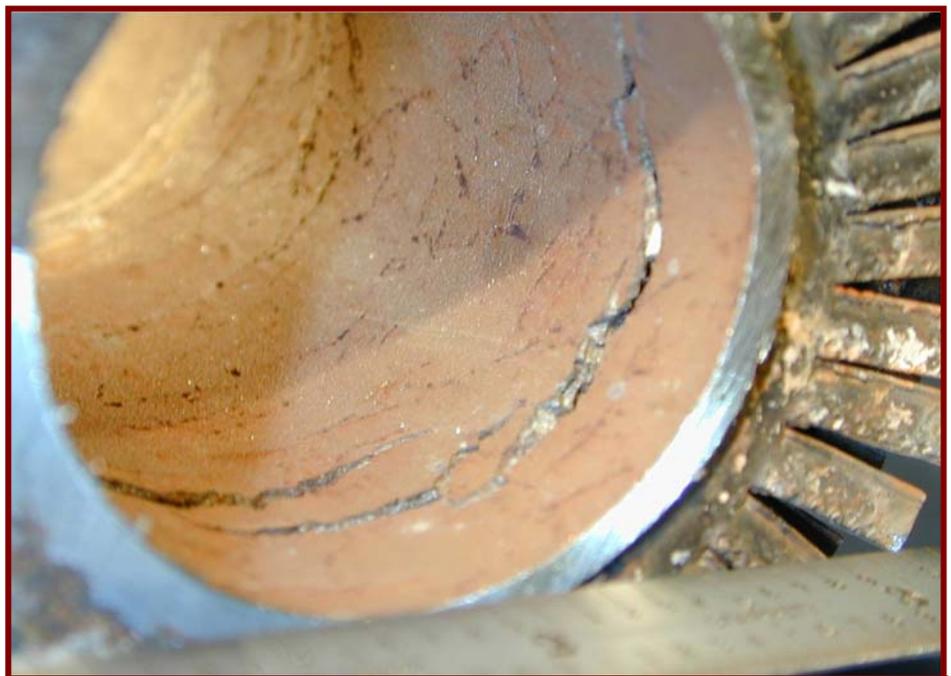
Figure 1. Multiple cracks on this stainless steel feedwater pre-heater tube actually started on the OD of the tube.

Recently, M&M Engineering Associates, Inc. examined six finned stainless steel preheater tubes from an ethanol plant. The tubes contained numerous circumferential cracks that went all the way through the tube walls. However, there was very little deposit and no evidence of pitting or corrosion on the waterside surfaces (Figure 1).

M&M Engineering found that the tubes in the feedwater preheater tubing failed due to chloride-induced stress corrosion cracking from the OD or gas side of the tube. The polished metallurgical samples found the classic branched cracking associated with this failure mechanism. (Figure 2) For stress corrosion cracking to form on the outside of the tube, chloride-containing water had to be sprayed onto the tubes and concentrated as the tubes were subjected to a number of wet-dry cycles.

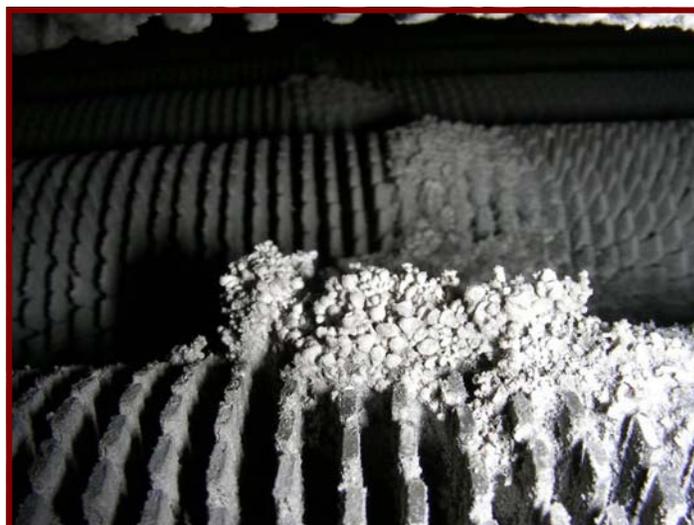
Figure 3. Deposits on the cook water tubes.

Initially, it was suspected that there was a leak in the cook water tubing that contaminated the downstream tubes, but visual inspection of these tubes found no obvious leaks. However, there were deposits on the cook water tubes (Figure 3) and metallurgical analysis found incipient chloride stress corrosion cracking on these tubes also.

M&M Engineering was able to trace the source of the chloride and made recommendations to the plant to eliminate this as a potential source in the future.

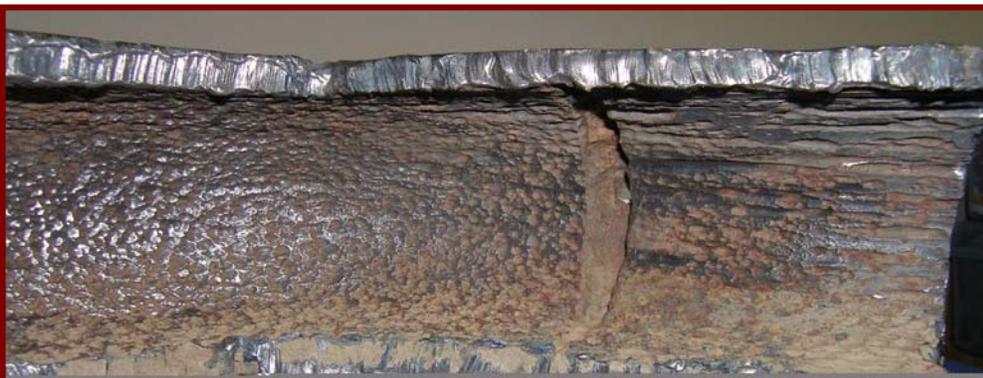
Some incidences of OTSG corrosion (Figure 1) are related to the recent increase in the bicarbonate alkalinity of the feedwater blend. Since the rate of replacement of fresh water and

Boiler tubes provided to us clearly show two examples of severe localized corrosion, which are classic examples of FAC (flow assisted or accelerated corrosion). In one case, the dimpled or round-bottom pits, the longitudinal grooves in deep radial channels caused the loss of that magnetite film from erosion due to turbulent water flow within the temperature range required for FAC. In these boilers, magnetite formation/reformation is removed in part by the effect of carbonic acid formed when the carbon dioxide gas, liberated from the decomposition of bicarbonate alkalinity in the boiler water, re-dissolves in the water at the heat transfer surface of the tube. The repetition of this magnetite film formation and removal process is a corrosion mechanism and results in the extreme metal loss in the tube bend. Excessive alkalinity (and poor alkalinity and pH control) can also serve to accelerate dissolution of magnetite. This can be called a complex single-phase FAC.

Figure 1. OTSG return pass bend (longitudinal section) showing typical single-phase FAC “orange peel”, along with grooves (merged pits).

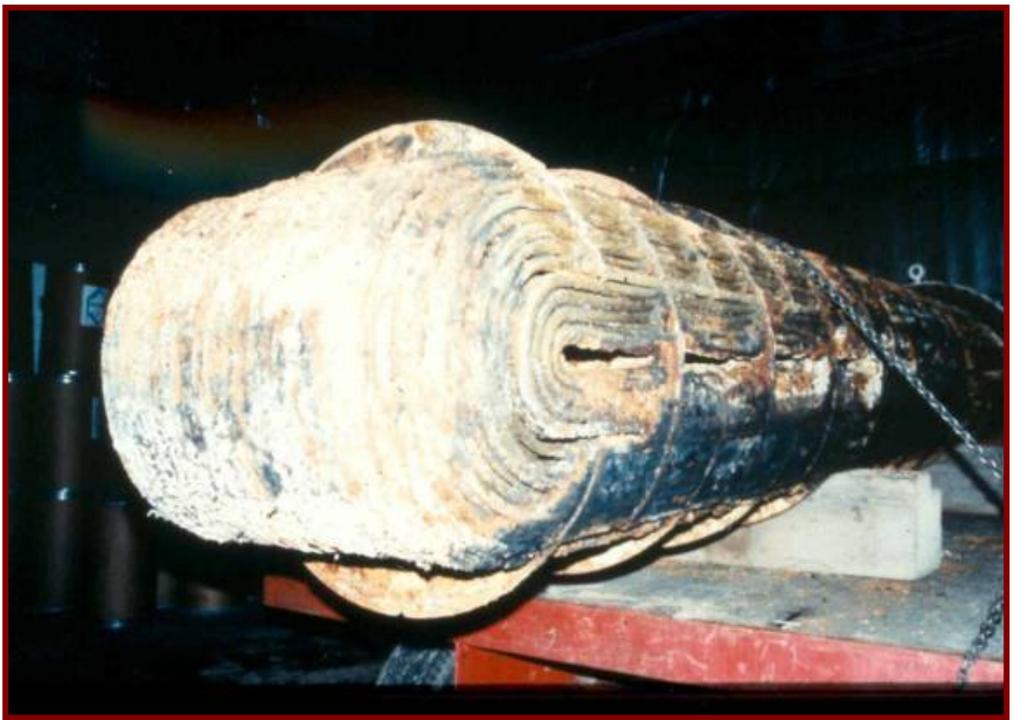
Figure 1. Severely scaled floating head tube bundle (cooling water on shell side).

This latent problem should have been anticipated and prevented by the technical service representatives of the refinery’s water treatment chemical supplier, but it was not and, after several months of operations under these adverse conditions, inspections during a scheduled multi-unit turnaround revealed a severe heat exchanger fouling condition. The additional maintenance that the
