# the Conduit

## Inspection and Repair of Batch Digesters Part 2 of 3

### Part 2 – Application and Repair Strategies

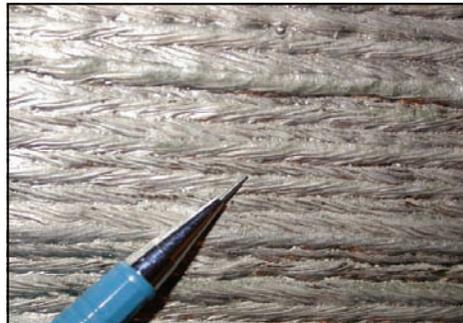
Type 312 Stainless Steel  
GMAW  
New

**Figure 1. Examples of stainless steel gas metal arc welded (GMAW) Type 312 stainless steel overlay in the batch digester showing as-welded (top) and with two different stages of corrosion deterioration.**

The examples in Figures 1 and Figure 2 can be used as guidelines for evaluation of the condition and extent of corrosion in digester automatic SAW and GMAW

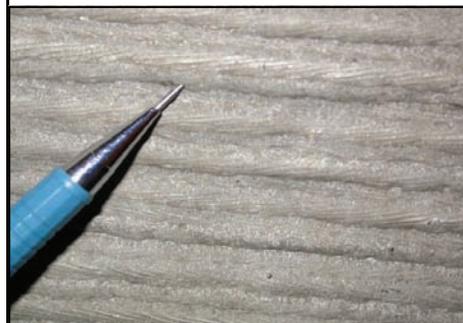
Type 312 Stainless Steel  
GMAW  
Light General Corrosion

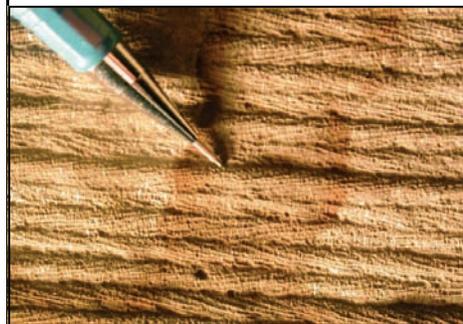
Type 312 Stainless Steel GMAW  
Severe General Corrosion  
(Still serviceable.)

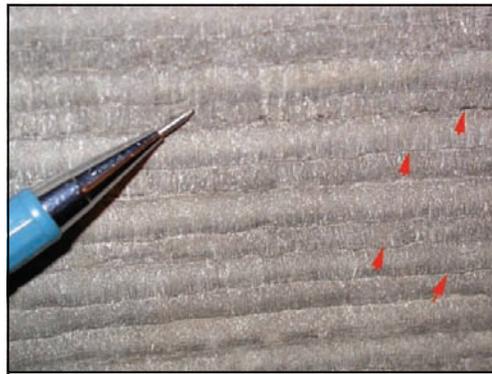
Type 309L Stainless Steel SAW  
Moderate Corrosion Inter-Bead Attack  
(Arrows)

**Figure 2. Moderate corrosion attack and inter-bead deterioration of Type 309L stainless steel SAW overlay (top). The lower two examples show SAW overlay that has deteriorated severely—the overlay should be replaced.**

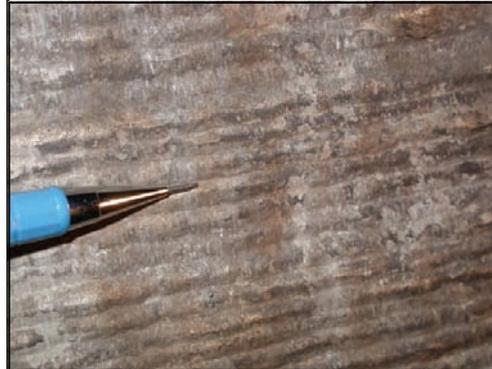
Type 309L Stainless Steel SAW  
Severe Deterioration  
(Replacement Needed)

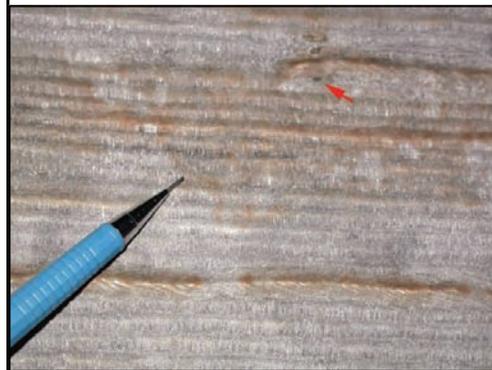
Type 309L Stainless Steel SAW  
Severe Corrosion  
Carbon Steel Exposure at Arrow

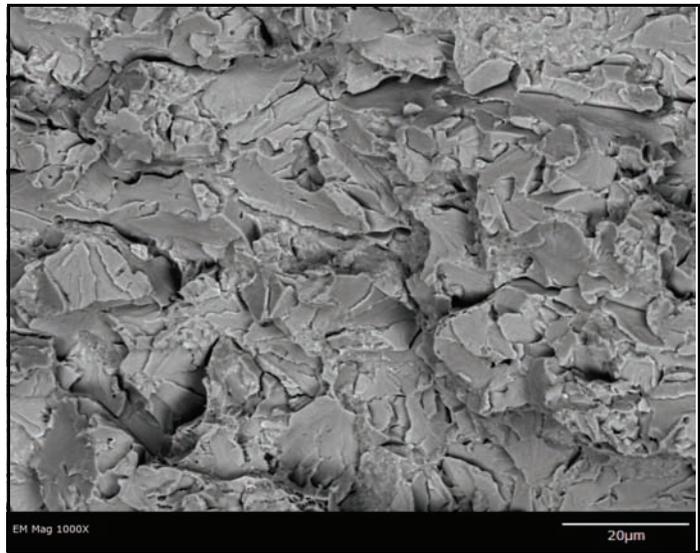
Figure 1. SEM backscattered electron image shows a cleavage-type fracture surface on a low-alloy steel that cracked at cryogenic temperatures (1000X).

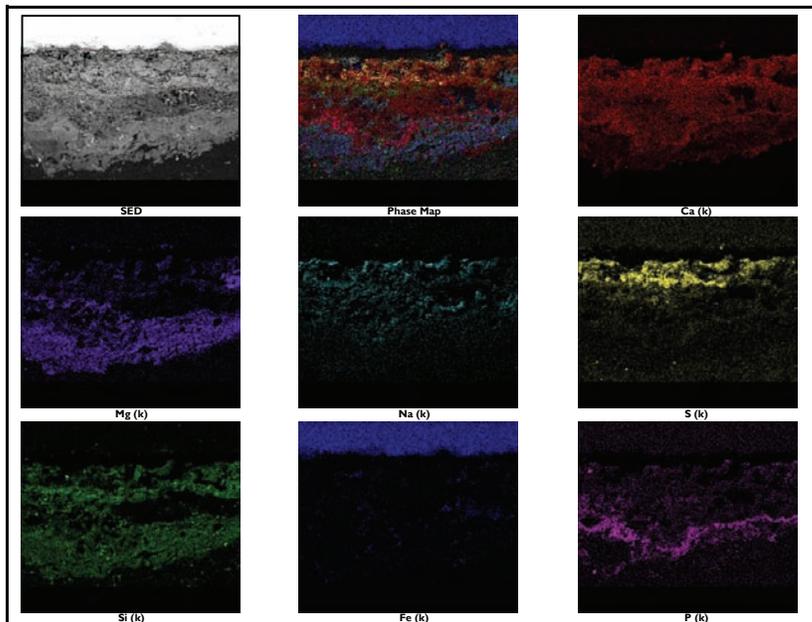
Figure 2. Semi-Quantitative Analysis of Deposits.

The new equipment continues to have the same capabilities as the previous SEM with some exciting improvements. Image capturing and spectrum analysis are now run through Windows 7-based software. Color enhancement of images is possible to highlight the locations of elements. Control of image adjustment is now much easier with a new monitor and more user-friendly procedures. The SEM uses a Lab6 filament rather than tungsten that lasts much longer and produces better results. It can examine sample features, such as fracture surfaces, up to 50,000 times magnification. We continue to be able to conduct energy dispersive X-ray spectroscopy (EDS) of deposits and debris for elements as light as carbon and can provide semi-quantitative results.

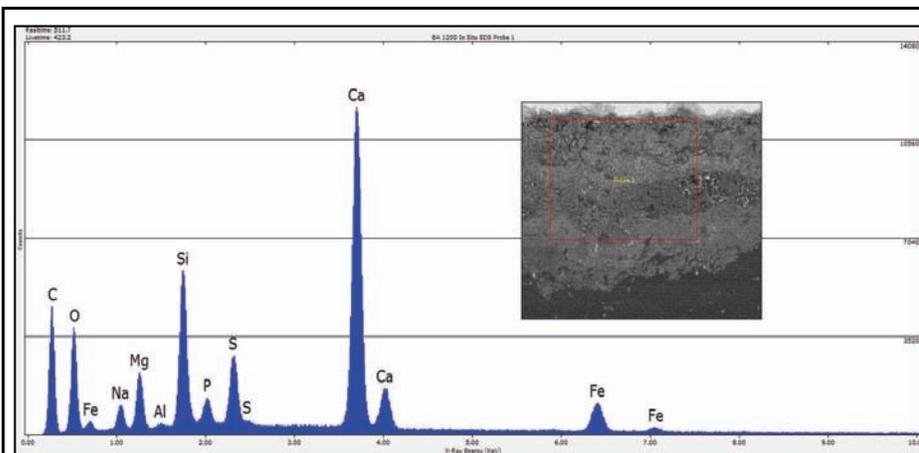
Quantitative Results for 8A 1200 In Situ EDS Probe 1  
 Analysis: Bulk Method: Standardless  
 Acquired 11-Feb-2010, 20.0 KeV @10 eV/channel

Figure 3. EDS Spectrum for a debris sample from an obstructed superheater tube.

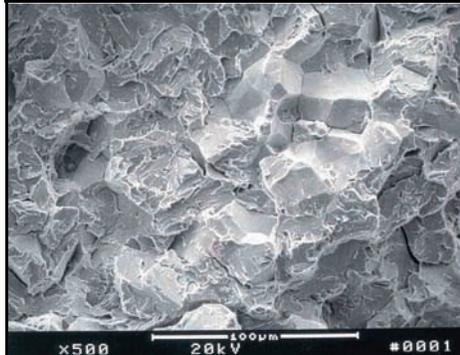
**Figure 2. Hydrogen damage induced by weld repair.**

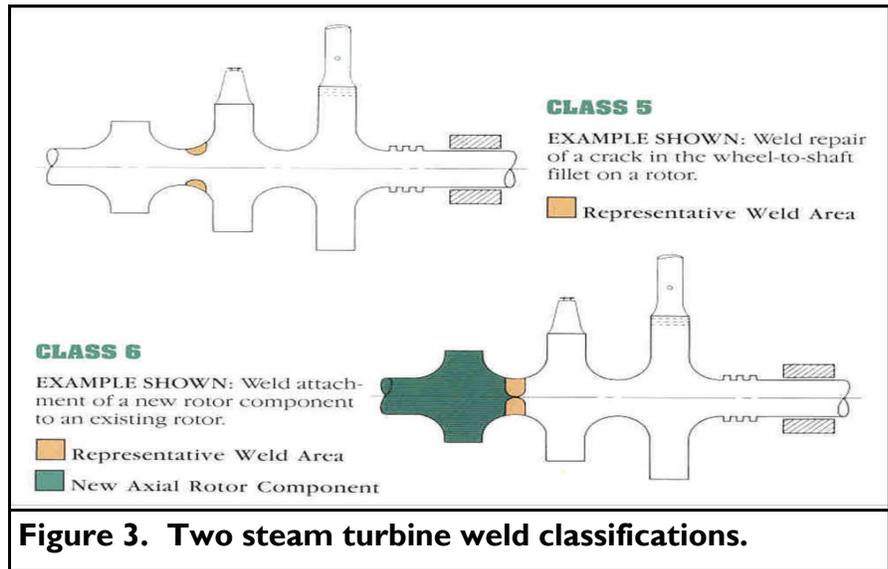
**Figure 3. Two steam turbine weld classifications.**

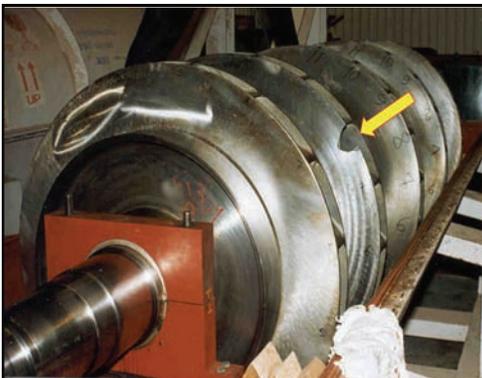
**Figure 1. Failure in centrifugal compressor initiating in fabrication weld.**

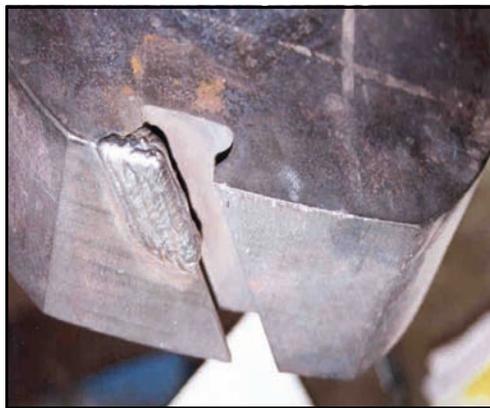
**Figure 4. Mockup weld for repair of combustion turbine compressor disc.**
