The Metal Never Lies

INSIDE THIS ISSUE

VOL 16, NO 1

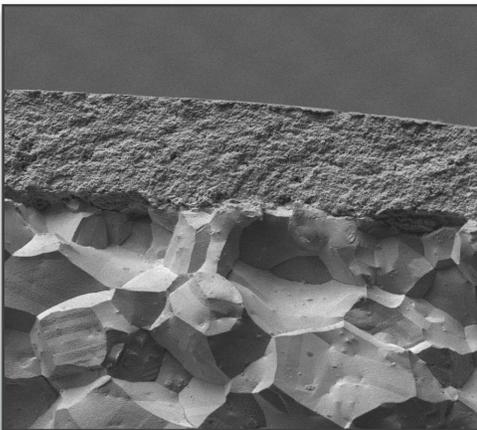
This SEM photograph shows the coating/blade interface on a gas turbine blade near the leading edge. The mode of fracture of the blade airfoil is intergranular. Magnification: 150X

Examination of the fracture surfaces identified blades with pre-existing fatigue cracks. The largest crack grew until it became critical and the blade failed. The cracking most likely occurred during startups and shutdowns when certain blade harmonics were excited. Furthermore, the blade was embrittled as evidenced by significant reduction in room temperature ductility (% elongation) and intergranular failure mode. An embrittled microstructure will lower the fracture toughness and as such, reduce the size a crack has to grow before it becomes critical. The blades also contained coating cracks in the regions of the pre-existing cracks. These coating cracks could have acted as stress raisers to help fatigue crack initiation in the airfoil.

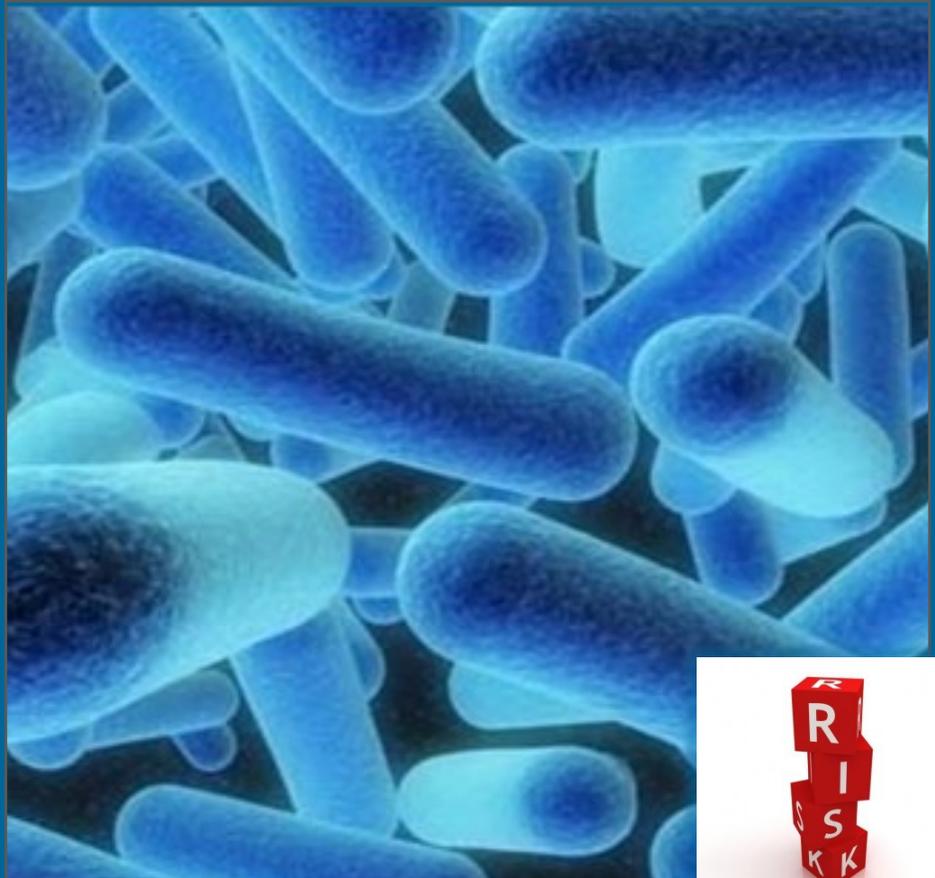
The ASHRAE Risk Assessment is just that—an overview of what is present and what the site is doing about it. It seeks to identify all the potential sources of Legionella. (photo courtesy: <https://wwwn.cdc.gov/elite/public/elitehome.aspx>)

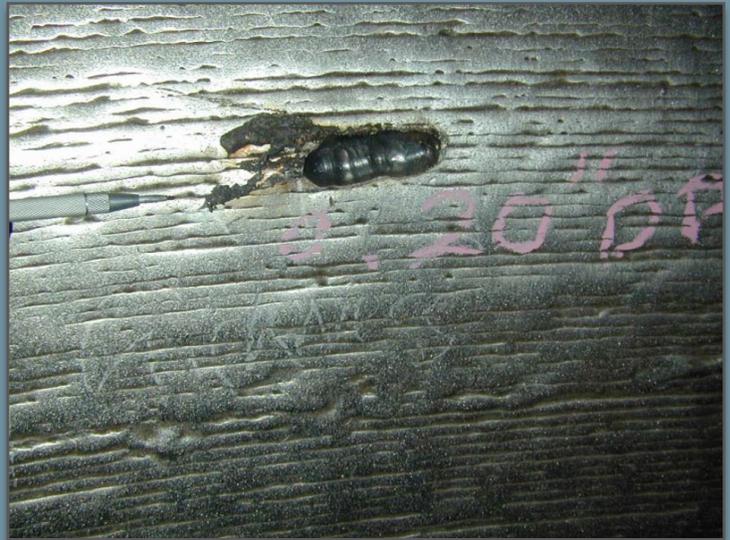
Figure 1. Air-Arc cut gouge for thickness measurement of the overlay by staining with copper sulfate.

When preparing to do the re-welding, the contractor will generally need to know how thick the stainless layer is. They will air-arc cut a shallow gouge into the wall, stain the area with copper sulphate and then physically measure the unstained stainless steel layer with a machinist scale (Figure 1).

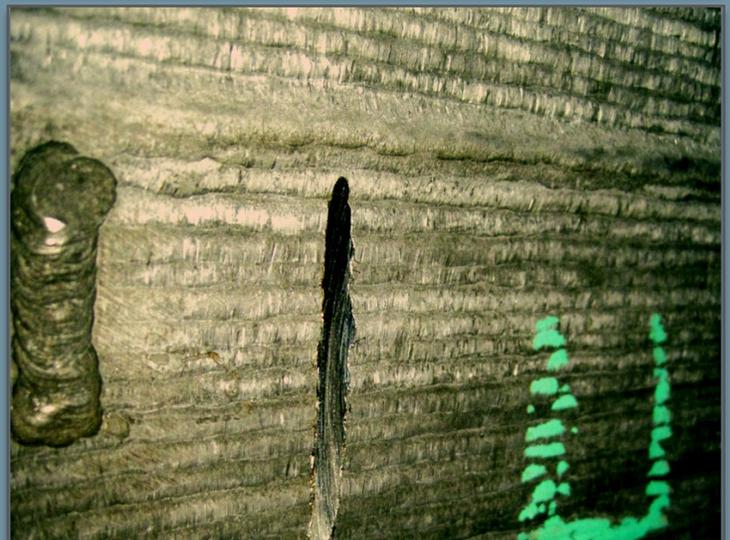
Figure 2. Plunge cut with a grinder that goes until the sparks change, and then the depth is measured.

Instead of using the air-arc and stain method, which is expensive and technical, carefully cut into the stainless using a plunge cut with a grinder (Figure 2). Watch the sparks of the stainless (shorter white and fewer than carbon steel sparks) as the plunge proceeds. When the sparks change, stop. Measure the plunge cut depth.

This thickness value is a conservative measure of the remaining stainless steel overlay weld thickness. The spark appearance will change when more carbon is present, usually in the diffusion zone of the weld which is present just before the “actual” weld interface. Use this value to estimate the remaining overlay thickness and overlay life reduction rate for the stainless weld and the aggressiveness of your batch digester load and process parameters.

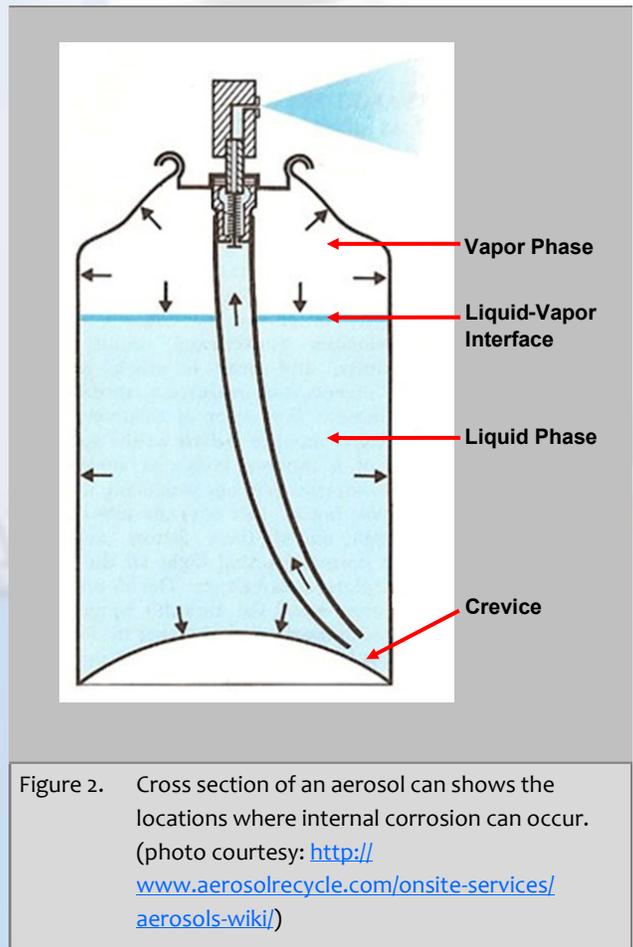
Figure 2. Cross section of an aerosol can shows the locations where internal corrosion can occur. (photo courtesy: <http://www.aerosolrecycle.com/onsite-services/aerosols-wiki/>)

discoloration of the product, or it can affect the usability of the product. For example, rust inside a spray starch can would ruin your clothes and would therefore make the product unusable. Internal corrosion is more likely to lead to failure than external corrosion, as any corrosive environment would be constantly present and can be more unique chemically than what is present outside the can. More specifically, internal corrosion can occur in four different scenarios (Figure 2):

1. Liquid Phase Corrosion
2. Vapor Phase Corrosion
3. Liquid-Vapor Interface Corrosion
4. Crevice Corrosion

The first two types of internal corrosion are fairly straight forward. Corrosion either occurs within the liquid phase of the can where the product sits (the lower portion), or it occurs in the vapor space above the liquid (the upper portion). The vapor space will contain the propellant (if it is a compressed gas), a small amount of the product in gas form, as well as any air and moisture that was not removed from the can during filling. Vacuum sealing the can is crucial to some applications, because water vapor in the air that stays in the can may lead to vapor phase corrosion, or liquid phase corrosion if it condenses.

Liquid-vapor interface corrosion occurs at the line between the liquid phase and the vapor phase due to the unique chemical mixture present where the two phases interact. If a liquid propellant is used, then there will likely be two interfaces – one between the product and propellant, and one between the propellant and the vapor phase.

Crevice corrosion is more a function of the geometry of the can. If the can is of two or three piece construction, there is a crevice created where the bottom is double-seamed onto the body. This crevice creates a unique chemical environment where one of the product ingredients or a contaminant can concentrate and accelerate corrosion. Crevice corrosion can also happen at the top of the can if there is a top double seam, or at the valve cup due to vapor phase corrosion, but this is less common. Crevice corrosion testing is typically conducted on new formulations to see if they are prone to this type of corrosion.

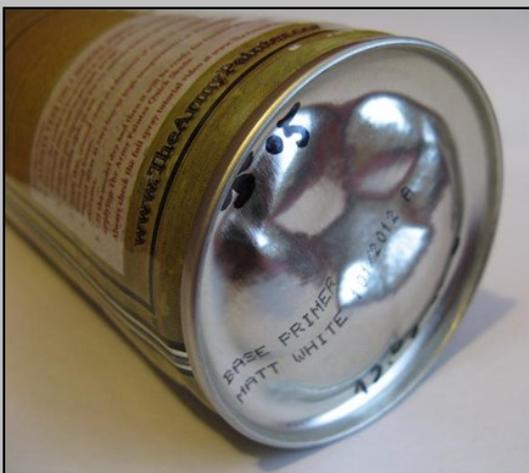
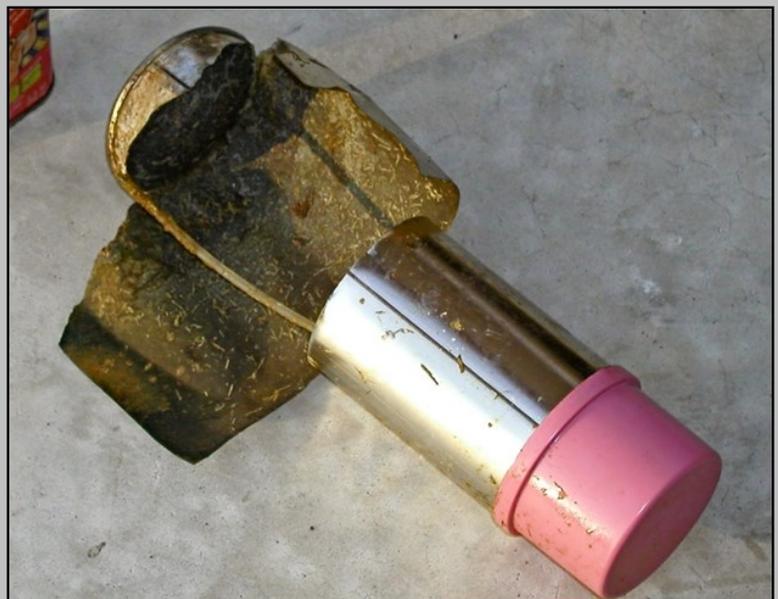
Figure 3. Left: Bulged bottom of an aerosol can (www.coolminiornot.com/forums/showthread.php?50293). Right: Burst can that split at the weld seam (metroforensics.blogspot.com/2014/11/safety-reminder-when-aerosol-cans-are.html).

Another way that aerosols may fail is if the rated pressure is exceeded and the can deforms or opens up (Figure 3). Aerosol cans are rated to withstand certain pressures during the filling process, storage, and use. Table 1 from Part 1 is repeated here to show the pressures that a can must withstand before buckling (deforming) and

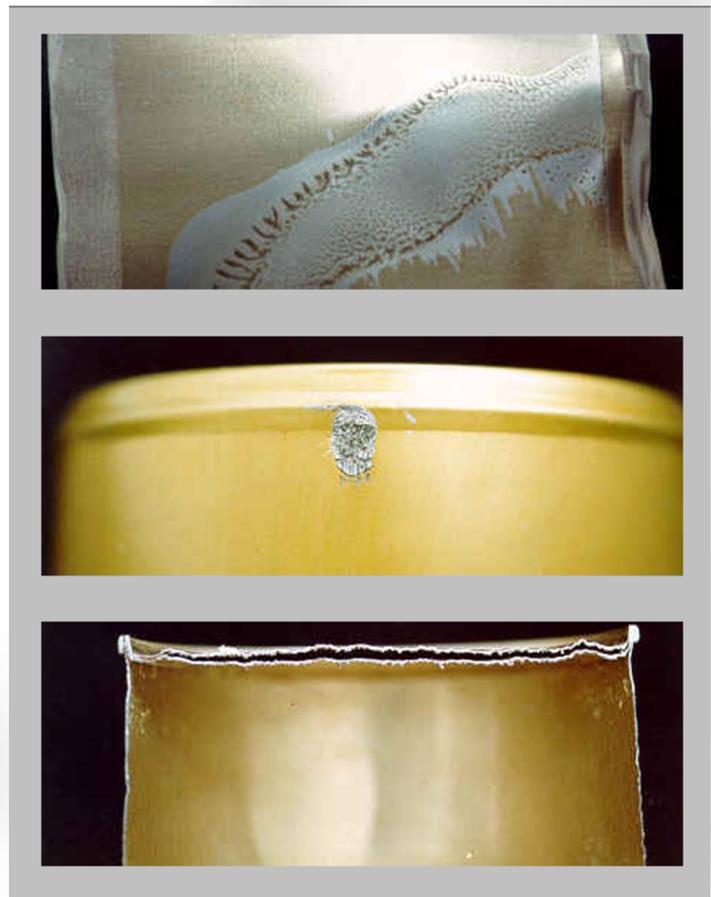
Figure 4. Examples of can manufacturing defects: top – coating skip, middle – coating drip, and bottom – double bottom (www.inspection.gc.ca/food/fish-and-seafood/manuals/metal-can-defects).

Some examples of aerosol can manufacturing defects are described here and shown in Figure 4. Parts may sustain mechanical damage in the manufacturing process, such as a burr getting stuck in a piece of equipment and scratching any

parts that come by. If the can is three-piece, there can be weld defects if the welding machine isn't operating at peak performance. Coating defects can occur if the paint isn't applied uniformly, or if the curing oven is at the wrong temperature. Wall thickness variations can be present either due to press operations or as supplied by the mill. Material defects could be present from the metal or coating supplier, e.g. the wrong temper of the metal. In addition, mistakes in the formulation of product can also be considered a defect that could lead to corrosion.

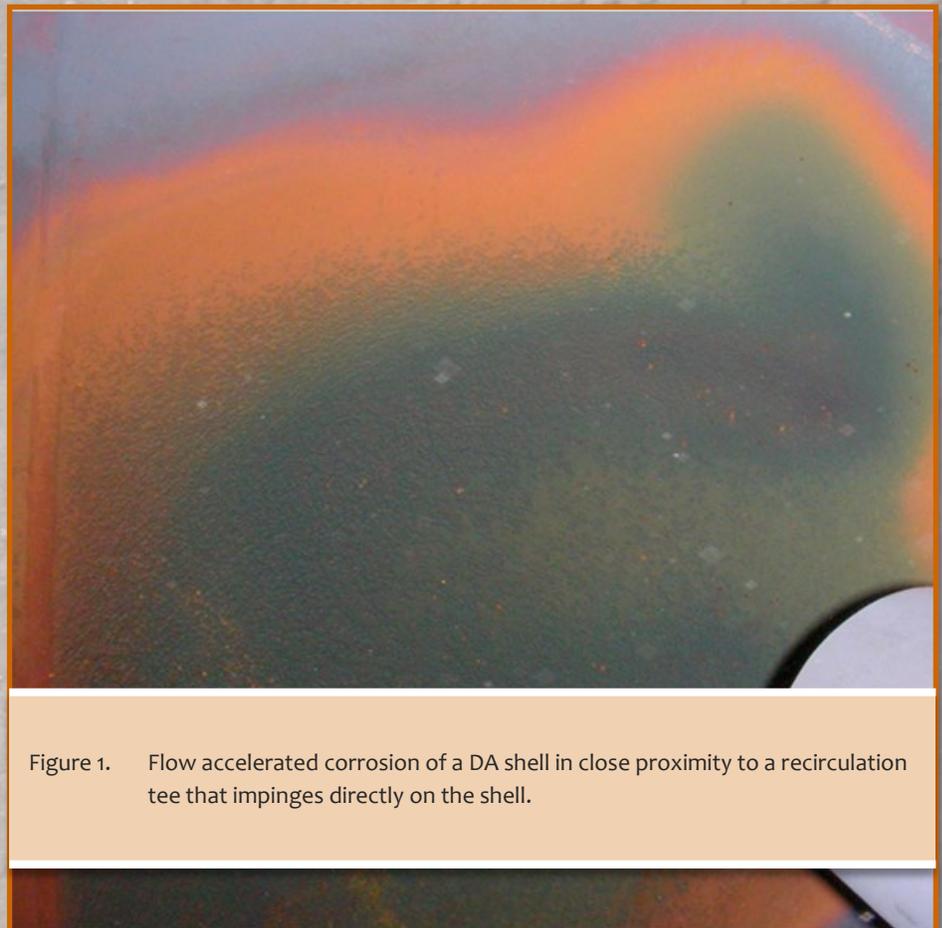
Figure 1. Flow accelerated corrosion of a DA shell in close proximity to a recirculation tee that impinges directly on the shell.

Visual inspection of the interior of the deaerator is the best means of detecting FAC, and when found, the remaining metal thickness can be measured using ultrasonic thickness testing. During the inspection, look for metal gouging, pitting or thinning where the metal has a polished appearance and/or a gray or black color, contrasting from the normal reddish-brown color of the deaerator interior. Areas in the deaerator most susceptible are the steam inlet where steam enters the end of the vessel, where steam/water flows under the trays, and where water exits through bottom outlet pipes that connect to the DA storage tank. Examples of typical FAC damage are shown in Figures 1-4.

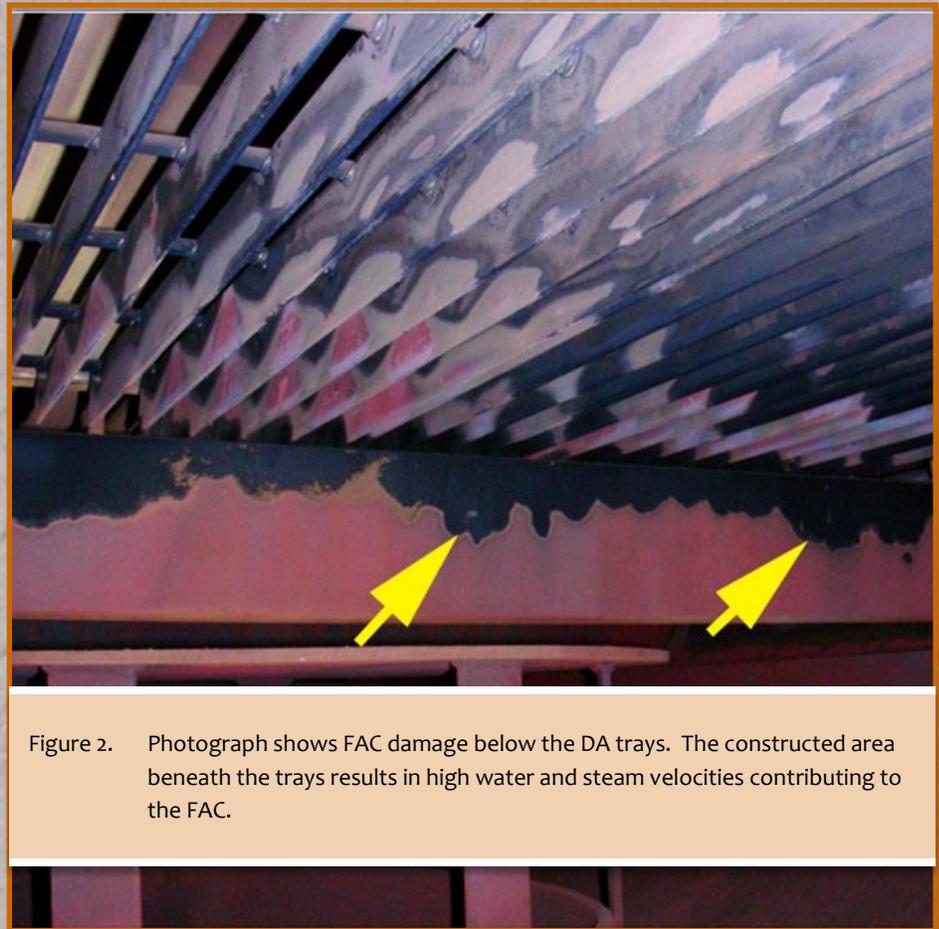
Figure 2. Photograph shows FAC damage below the DA trays. The constructed area beneath the trays results in high water and steam velocities contributing to the FAC.

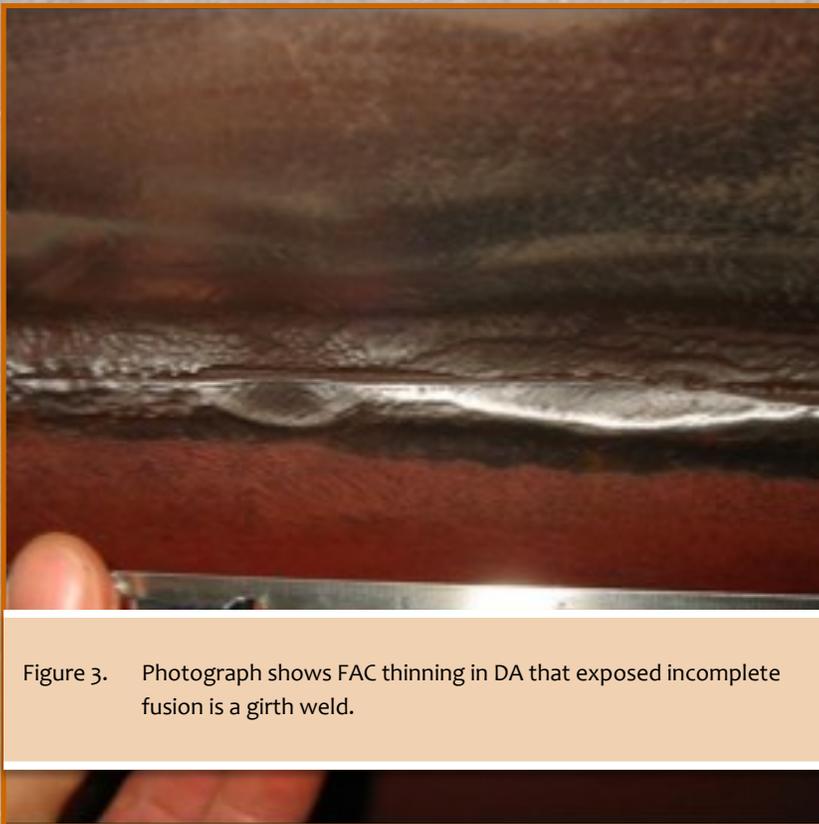
Figure 3. Photograph shows FAC thinning in DA that exposed incomplete fusion in a girth weld.

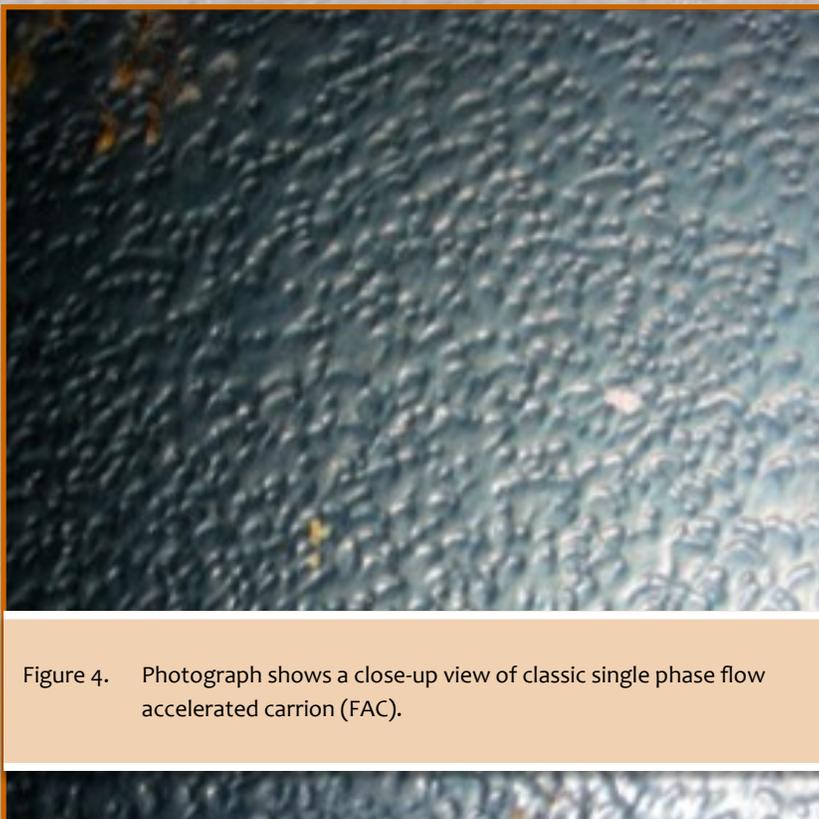
Figure 4. Photograph shows a close-up view of classic single phase flow accelerated corrosion (FAC).

FAC can occur when the liquid water phase is present (single-phase FAC), or when a combination of both water and steam are present (two-phase FAC). While the result of both single and two-phase FAC is the same (metal thinning), the visual appearance of the damage is different. Single-phase FAC will have a scalloped (orange peel) appearance while two-phase will have a horse-shoe shaped gouging or tiger-striping.
