M&M Engineering's Boiler Tube Failure Handbook

Crack—Not in or near a weld—Longitudinal

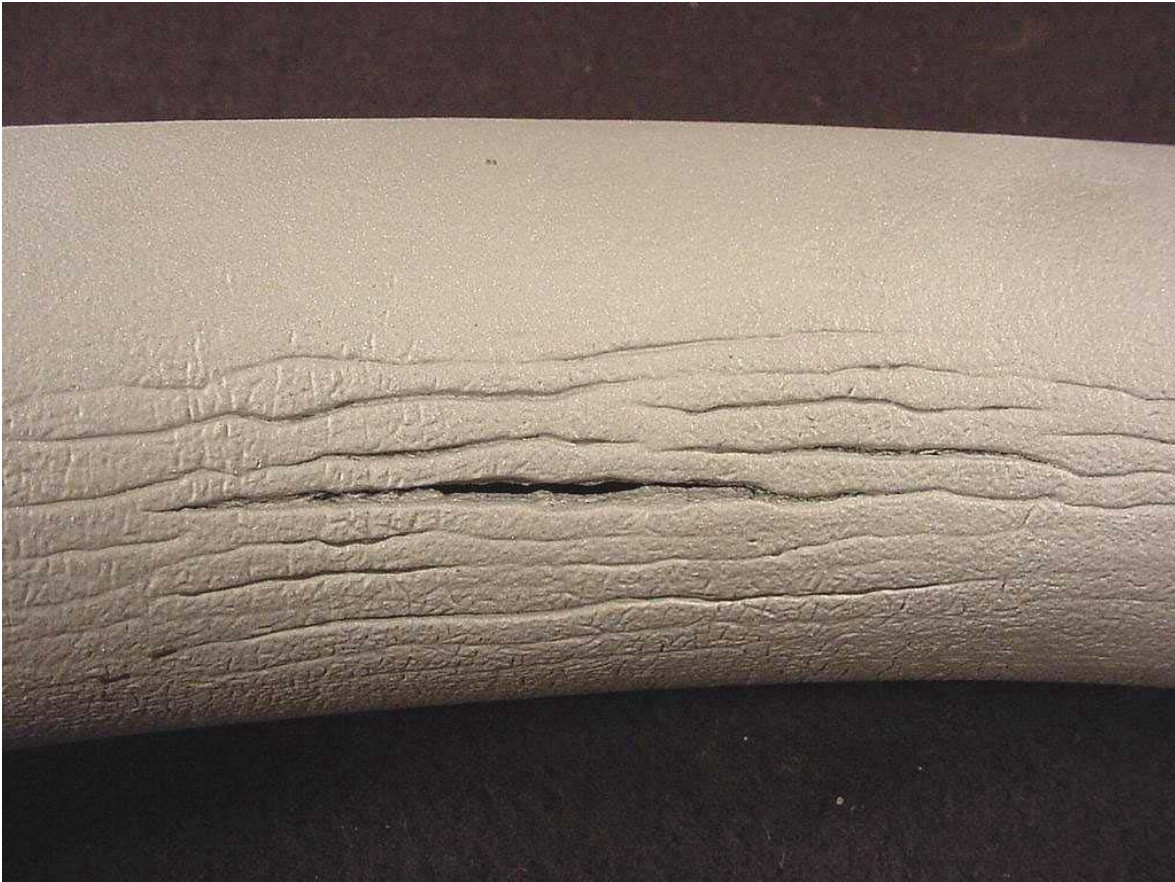
Locations	Superheater, Reheater
Boiler Type	Power
Industry	Electric Utility

Appearance	Thick-lipped rupture and adjacent longitudinal fissuring
Mechanism	Creep
Comments	Prolonged exposure (over 40 years) to high-temperature service.
