the Conduit

Summer 2008

Recovery Boiler Lower Furnace Problems

**By Ronald Lansing, P.E.
and Max Moskal**

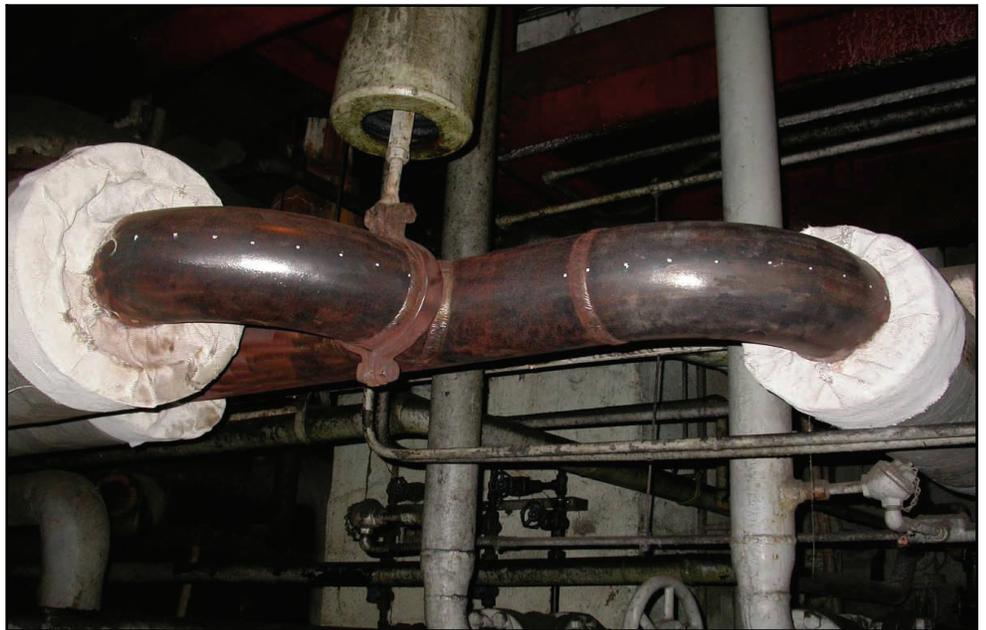
Surprisingly, evaluation of the boiler feedwater piping determined that very little thinning had occurred during the past fifty years of operation. Localized thinning down to 67% of the nominal thickness was measured on one elbow. On average, boiler feedwater piping thicknesses were near the nominal thickness. Since little thinning had occurred, it was recommended that future inspections of the boiler
