A quarterly publication from M&M Engineering Associates, Inc.

#### Vol. 14, No. 3

## **Failure Mechanisms Working in Collusion**

## Why These Two and Not the Others?

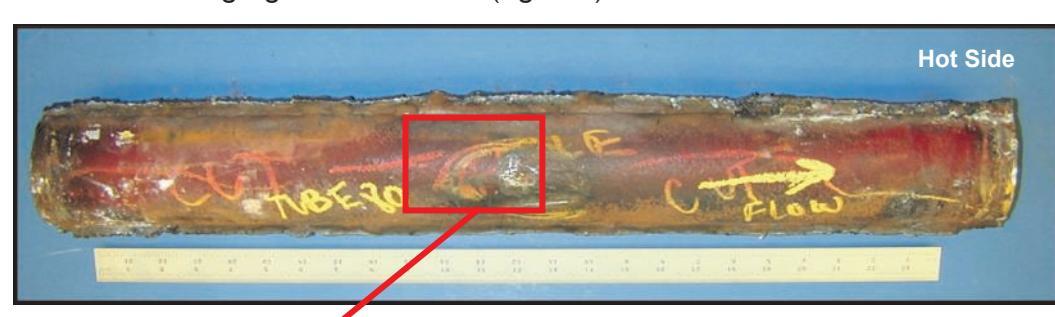
We received a boiler floor tube that contained a bulge and large blister on the hot side, with a likely throughwall failure at the peak of the blister (Figure 1). The tube was sectioned about 2 inches away from the blister to reveal significant thinning and gouging of the tube wall (Figure 2). The tube sections were then split longitudinally to examine the internal surfaces. Heavy, layered deposits that were red, gray, and white in color were noted within the gouge on the hot side (Figure 3).

There were also some patches of green deposit and copper-colored deposits. The gouge was approximately 1.5 inches wide and ran almost the entire length of the tube sample (about 18 inches).

The appearance of the gouge and the deposits was consistent with an under-deposit corrosion mechanism such as caustic gouging.

Figure 3. Photograph shows the internal surface of the tube in the failure area with layered deposits.

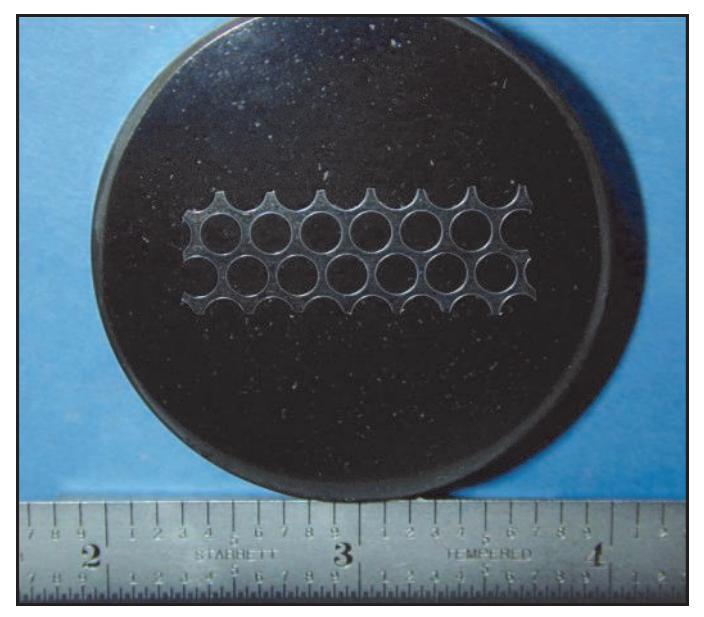
Samples from all the baskets were prepared for metallographic examination followed by examination using an metallograph (Figure 8). This was done in order to evaluate the fracture morphology corresponding to the cracked ligaments and to identify any anomalies. Examination of the fractured ligaments showed that the fracture surfaces primarily had a transgranular (across the grain) morphology (Figure 9). Secondary cracks having a transgranular morphology were also noted. In addition, small pits along the perforated surface were observed. (At many locations, it appeared that the secondary cracks originated from the small pits.)

Figure 8. Photograph shows a sample of the basket as prepared for metallographic examination.
