The Metal Never Lies

the CONDUIT

VOL 18, NO 1

Part 1 of 3: Fractography

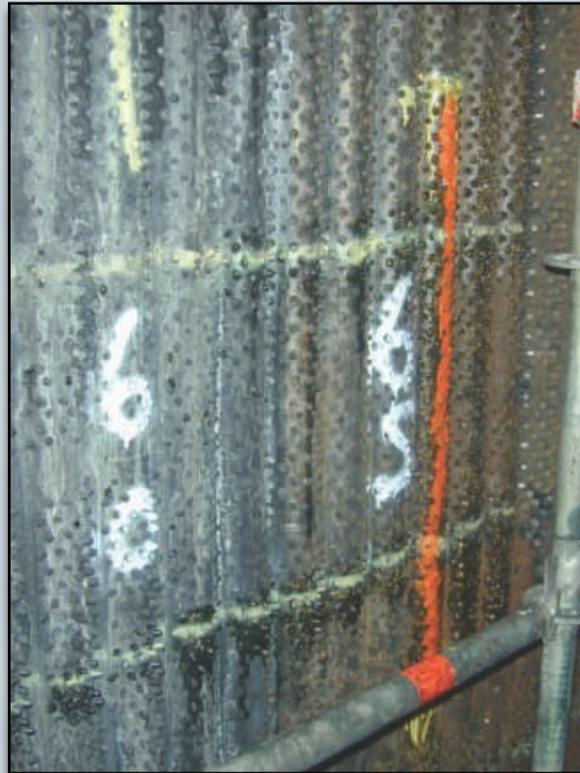
Figure 1. Photograph shows how lower furnace studded tubes can become thin and difficult to test with UT between studs. Thinned tubes can be seen in the orange area.

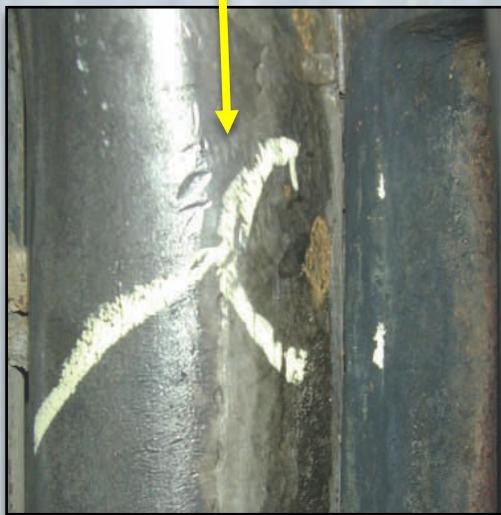
Figure 2. Photographs show a primary air port “balding” (rusty steel exposed).

At the air ports, inspections and metallurgical studies have shown that the thinning mostly occurred in the stainless steel. Small bald spots (Figure 2) thin much slower and could be more easily monitored and repaired by welding as necessary. Many mills used

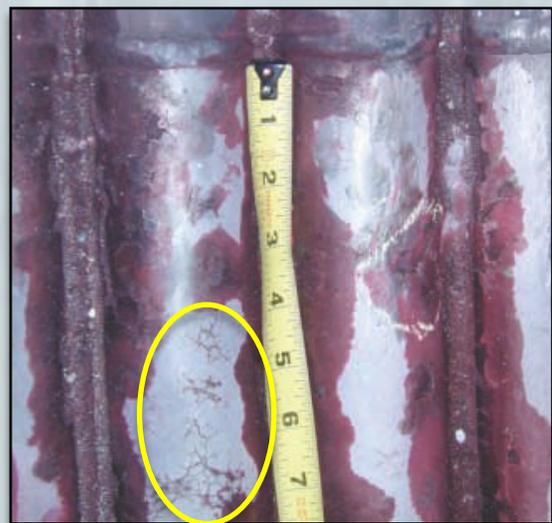
Figure 3. Photograph shows how SCC on a stainless steel clad floor tube can lead to spalling (circled).

Floor tube stress corrosion cracking (see Figure 3) under the smelt bed was found to be due to contact with hydrated smelt in the critical tube temperature range of 300°F to 400°F. Most of these cracking problems occurred when boilers were reheated above 300°F for dryout while the tubes were in contact with the smelt. The cracking that had been identified using penetrant dye testing seemed to be present mostly within the stainless clad metal and self-arrested areas at the carbon steel interface. If cracking in 304L composite floor tubes occurs, it is often best to wait until cracking becomes more widespread to replace the tubes, and then use the Alloy 825 (high nickel

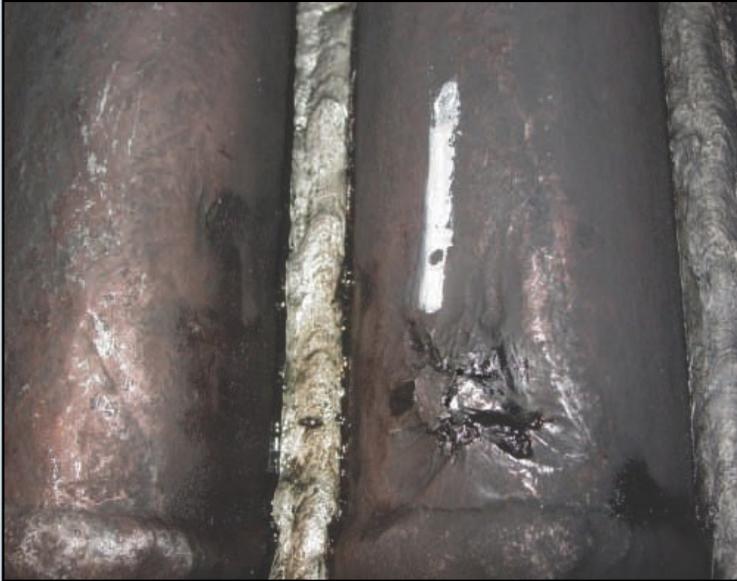
Figure 4. Photograph shows a floor tube leak at a weld. The low flow of the horizontal tube combined with weld drop-through initiated DNB tube overheating/thinning.

horizontal floor designs were. The horizontal floor tubes can be prone to low-flow problems, sometimes leading to localized tube overheating (Figure 4). In addition, sagging can cause low areas in the floor, which may further inhibit flow (Figure 5).

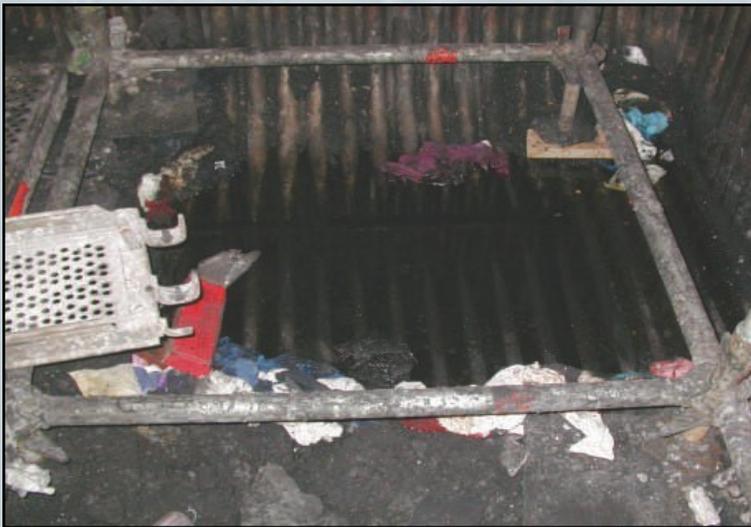
Figure 5. Photograph shows a decanting floor, a low area which inhibits water circulation, with the smelt bed removed.
