M&M Engineering's Boiler Tube Failure Handbook

Hole—Fireside

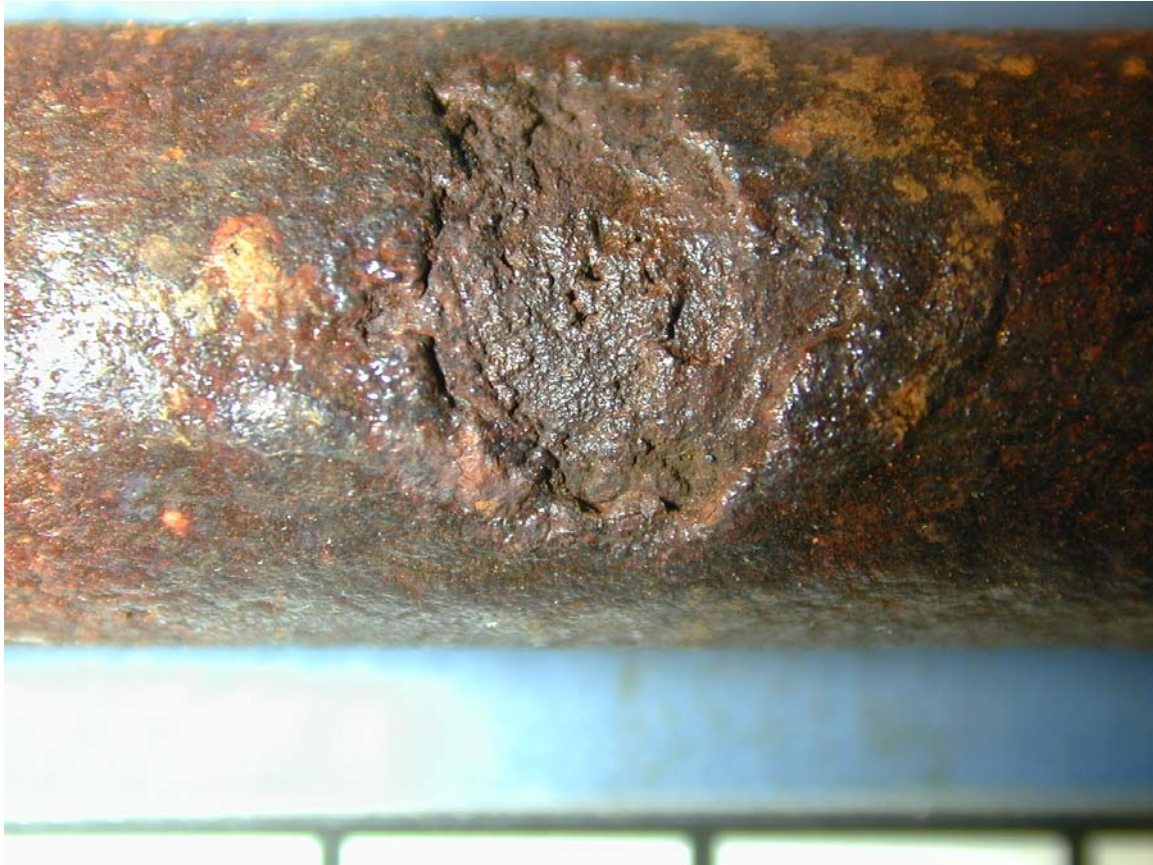
Locations	Waterwall
Boiler Type	Reformer
Industry	Petrochem

Appearance	Metal wastage
Mechanism	Fireside Corrosion
Comments	Corrosion often due to sulfur in the fuel creating acidic deposits.
