M&M Engineering's Boiler Tube Failure Handbook

Crack—In or near weld or attachment—Transverse

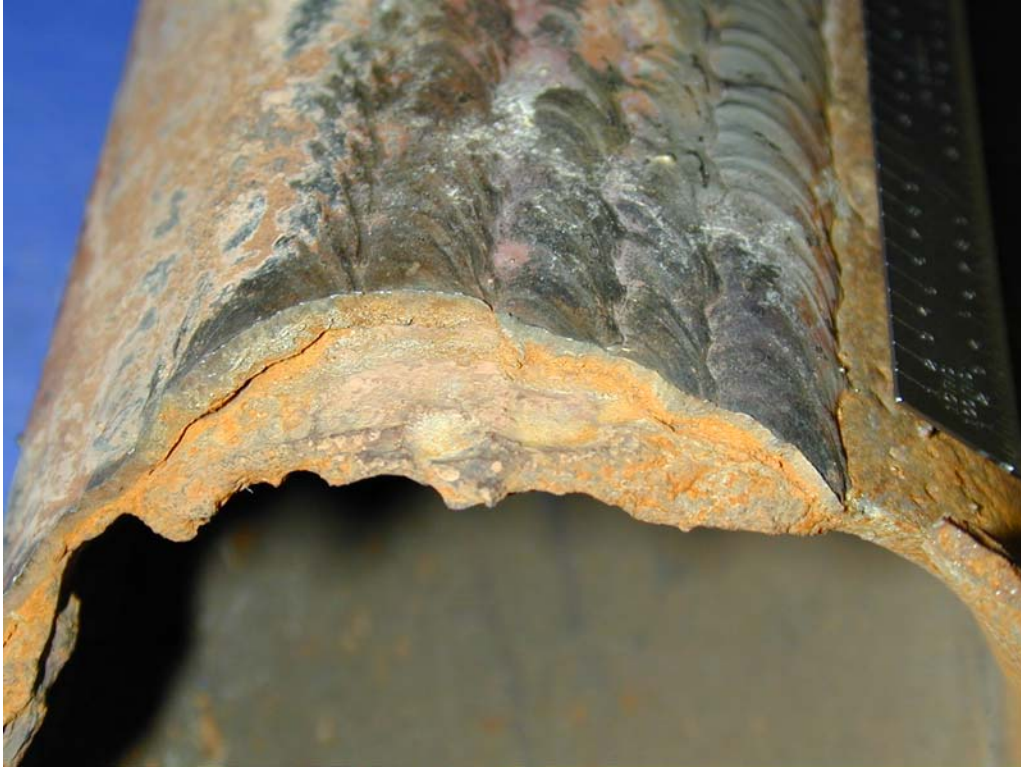
Locations	Waterwall
Boiler Type	Power
Industry	Electric Utility

Appearance	Catastrophic failure associated with weld overlay
Mechanism	Hydrogen damage
Comments	Hydrogen damage is an under-deposit corrosion mechanism. Weld overlay exacerbates hydrogen damage. High probability that other tubes are similarly affected. All affected tubes must be replaced.
