M&M Engineering's Boiler Tube Failure Handbook

Crack—Not in or near a weld or attachment—Longitudinal

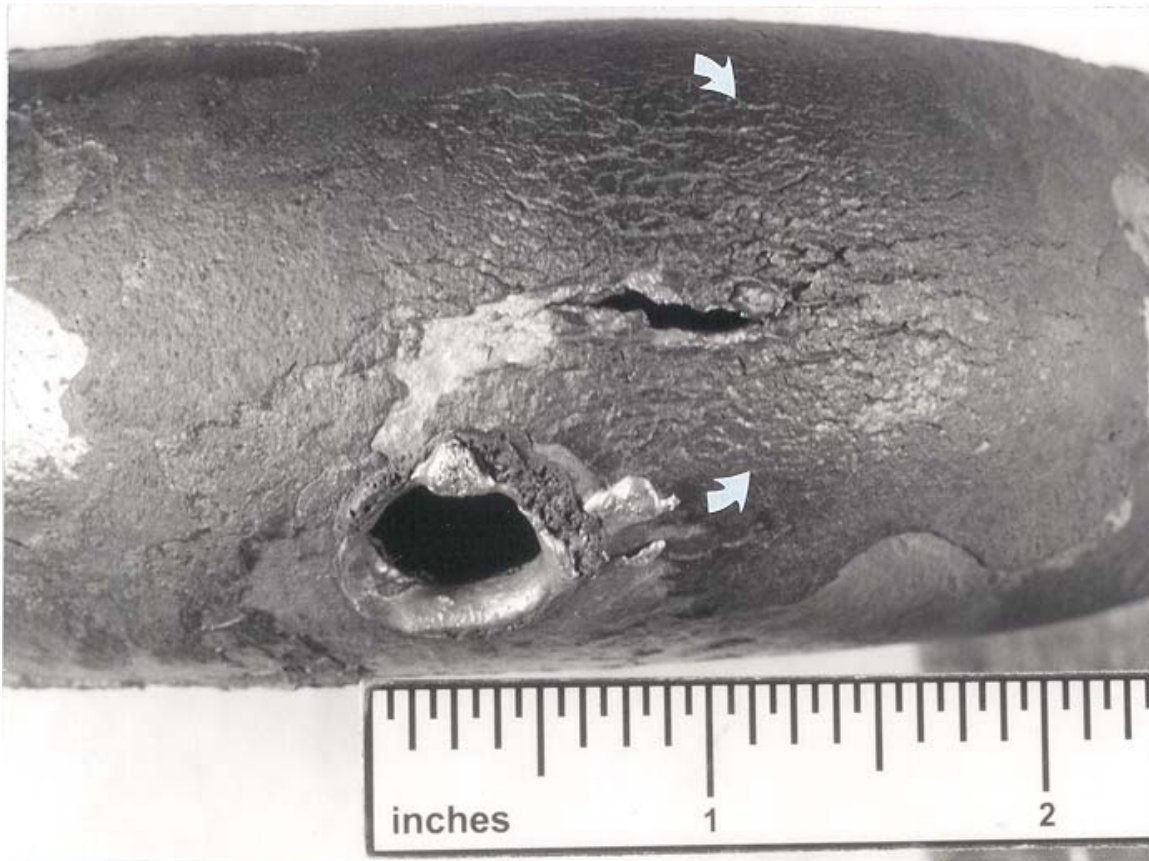
Locations	Superheater
Boiler Type	Industrial
Industry	Process/Heating

Appearance	Multitude of cracks parallel to tube
Mechanism	Long Term Overheat/ Creep
Comments	Deposits can accumulate in the bottom bend of superheaters acting as insulation and contributing to a long-term overheat condition. (Hole was created by cutting torch and is not part of the failure)
